Corrosion Repair Strategies for Steel Girder Ends Using High Performance and Traditional Materials

FINAL REPORT

CONTRACT # 4400018535 / 511801
WORK ORDER # PIT 002

University of Pittsburgh
Civil and Environmental Engineering

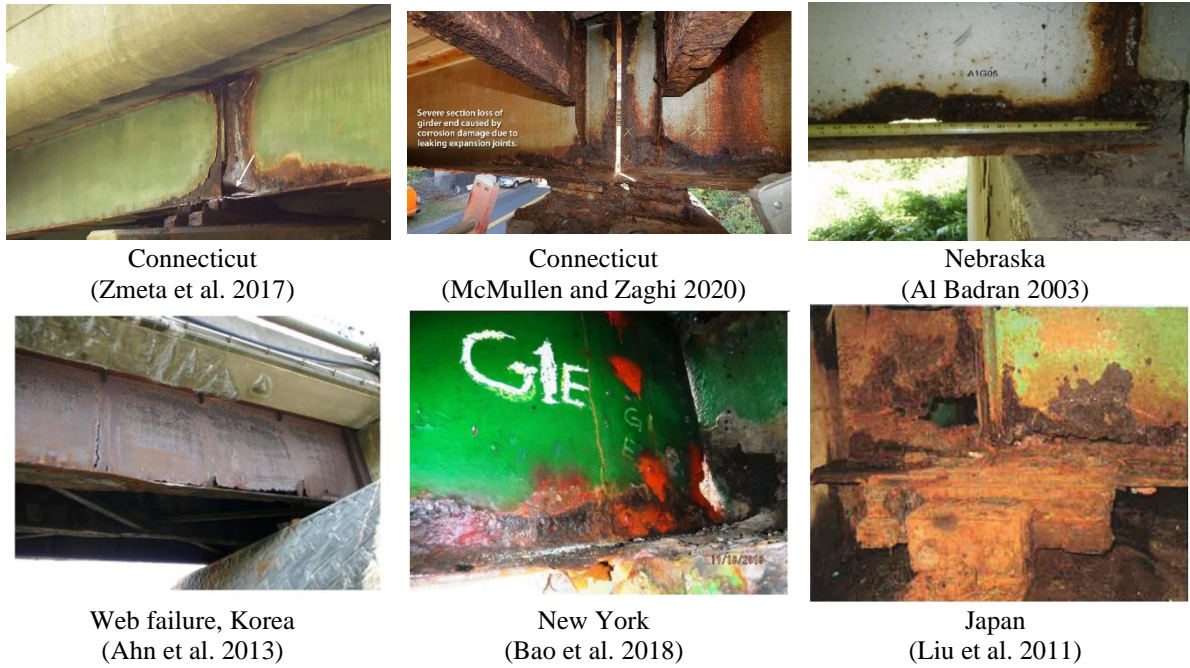
Figure 2 Examples of beam end corrosion.

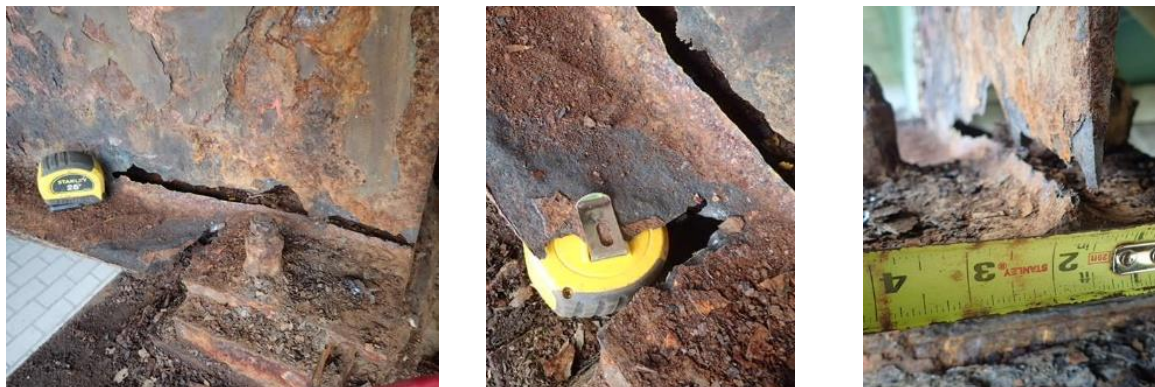
A few reports identified distortion of the corroded girders at the end bearings. Bridge B exhibits an extreme example of M1 damage – the complete loss of the web section above the bearing extending approximately one bearing length into the span (Figure 5a). This bearing region also has what appears to be a cut through the entire flange just inboard of the bearing (Figure 5b). The combination of the loss of web section, the absence of a bearing stiffener, and the now nonsymmetric section results in a lateral displacement of the web as seen in Figure 5c. It should be clear from Figure 5 that without a bearing stiffener, this girder end is presently carrying no appreciable load. Bridge B has only four girders and therefore a considerable incremental load has been redistributed to the remaining three girders at this pier support. Although not noted and not seen in Figure 5, one expects a distortion of the flange to accompany this damage.

a) Pattern M1 damage
(b = 17 in.; a = 1.5 in.)

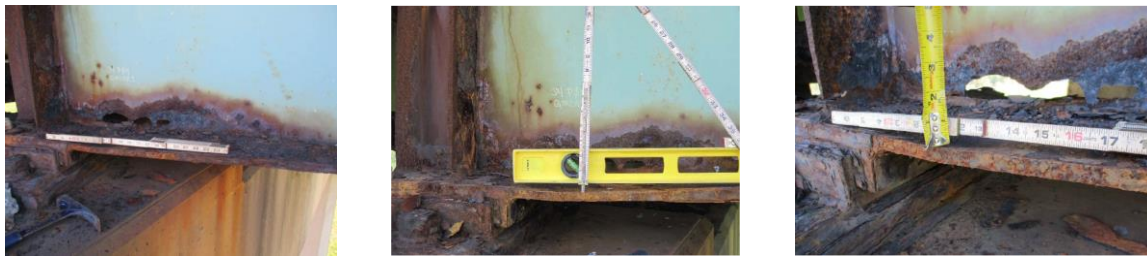
The loss of web support at the bearing – particularly associated with Pattern M1 damage – leads to the lower flange being placed in flexure about its own weak axis as long as some bearing resistance remains. Bridge J, shown in Figure 6, has bearing stiffeners. In this case, the loss of web section has resulted in an unsupported flange as shown by the obvious flexural distortion seen in Figure 6.

a) Pattern M1 damage
(b = 10 in.; a = 2 in.)

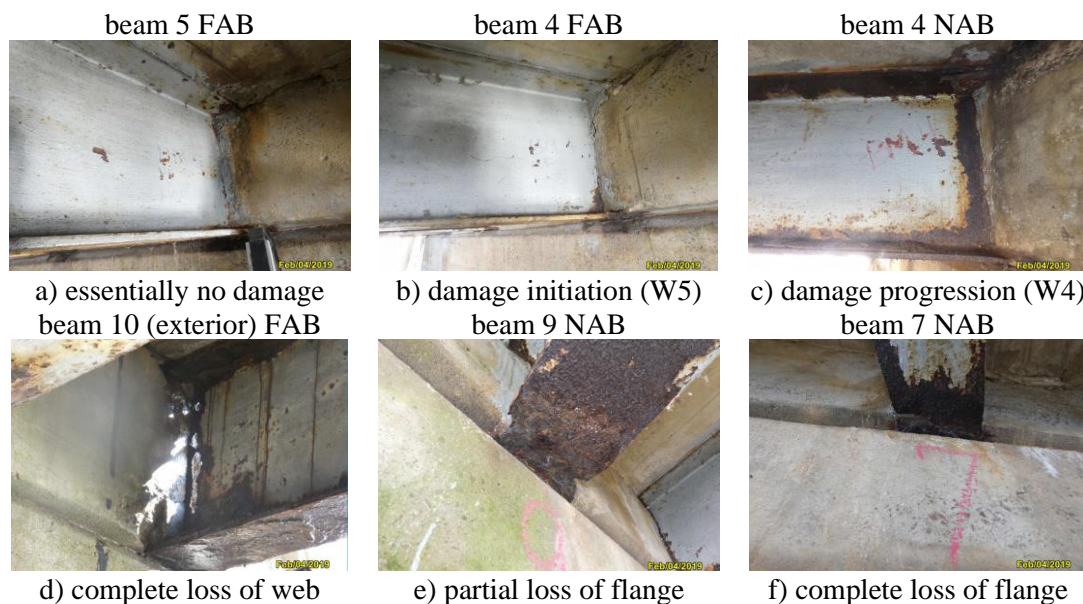
Each of the bridges having embedded bearings exhibited significant damage at the face of the embedment, up to and including complete loss of the web section. Figure 7 shows the spectra of such damage observed in single structure (Bridge O).

Figure 7 Spectra of damage at embedded beam ends of single bridge (Bridge O)

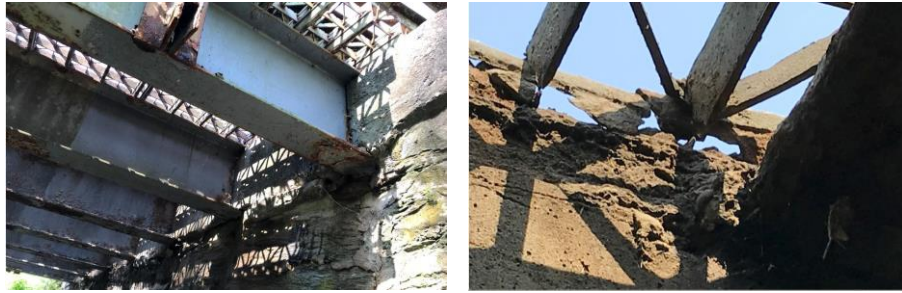
a) condition of far abutment prior to encasement (pre 2020)

note relatively little beam end corrosion compared to near abutment shown in Appendix A.

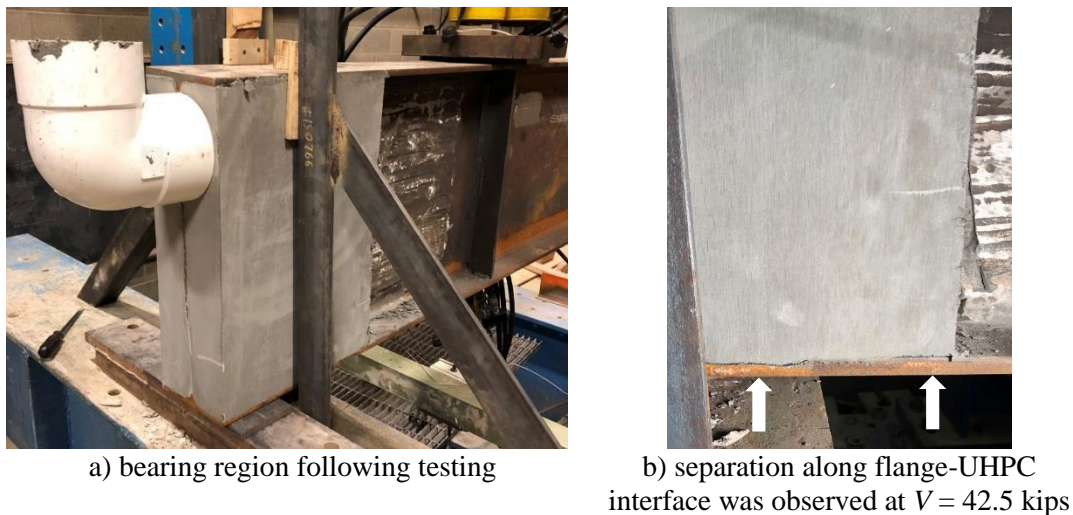
Figure 52 Girder 4A following testing.

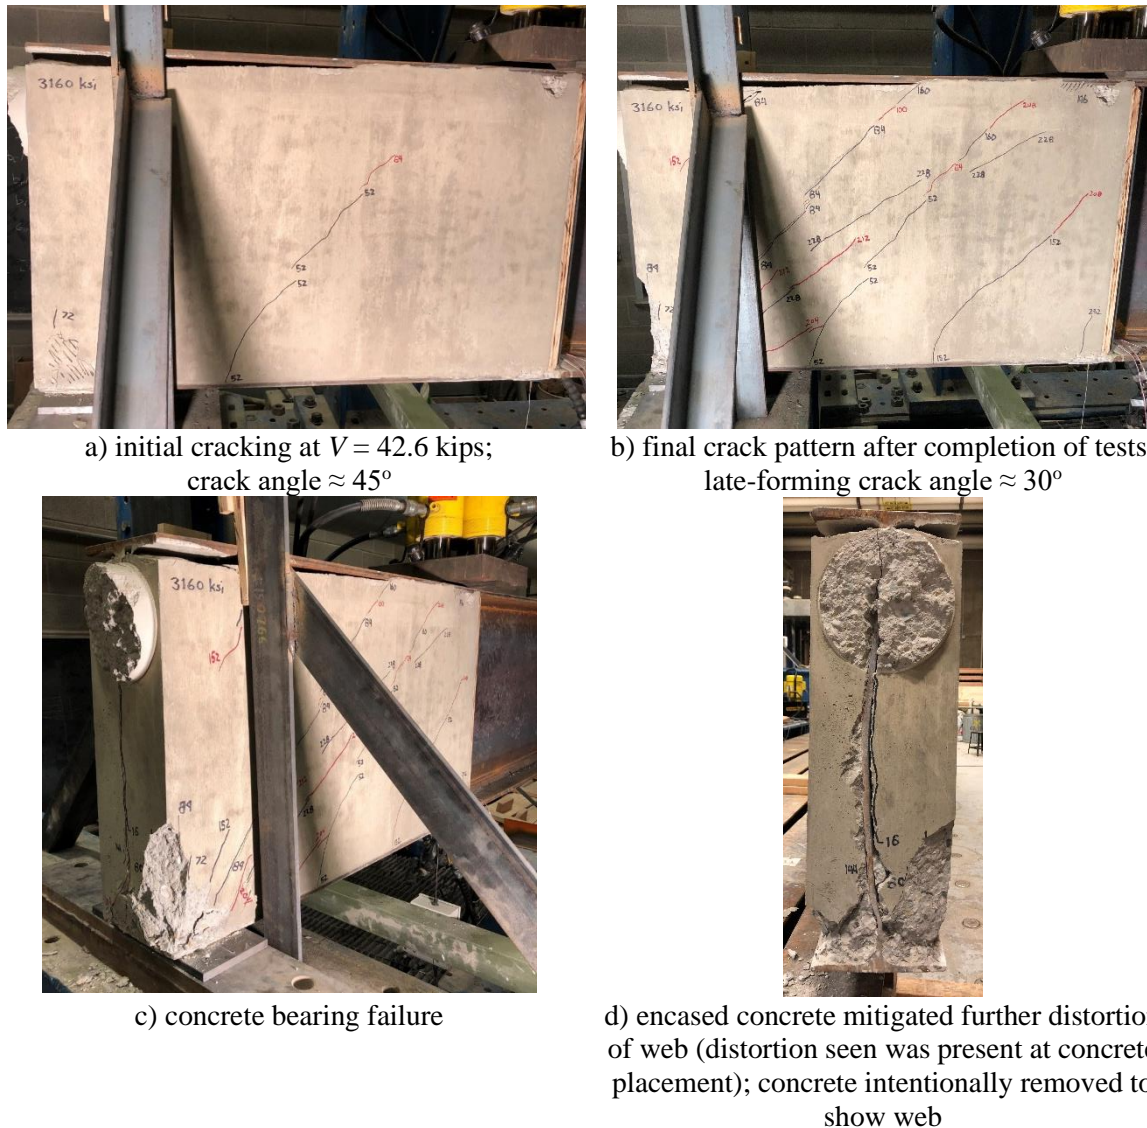
Figure 53 Girder 5A during and following testing.

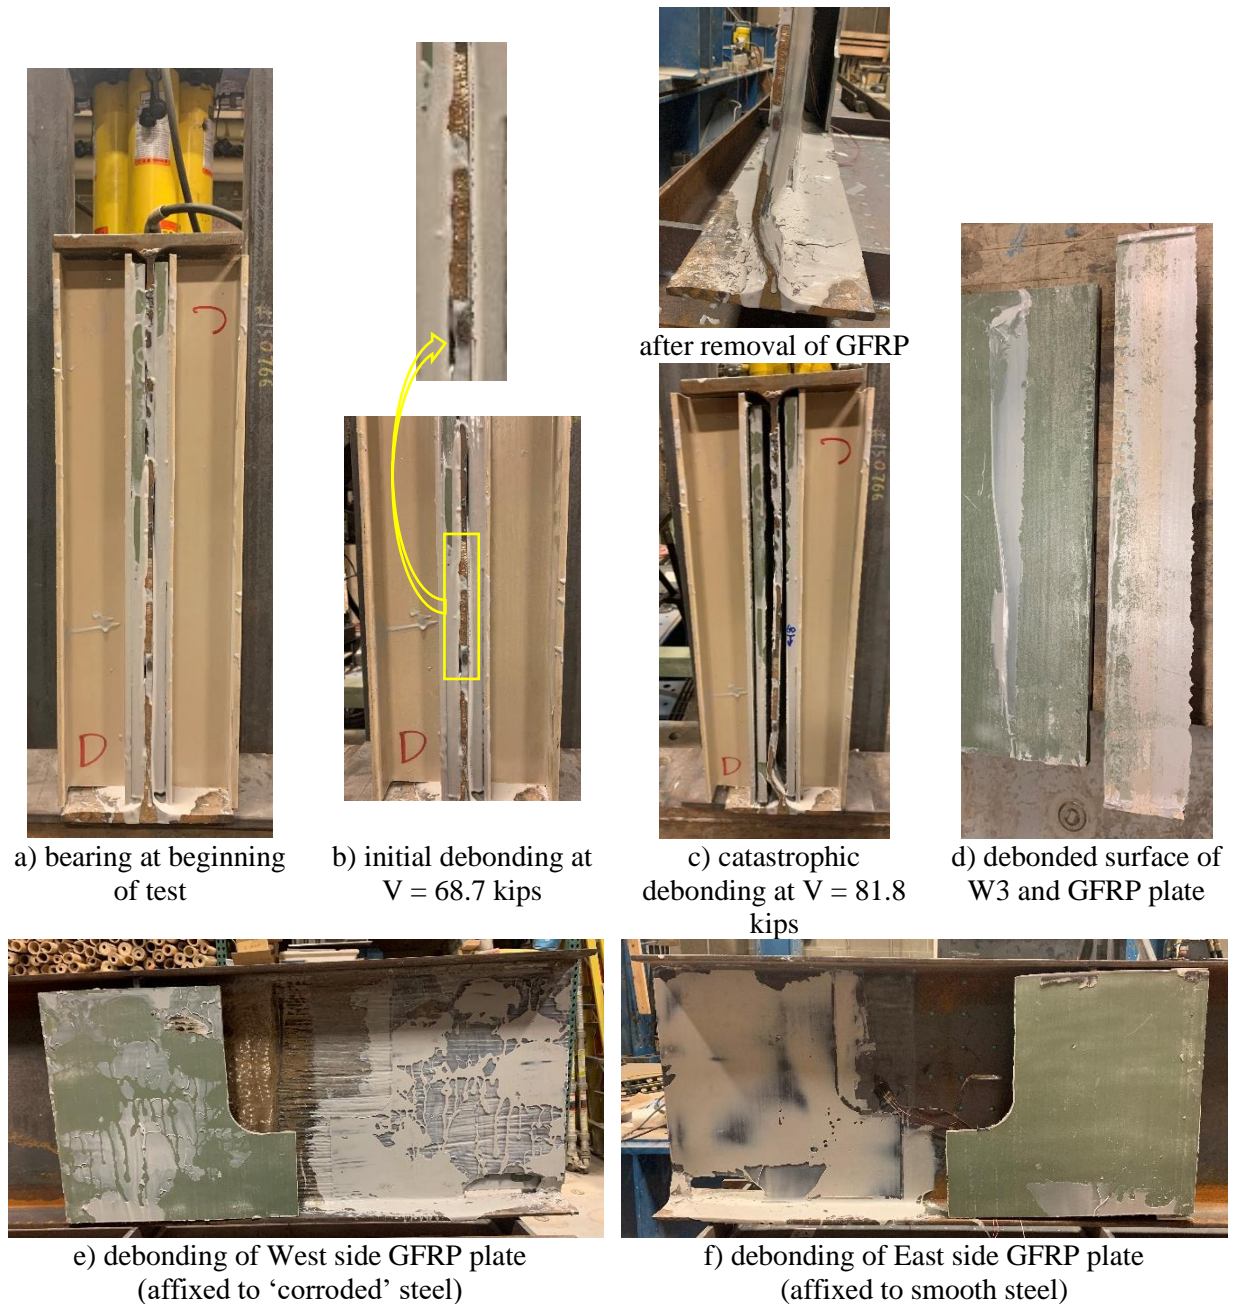
Figure 54 Girder 6A following testing.

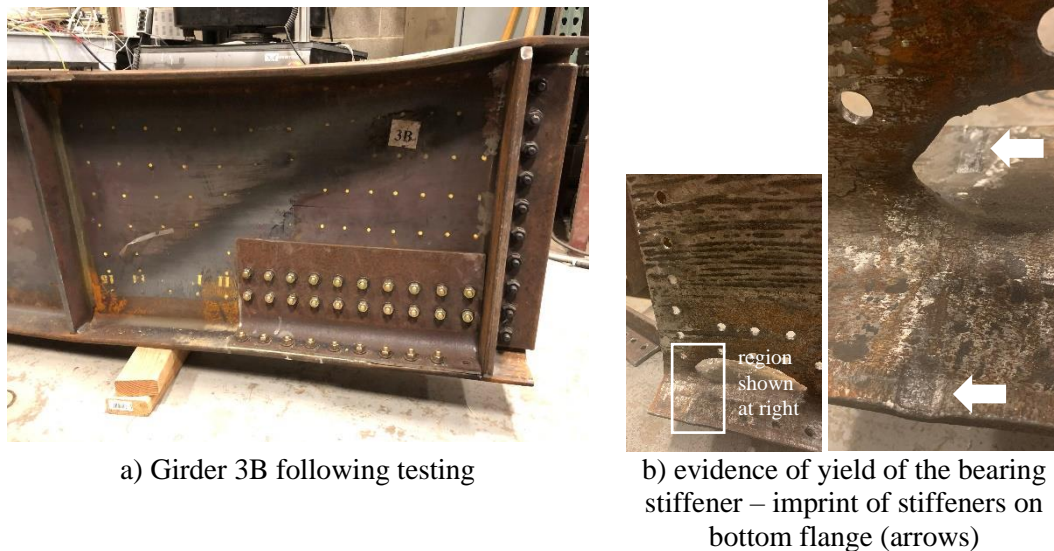
Figure 59 Girder 3B following testing.

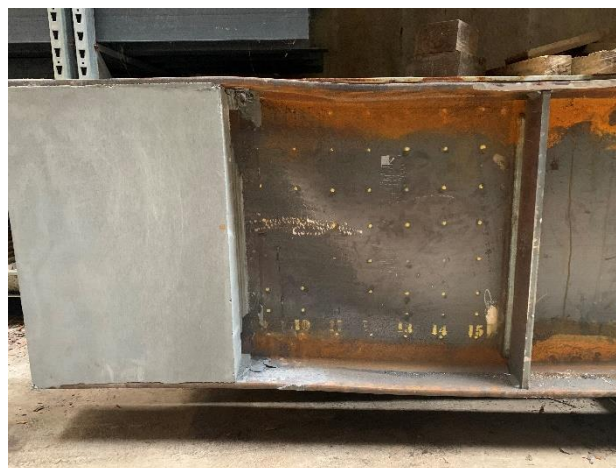
Figure 60 Girder 4B following testing showing panel buckling of the unencased portion of the web.

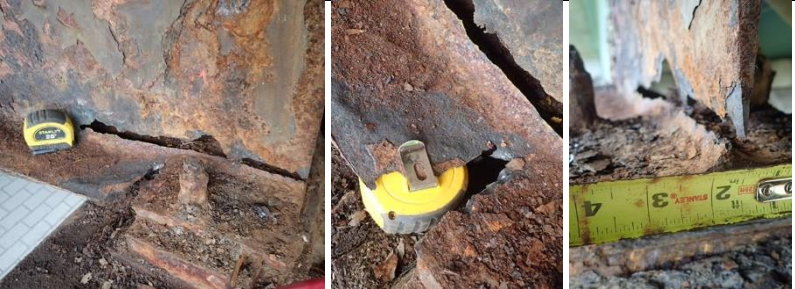
<p>Pier 3 Span 4 Beam 2</p>	<p>M1: $b = 4$; $a = 0.5$; inboard of bearing CL M1: $b = 3$; $a = 3$; end of beam</p>

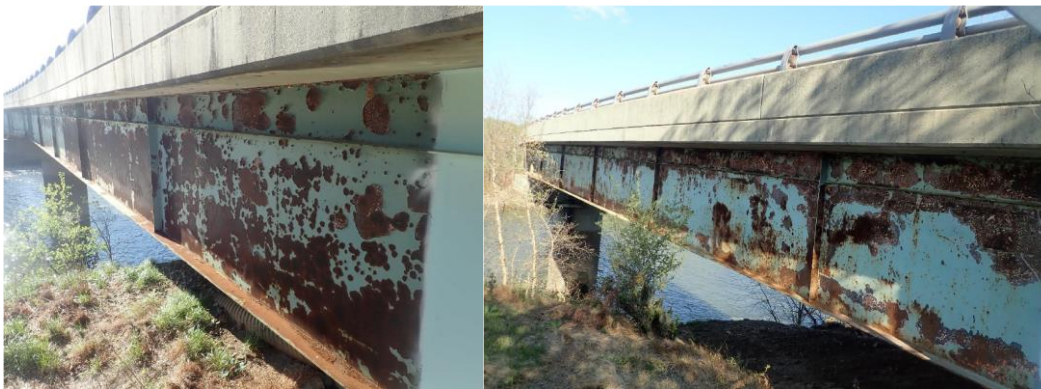
Near Abutment	Beam	Far Abutment
M1: b = 7; a = 3.5 M1: b = 5; a = 4 no other details provided	1	beam end corrosion noted, no other details provided
beam end corrosion and section loss noted, no other details provided	2	M1: b = 9; a = 3 M1: b = 9; a = 4 no other details provided
M1: b = 5; a = 1.5 M1: b = 3.5; a = 1.5 M1: b = 9; a = 4 $t_{w \min} = 0.113''$ (15%) $t_{bf \min} = 0.528''$ (70%) no other details provided	3	M1: b = 10.5; a = 2 M1: b = 9; a = 7 no other details provided
$t_{w \min} = 0.299''$ (40%) $t_{bf \min} = 0.528''$ (70%) no other details provided	4	M1: b = 7; a = 2 no other details provided
beam end corrosion and section loss noted, no other details provided	5	beam end corrosion noted, no other details provided
