# Development of a Strategic Plan to Upgrade Stations on the Keystone Corridor

Final Report

JULY 7, 2009

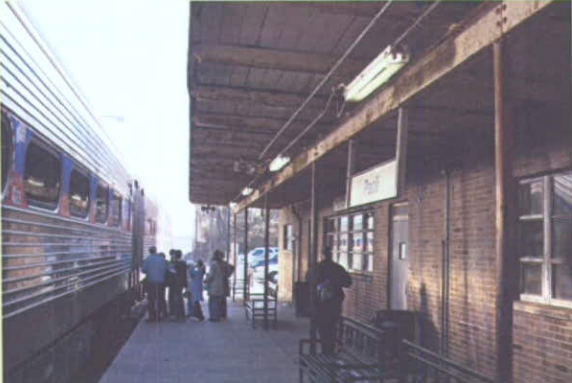
Warning Strips – Eastbound Platform	
Platform	
Type	Yellow paint
Surface	Smooth
Dimensions	Eight inches by 660 feet
Condition	Poor
Photograph

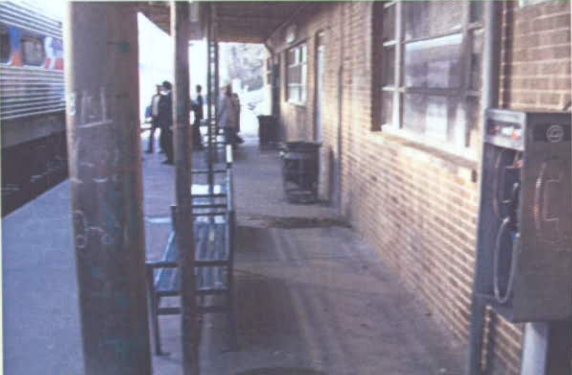
Surface Condition – Eastbound Platform	
Primary Platform	
Surface	Concrete
Dimensions	20 feet by 660 feet
Condition	Good
Photograph

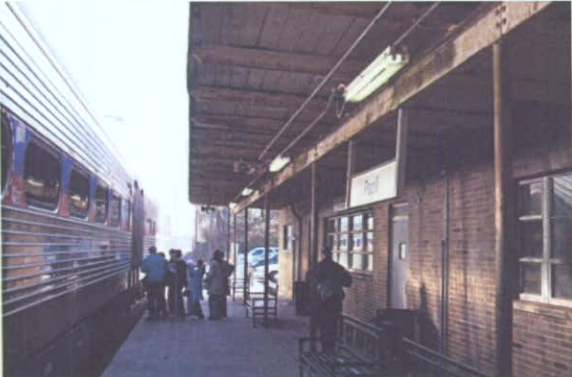
Lighting – Eastbound Platform	
Canopy	
Type	Incandescent
Quantity	Nine
Condition	Good
Photograph

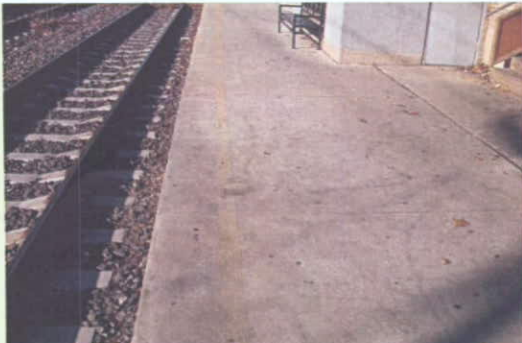
Surface Condition – Westbound Platform	
Platform	
Surface	Concrete
Dimensions	Ten feet by 380 feet
Condition	Good
Photograph

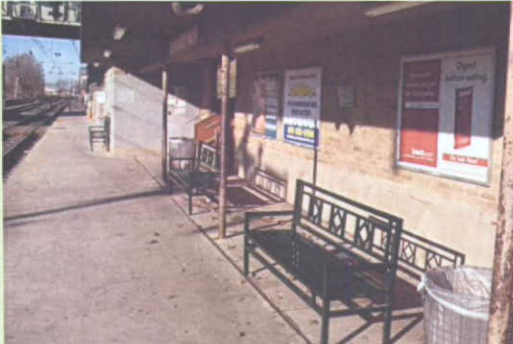
Seating and Shelter – Westbound Platform	
<i>Shelter</i>	
Type	Metal benches
Condition	Good
Quantity	Three
Covered	Yes
Photograph

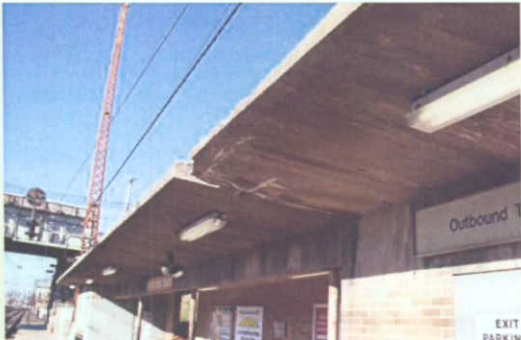
Lighting – Westbound Platform	
<i>Ceiling of Shelter</i>	
Type	Florescent/incandescent
Quantity	Five/one
Condition	Good
Photograph

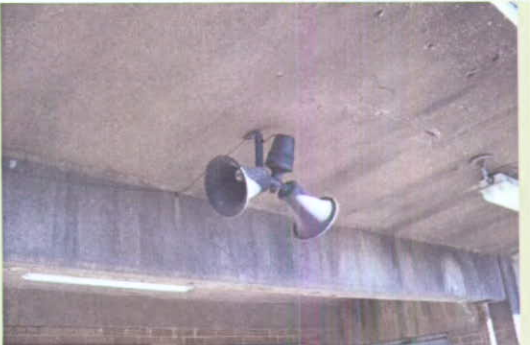
Schedule and Public Address Speaker – Westbound Platform		
	Schedule	Public Address Speaker
Type	None	One speaker
Condition	N/A	Good
Clarity	N/A	Not observed
Secured	N/A	Yes
Photograph

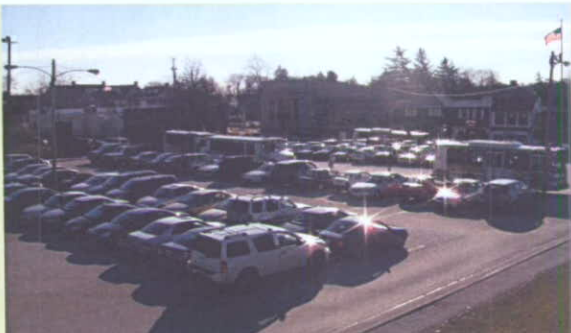
Parking/Loading – Eastbound Platform	
<i>Parking Lot Adjacent to Platform</i>	
<i>Total Spaces</i>	133
<i>Handicap Spaces</i>	Three
<i>Surface</i>	Asphalt
<i>Curbing</i>	Yes
<i>Condition</i>	Good
<i>Dimensions- Parking stall</i>	Nine feet by 20 feet
<i>Interior Travel Lanes</i>	24 feet
<i>Lot Access</i>	24 feet
<i>Fair Box</i>	Yes
<i>Daily Fee</i>	\$1.00
<i>Parking Overflow</i>	No
<i>Passenger Loading</i>	Yes
<i>Photograph</i>

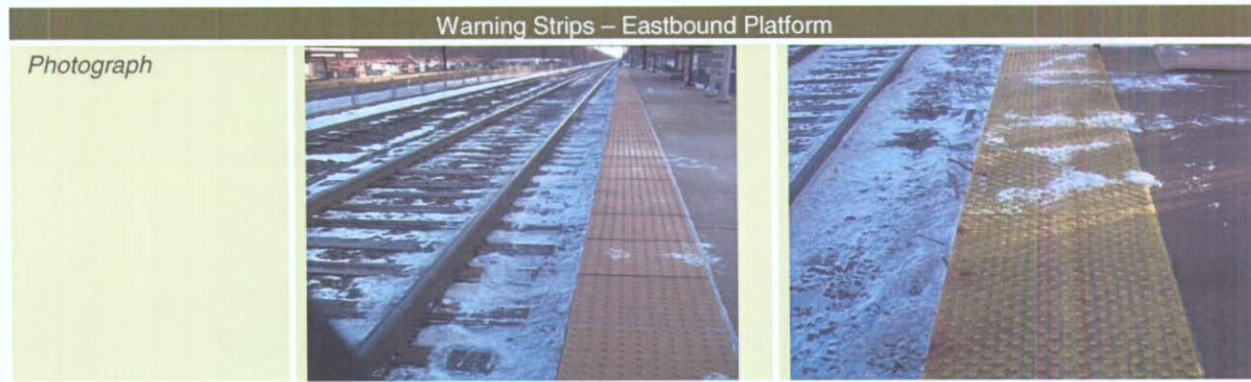
Warning Strips – Eastbound Platform		
	Primary Platform	Mini-High Level Platform
Type	Cast in place detectable/tactile warning system	Surface applied detectable/tactile warning system
Surface	Concrete	Plastic
Dimensions	Two feet wide by 284 feet length	Two feet wide by 18.5 feet length
Condition	Excellent	Excellent

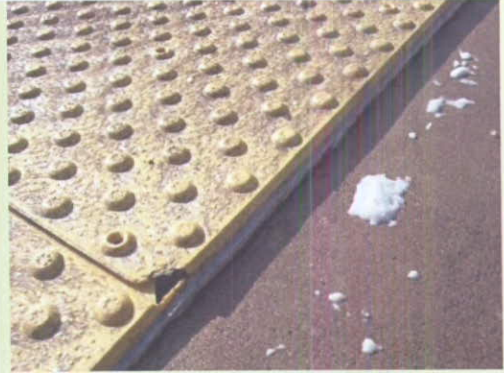
Warning Strips – Westbound Platform		
	Primary Platform	Mini-High Level Platform
Type	Cast in place detectable/tactile warning system	Surface applied detectable/tactile warning system
Surface	Concrete	Plastic
Dimensions	Two feet width by 199 feet length	Two feet width by 18.5 feet length
Condition	Excellent	Good - some slight buckling is beginning.
Photograph

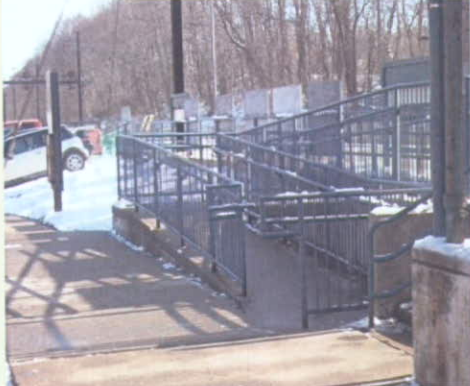
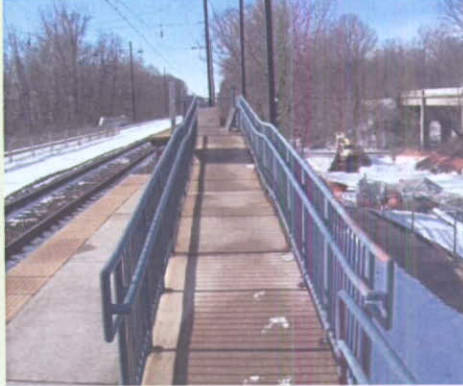
ADA Accessibility – Westbound Platform		
	Primary Platform	Mini-High Level Platform
Type	Wheelchair ramps Railing Tactile warning strips	Wheelchair ramps Railings Tactile warning strips
Surface	Concrete- ramps and warning strips	Concrete - wheelchair ramps Railings - painted metal Plastic - tactile warning strips
Number	Wheelchair ramps (two) Warning strips- entire length	Two ramps Railings - entire length of wheelchair ramps
Dimensions	Wheelchair ramps - five feet by 30 feet (two) Warning strips - entire length two feet by 199 feet and two feet by 30 feet	Wheelchair ramps - five feet width by 43.5 feet Warning strips - entire length two feet by 18.5 feet
Condition	Excellent	Excellent
Photograph

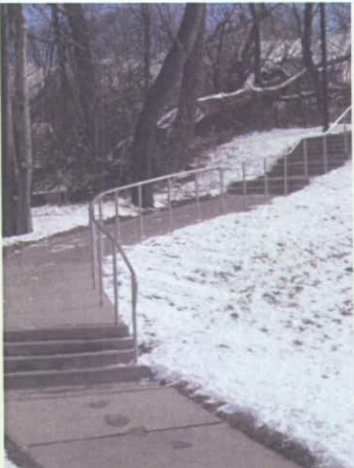
Sidewalks/Pedestrian Amenities		
	Pedestrian	Bicycling
Type	Sidewalk	Bike rack
Condition	Good	Good
Dimensions	Five feet wide	Two bike capacity
Photograph

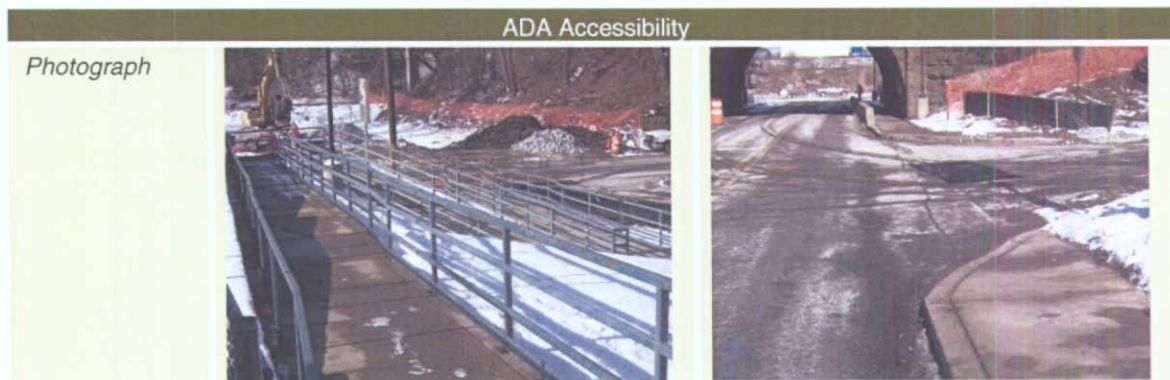
ADA Accessibility		
	Access	Circulation
Type	Ramps	Curb-cuts
Surface	Concrete	Concrete
Number	Several	Multiple
Dimensions	Five feet wide, varying lengths with slopes achieving ADA compliance	Vary - Do not meet PennDOT standard
Condition	Good	Fair

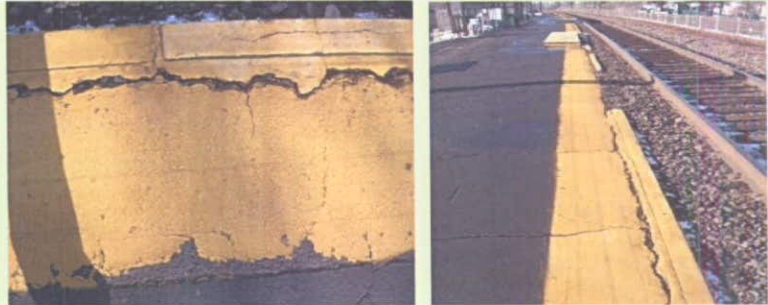
Warning Strips – Eastbound Platform	
Primary Platform	
Type	Yellow painted asphalt
Surface	Asphalt
Dimensions	Two feet by 497 feet
Condition	Fair/Good - paint is bright yellow with high visibility. Edge of asphalt is deteriorating in some areas. Cracks located intermittently.
Photograph

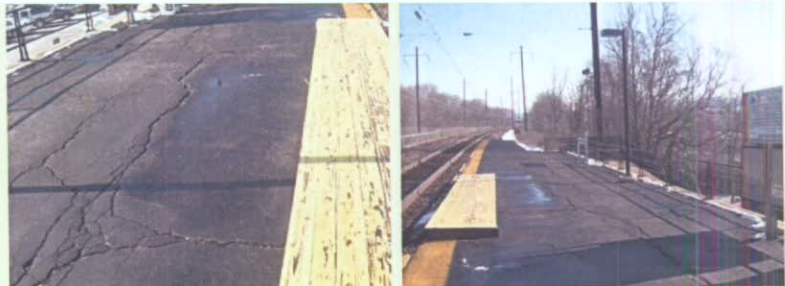
Surface Condition – Eastbound Platform	
Primary Platform	
Surface	Asphalt Wood- steps for boarding train
Dimensions	497 feet in length 11 feet wide (western 100 feet of platform) 20 feet wide Steps (four)- 3.5 feet by 16 feet by eight inches
Condition	Fair
Photograph

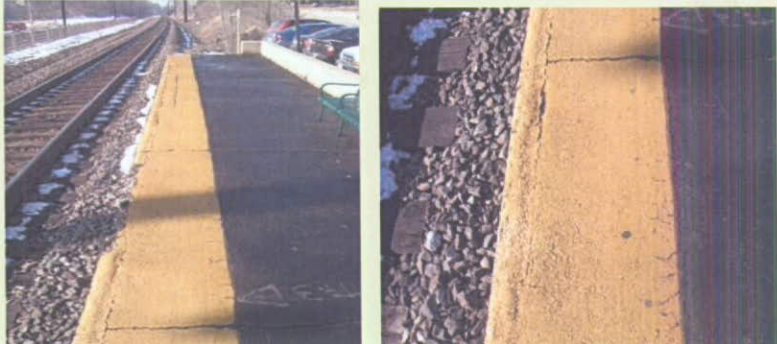
Warning Strips – Westbound Platform	
Primary Platform	
Type	Solid yellow paint
Surface	Painted asphalt
Dimensions	Two feet-three inches by 350 feet
Condition	Good - occasional cracking and some deterioration along edge.
Photograph

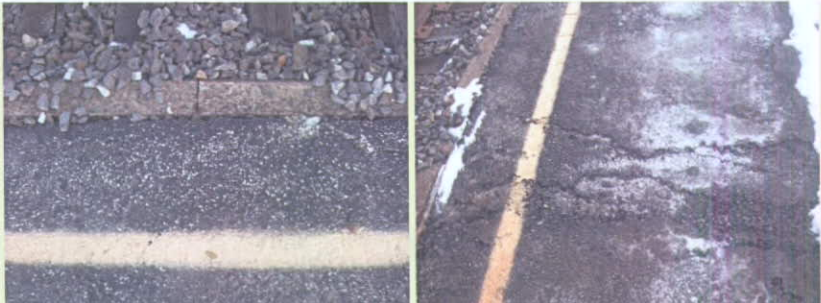
Warning Strips – Eastbound Platform	
Primary Platform	
Type	Yellow painted line
Surface	Asphalt with painted line, six inch concrete at edge of asphalt
Dimensions	Four inch line two feet behind edge of paved surface
Condition	Fair/Poor - The line is visible, but portions of the area between the line and platform edge are cracking and deteriorated.
Photograph

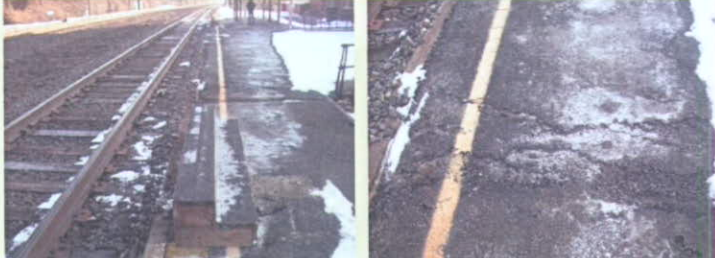
Surface Condition – Eastbound Platform	
Primary Platform	
Surface	Asphalt Wood steps (two)
Dimensions	205 feet by 26 feet (at building widens to 36 feet) 154 feet by eight feet (west of primary platform - mix of deteriorating concrete and gravel) 162 feet by 12 feet at eastern end. 16 feet by 1.5 feet (two wood steps)
Condition	Fair - cracks and some deterioration Poor (western portion with concrete and gravel)
Photograph

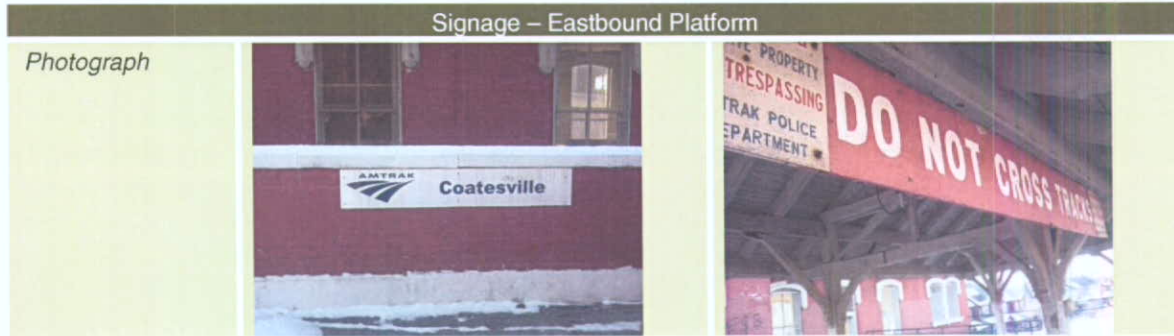
Signage – Eastbound Platform		
	Locational	Informational
Type	Wall mounted	Mounted to canopy
Condition	Good	Fair
Clarity	Good	Good
Secured	Yes. Attached to the wall of the building.	Yes. Attached to the ceiling of the canopy.

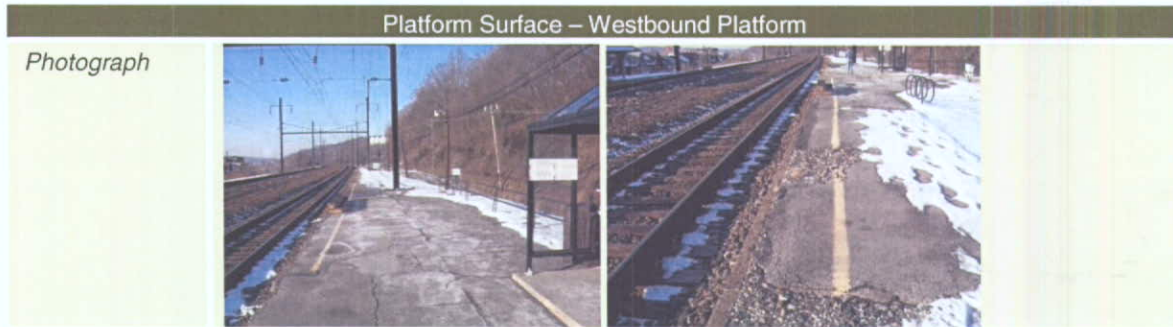
Platform Surface – Westbound Platform	
Primary Platform	
Surface	Asphalt
Dimensions	Length is 183 feet; Width is 24 feet for 110 feet of the platform. Narrows to eight feet at both ends.
Condition	Fair/Poor several cracks and random deterioration.

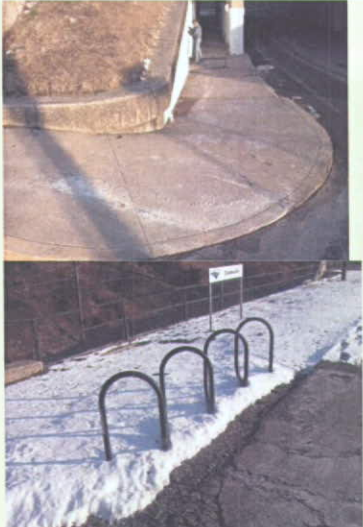
Sidewalks/Pedestrian Amenities		
	Sidewalks	Other Amenities
Type	Concrete sidewalks	Stairs to platform Bicycle racks
Condition	Good	Fair - stairs (deteriorating) Good - bicycle racks
Dimensions	Eight feet near station (six feet in underpass) Four to eight feet in remainder of neighborhood south of station None - north of station	Stairs- six feet wide (railing 2.5 feet high)
Photograph

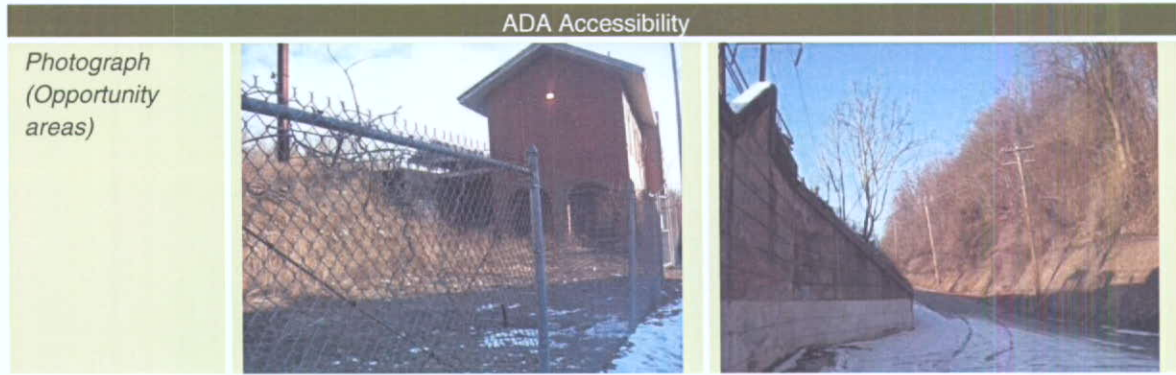
ADA Accessibility		
	South of Station	North of Station
Type	Curb-cuts	None
Surface	Concrete	
Number	Multiple	
Condition	Fair

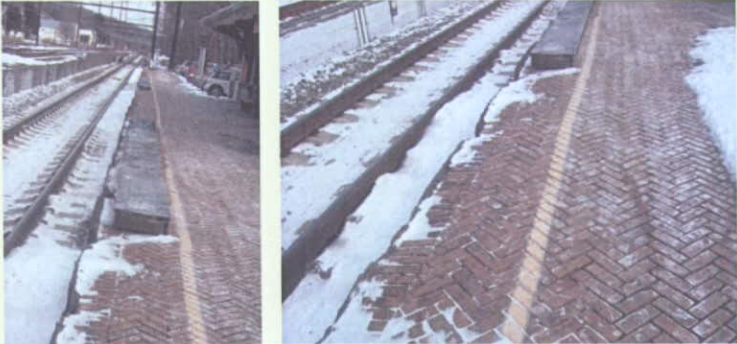
Surface Condition – Eastbound Platform	
Primary Platform	
Surface	Brick, Wood step for boarding
Dimensions	247 feet by 14.5 feet
Condition	Good/Fair - Some settling of bricks resulting in uneven surface. East side of building has board covering hole in brick. Wooden step available at edge of platform for boarding
Photograph

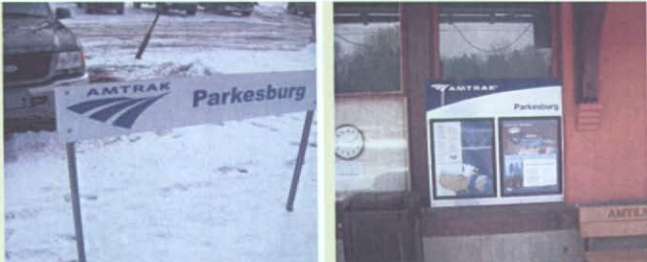
Signage – Eastbound Platform			
	Location	Information	Advertising
Type	Freestanding and building mounted	General train information	None
Condition	Excellent	Good	
Clarity	Good	Good	
Secured	Yes	Yes	
Photograph

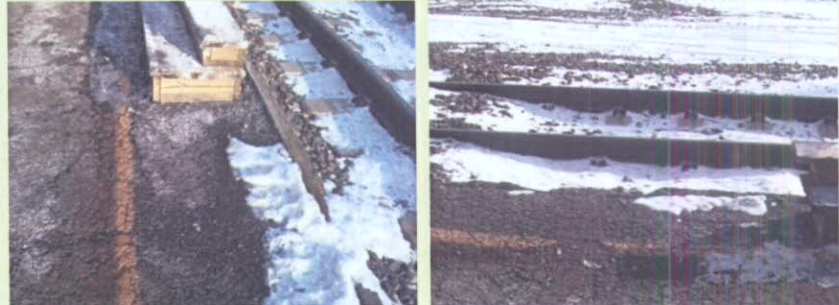
Warning Strips – Westbound Platform	
	Primary Platform
Type	Painted yellow line
Surface	Paint on asphalt
Dimensions	Four inch line painted two feet from edge of pavement
Condition	Poor - faded and missing in some areas
Photograph

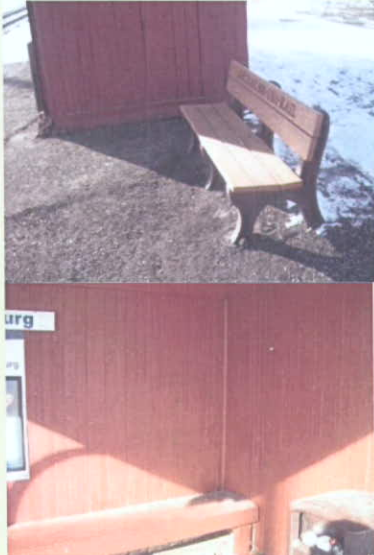
Platform Seating – Westbound Platform		
	Seating	Shelter
Type	Benches- wood, plastic	Three-sided, wood shelter
Dimensions	15 feet by two feet (built into shelter) Five feet (outside benches)	15 feet by 7.5 feet – overhang continues seven feet over platform Covered area - 15 feet by 32 feet
Condition	Good	Good
Quantity	One in shelter Two outside shelter, but under cover	One
Covered	Two covered	Yes
Photograph

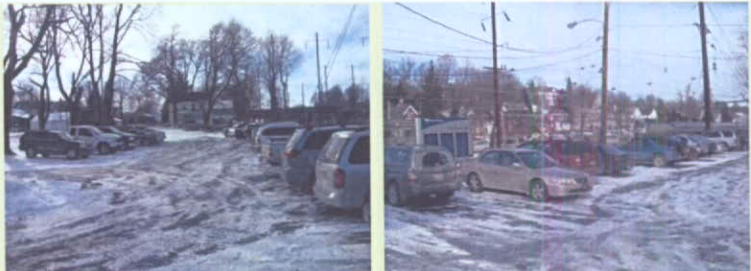
Parking/Loading Eastbound Platform	
Parking Lot Adjacent to Eastbound Platform	
Total Spaces	53 (estimated) - 49 vehicles parked in lot Additional space for approximately four vehicles
Handicap Spaces	None designated
Surface	Gravel
Curbing	No
Condition	Fair- gravel
Dimensions - Parking Space	Spaces not delineated
Interior Travel Lanes	
Lot Access	
Fair Box	No
Daily Fee	No
Parking Overflow	Nothing designated. Neighborhood streets with parking available
Passenger Loading	Not officially designated, but occurs in front of building
Photograph

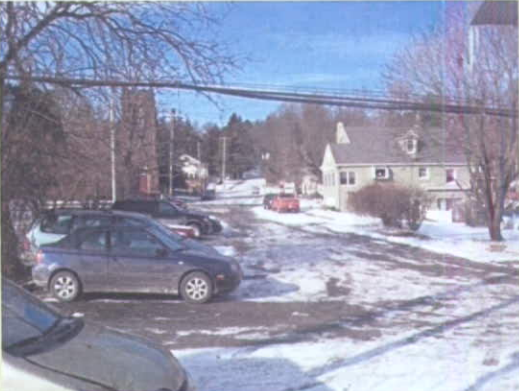
Parking/Loading Westbound Platform	
Parking Lot Adjacent to Westbound Platform on Wright Street	
Total Spaces	18 potential along street leading to platform
Handicap Spaces	0
Surface Type	Asphalt/hard-packed dirt and gravel
Curbing	No
Condition	Fair
Dimensions - Parking Stall	Not delineated
Interior Travel Lanes	N/A
Lot Access	Street ends at station
Fair Box	No
Daily Fee	No
Parking Overflow	On local streets
Passenger Loading	Not officially designated, but no parking permitted directly adjacent to platform area
Photograph

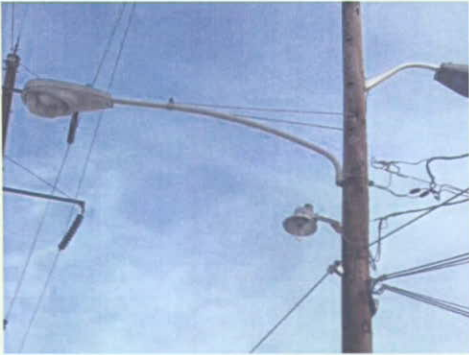
Site Lighting		
	Eastbound	Westbound
Type	Cobra	None
Condition	Poor- not operational	
Quantity	One	
Photograph

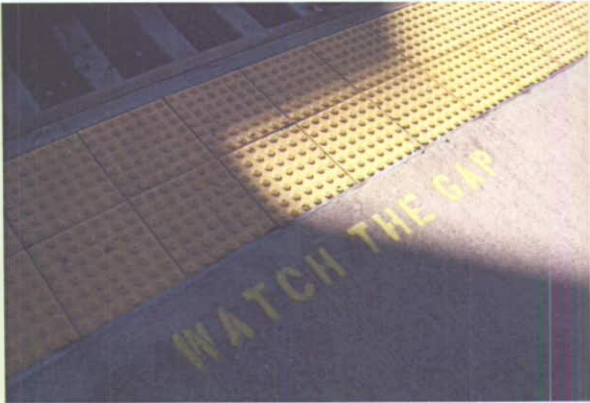
Warning Strips Eastbound Platform	
Platform	
Type	Cast in place detectable/tactile warning system
Surface	Concrete
Dimensions	Two feet by 300 feet
Condition	Excellent
Photograph

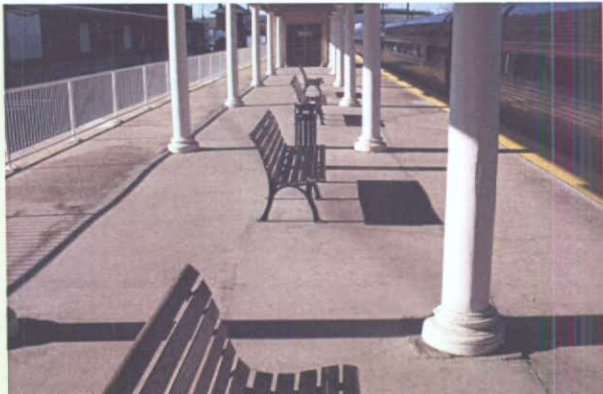
Surface Condition Eastbound Platform	
Platform	
Surface	Concrete
Dimensions	25 feet by 300 feet
Condition	Excellent
Photograph

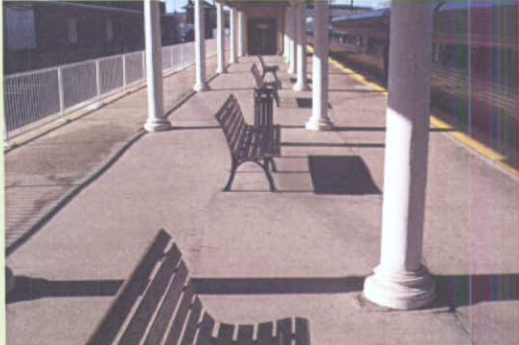
Seating and Shelter Eastbound Platform	
	<i>Seating</i>
Type	Wood and metal benches
Condition	Good
Quantity	Five
Covered	Yes
Photograph

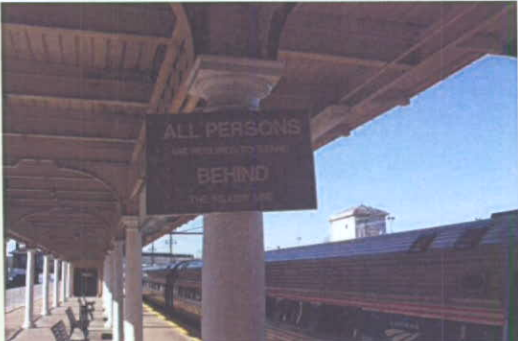
Lighting Eastbound Platform	
	<i>Attached to Canopy</i>
Type	Florescent/incandescent
Quantity	16/three
Condition	Good
Photograph

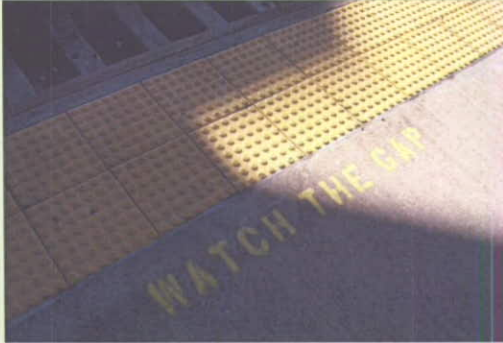
Warning Strips Westbound Platform	
Platform	
Type	Cast in place detectable/tactile warning system
Surface	Concrete
Dimensions	Two feet by 300 feet
Condition	Excellent
Photograph

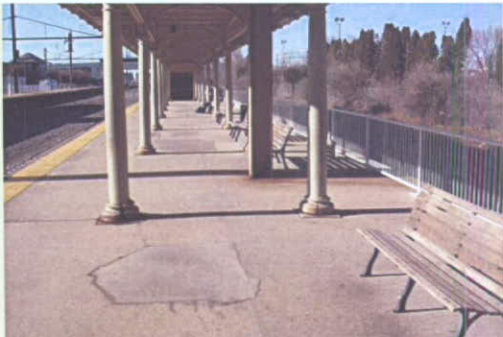
Surface Condition Westbound Platform	
Platform	
Surface	Concrete
Dimensions	25 feet by 300 feet
Condition	Good
Photograph

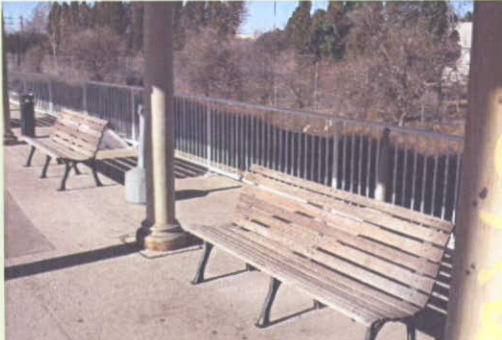
Seating and Shelter Westbound Platform	
	<i>Seating</i>
Type	Wood and metal benches
Condition	Good
Quantity	Five
Covered	Yes
Photograph

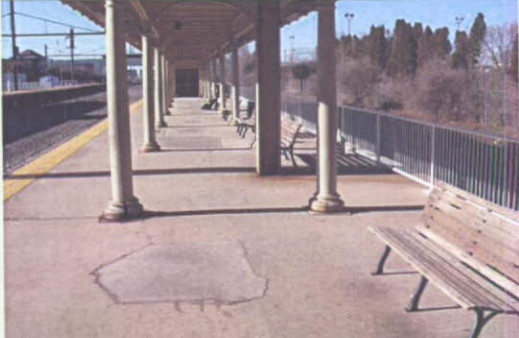
Lighting Westbound Platform	
	<i>Attached to Canopy</i>
Type	Florescent
Quantity	14
Condition	Good
Photograph

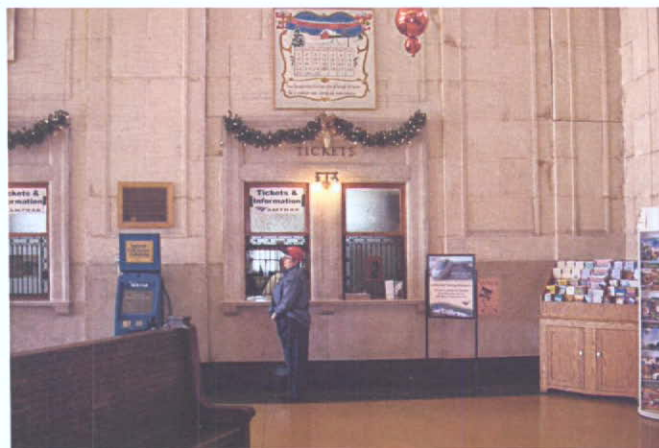
The station has two ticket windows and two other electronic ticketing kiosks. Window hours are not noted at either window.

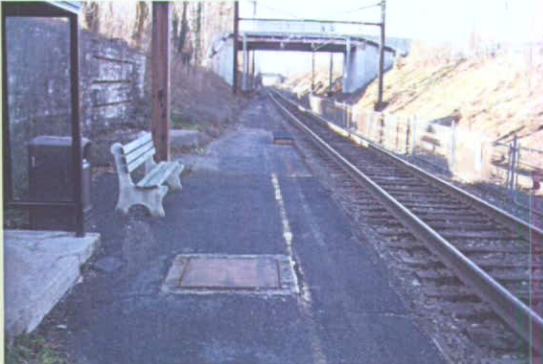
Warning Strips Eastbound Platform	
	<i>Platform</i>
Type	Yellow paint
Surface	Asphalt
Dimensions	Six inches by 265 feet
Condition	Poor
Photograph

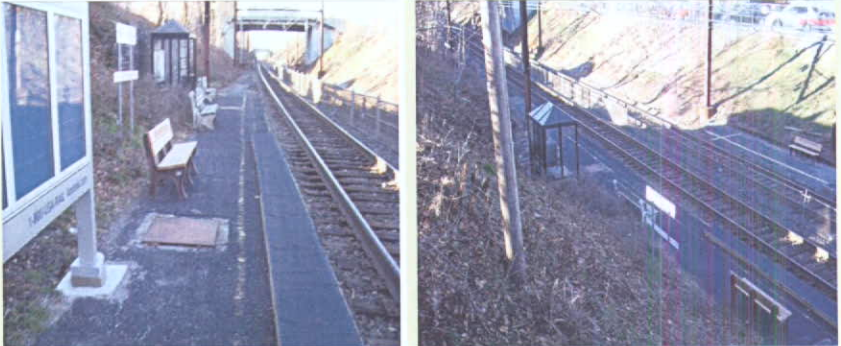
Seating and Shelter Eastbound Platform		
	<i>Seating</i>	<i>Shelter</i>
<i>Type</i>	Wooden benches	Metal and plexi-glass
<i>Dimensions</i>	N/A	Five feet by 10 feet
<i>Condition</i>	Good	Good
<i>Quantity</i>	Three	One
<i>Covered</i>	No	Yes
<i>Photograph</i>

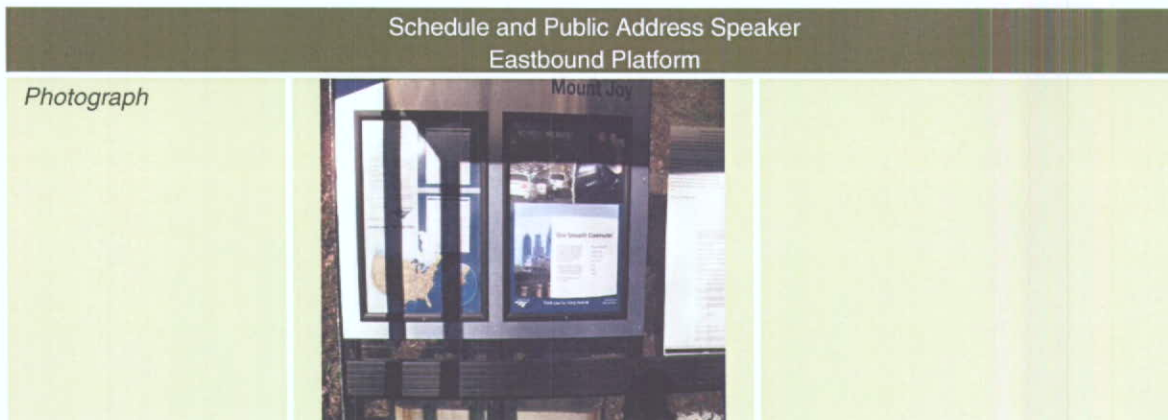
Schedule and Public Address Speaker Eastbound Platform		
	<i>Schedule</i>	<i>Public Address Speaker</i>
<i>Type</i>	Bulletin board in shelter	None
<i>Condition</i>	Good	N/A
<i>Clarity</i>	Yes	N/A
<i>Secured</i>	Yes	N/A

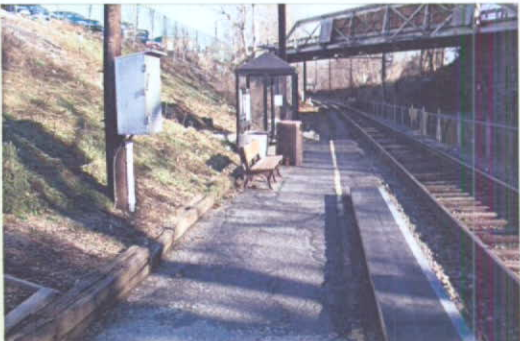
Surface Condition Westbound Platform	
Platform	
Surface	Asphalt
Dimensions	Eight feet by 265 feet
Condition	Fair
Photograph

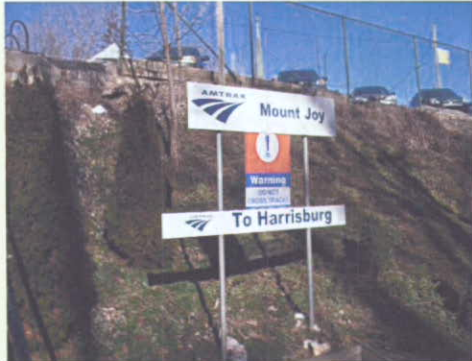
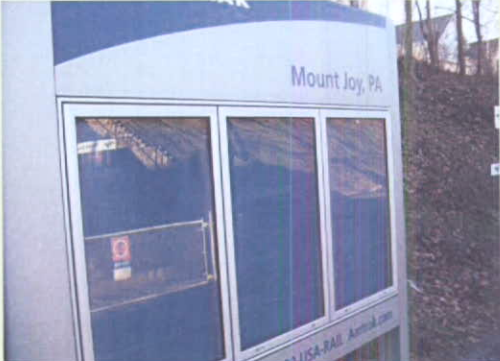
Platform Signage Westbound Platform		
	Location	Information
Type	Freestanding	Attached to shelter
Number	One	One
Condition	Good	Good
Clarity	Yes	Yes
Secured	Yes	Yes
Photograph

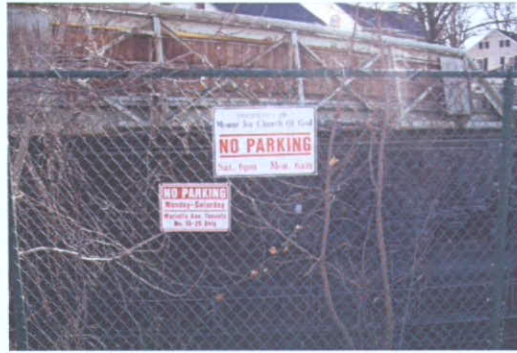
North and west of the station there is one parking lot immediately adjacent to the westbound platform. This parking has an asphalt surface is in good condition. The lot is shared with the Mount Joy Church of Christ and other commercial activities in the area. There is a total of 60 spaces. There is not a designated loading area, but an area located behind some of the parking spaces where people pull off of the road is used to unload passengers. This parking lot does not have any spaces designated for handicap parking.

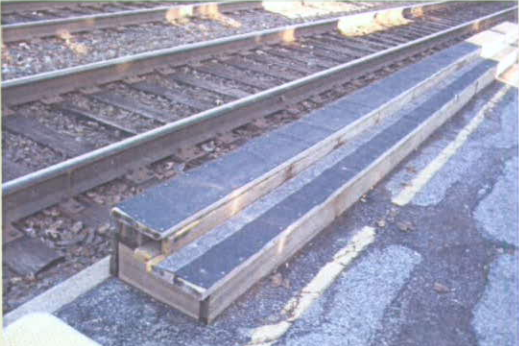
Warning Strips Eastbound Platform	
Platform	
Type	Yellow paint
Surface	Smooth
Dimensions	Eight inches by 180 feet
Condition	Fair
Photograph

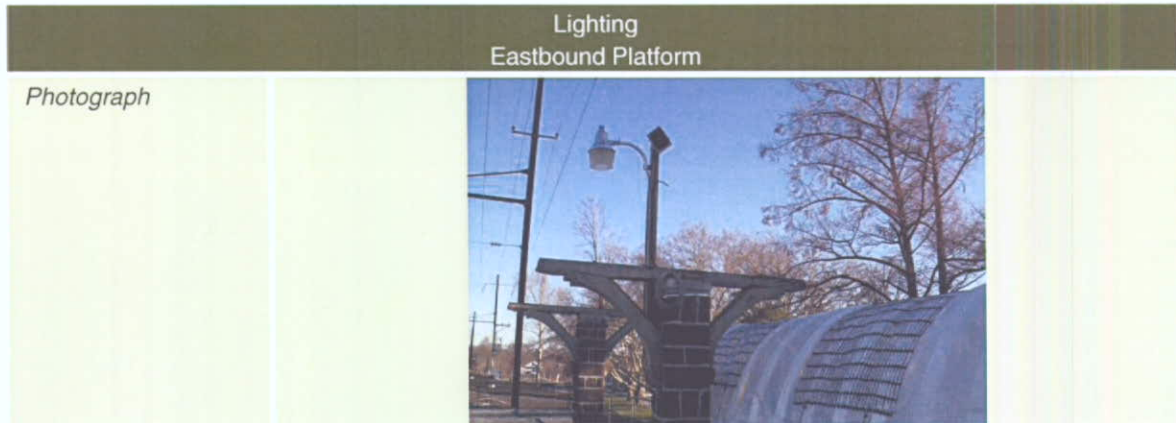
Lighting Eastbound Platform	
	Platform
Type	Incandescent
Quantity	Two
Condition	Good

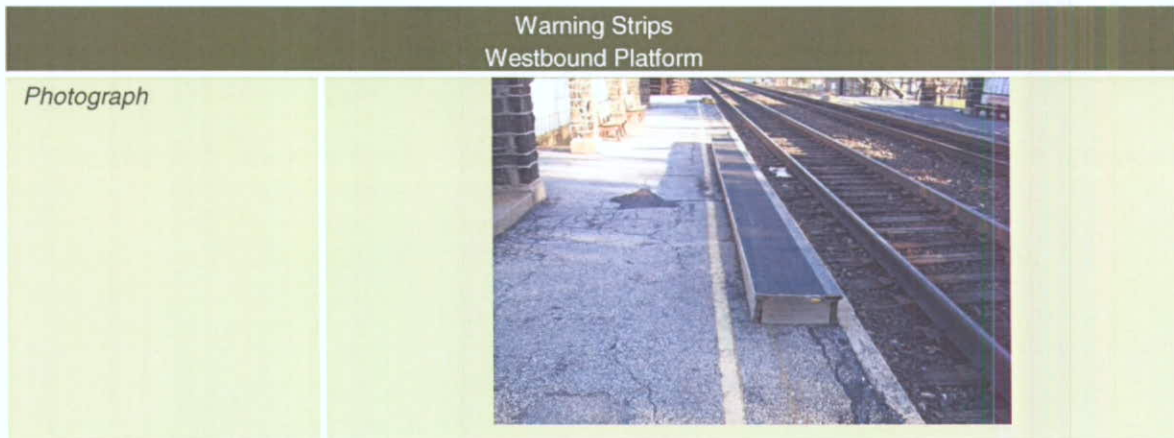
Warning Strips Westbound Platform	
	Platform
Type	Asphalt
Surface	12 feet by 180 feet
Dimensions	Fair
Condition	Asphalt
