Use of Double-Layer Chip Seals Over Paving Fabrics

FINAL REPORT

February 15, 2021

By Mansour Solaimanian and Scott Milander

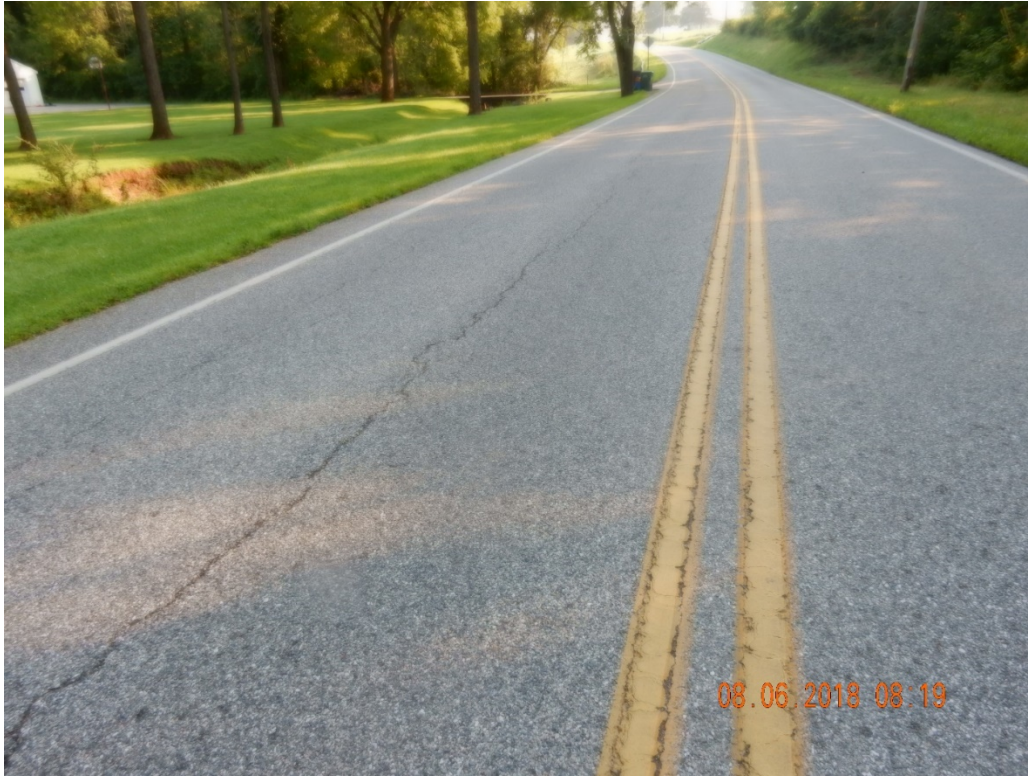
Figure 1. Longitudinal crack at the center of the mat on the southbound.

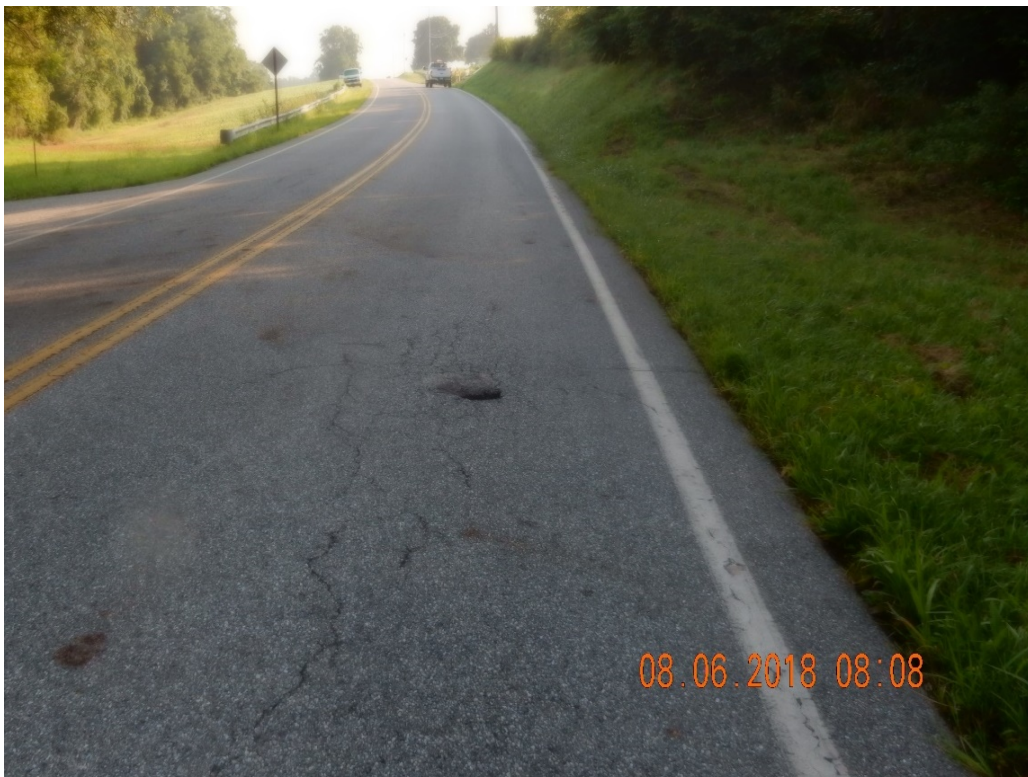
Figure 2. Alligator fatigue cracks on the northbound.

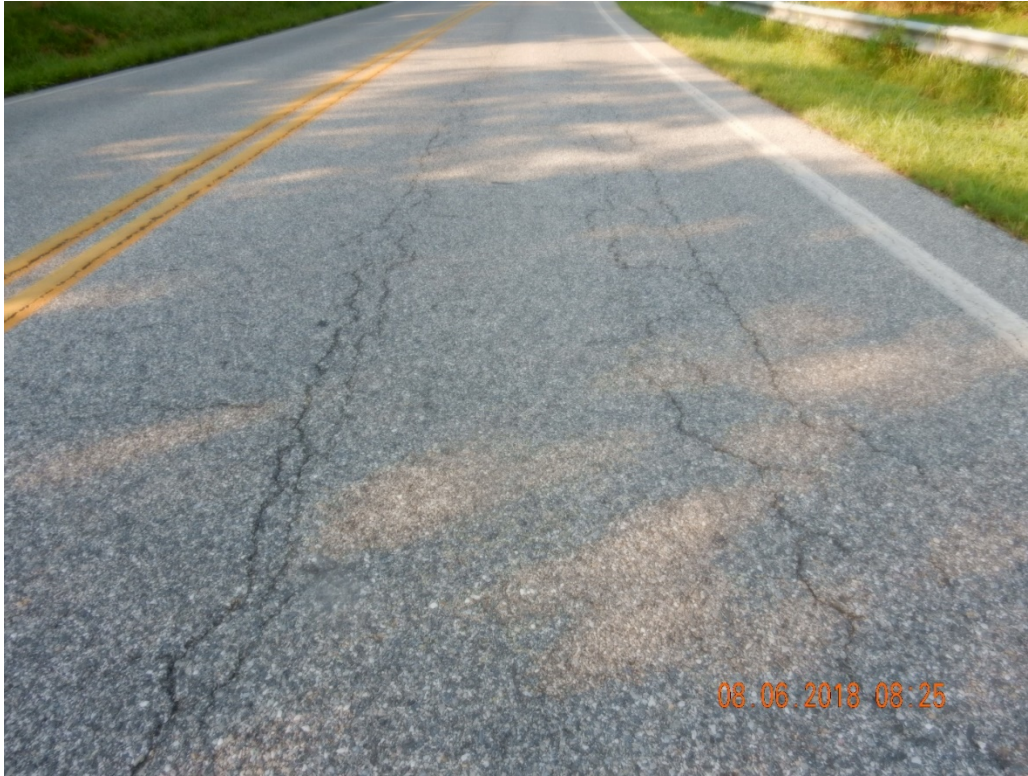
Figure 3. Longitudinal fatigue cracks on the southbound.

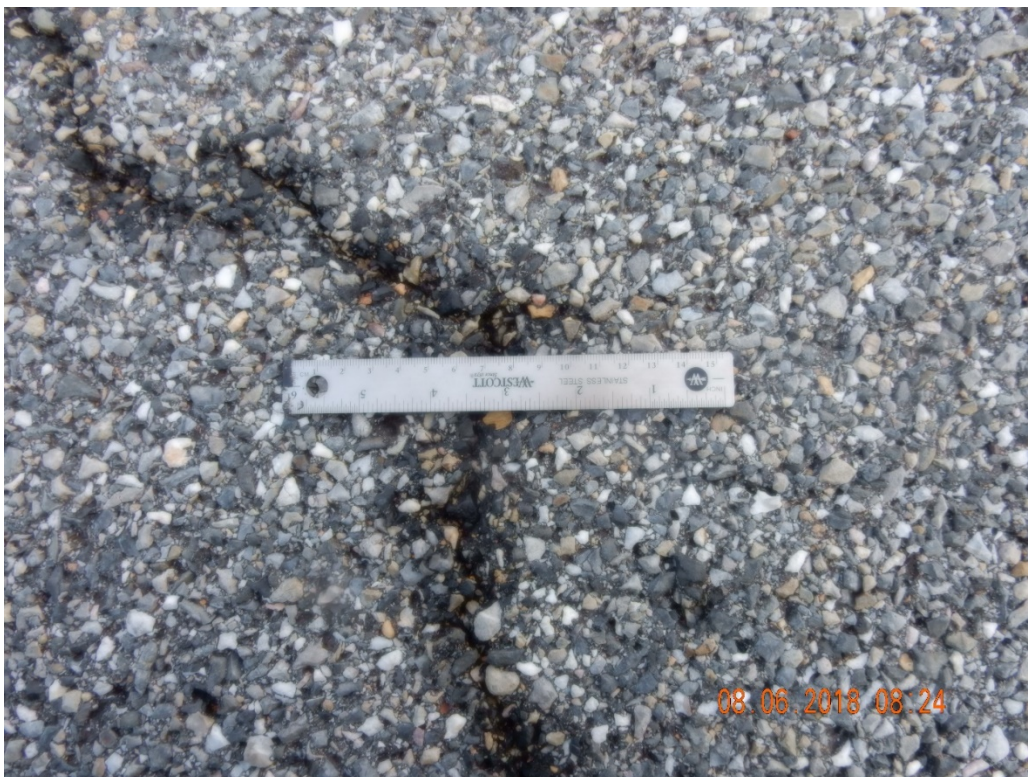
Figure 4. Cracks were mostly 1/8- to 1/4-inch wide.

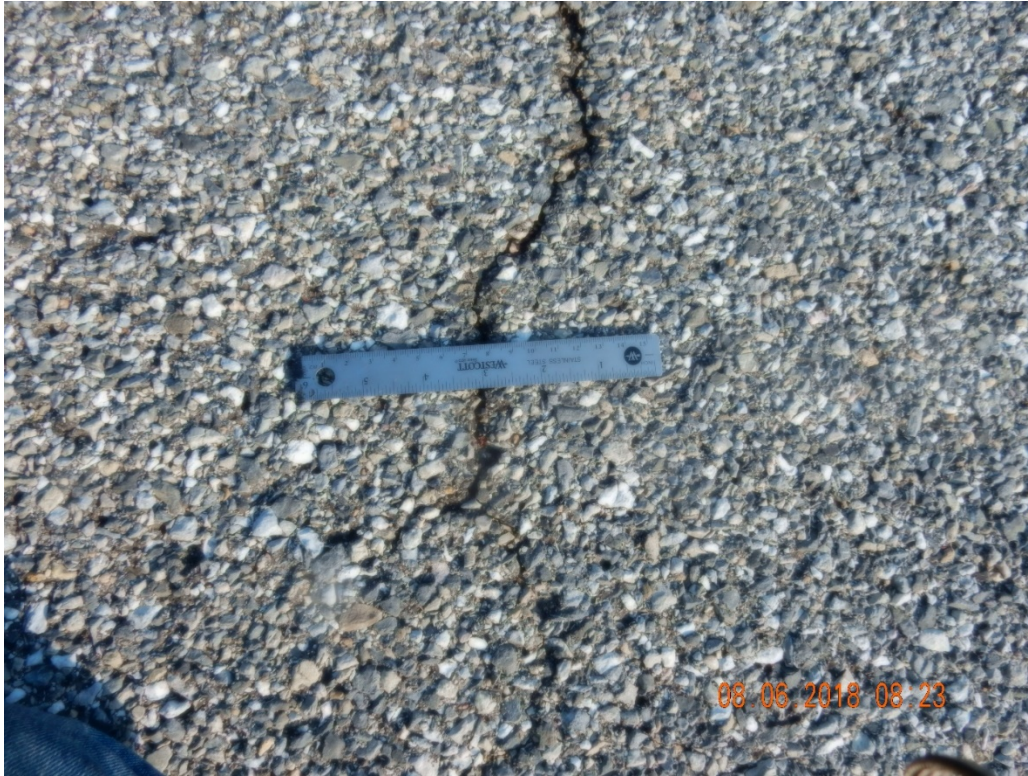
Figure 5. Another closeup view of surface cracks.

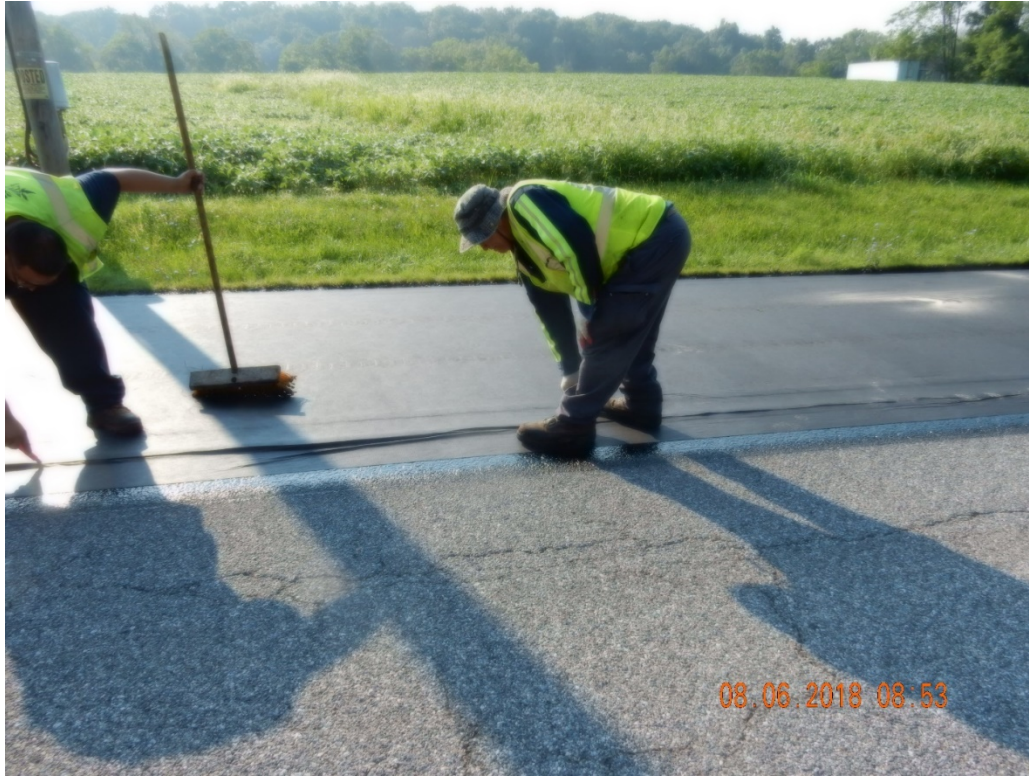
Figure 10. Cutting through wrinkled section of the geofabric to smooth it out.

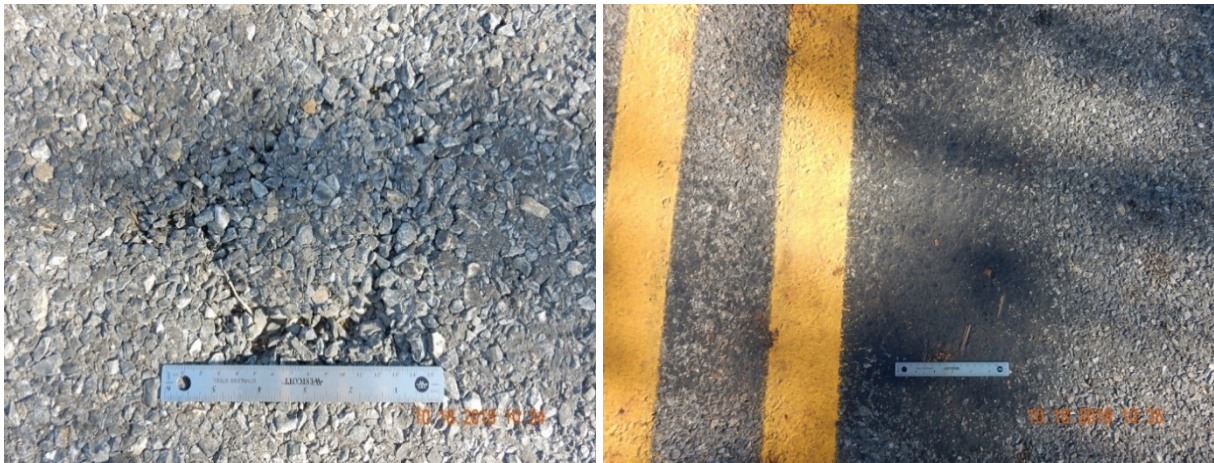
Figure 18. Several spots indicated the beginning of surface chip loss or minor bleeding.

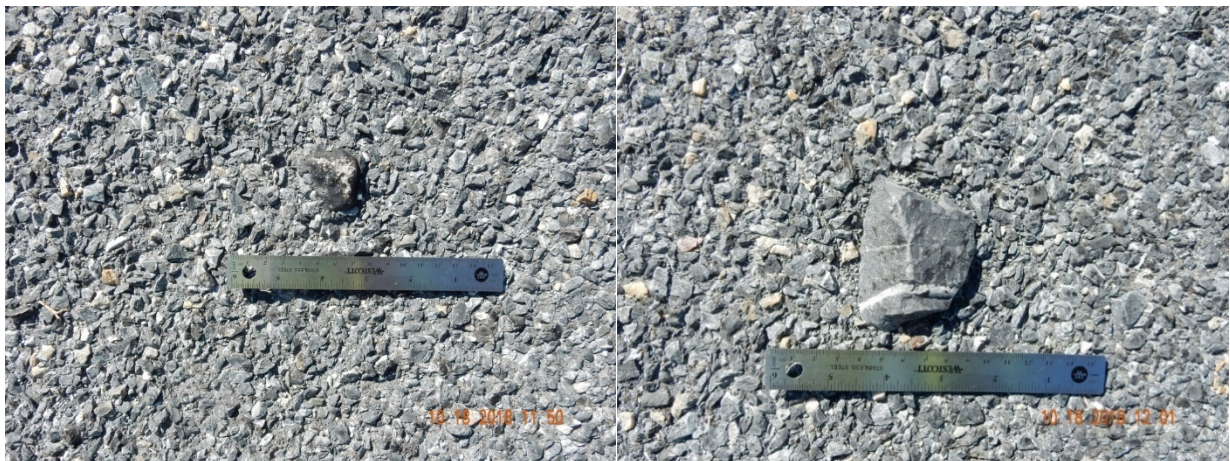
Figure 19. A few spots showed large pieces of aggregate stuck into the chip seal (southbound).

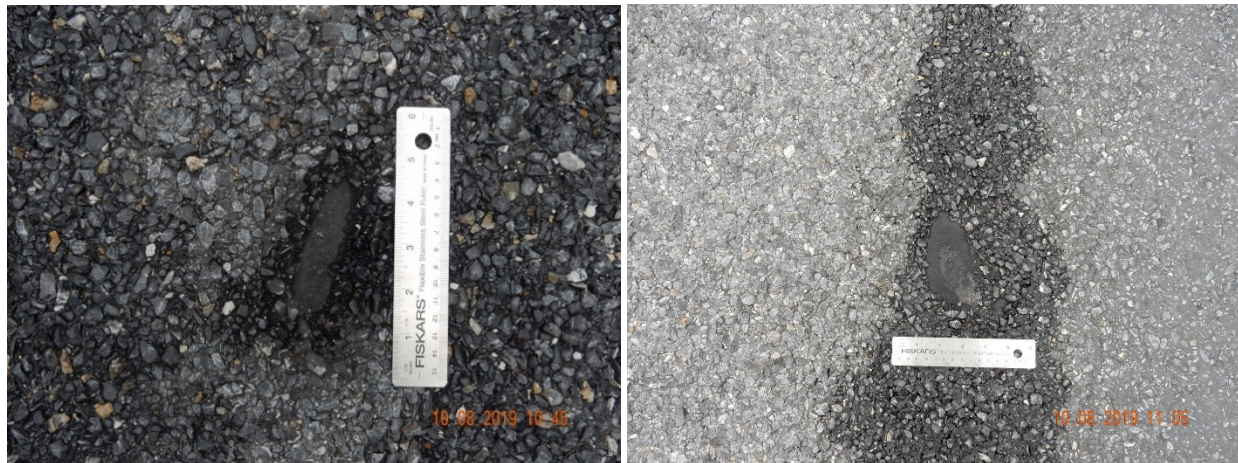
Both northbound and southbound lanes appeared in good shape (Figure 22), with the southbound being in a better condition. While the northbound appeared in good shape for the most part, there were almost 20 spots of small areas where aggregate was completely lost and the fabric was visible. These chip loss areas were not in the wheel path and were almost oval shaped with the long diameter approximately 4 to 6 inches and the small diameter roughly 3 to 4 inches in most cases (Figures 23 and 24). In most places where the chips were lost, the fabric was soft to the touch, it was wet, and under a push the water would come through to the surface. Considering the zero mark at the bridge on the northbound where the placement of chip seal started, the first chip seal loss appeared at approximately the 160-ft mark. The last one appeared roughly at the 950-ft mark. An interesting observation relates to the size and frequency of appearance of these spots. They were generally larger and more frequent in the early part of the road (further down the slope where water accumulated) compared to the areas closer to the top of the road. Several of these lost chip spots typically appeared together, about 10 to 20 ft apart from each other, appearing in a straight line. This straight line was mostly about 2.5 ft from the right-side white stripe of the lane (Figures 25 and 26). In one case, the straight line of lost chips appeared about 2 to 3 ft away from the center yellow stripe (Figures 27 and 28), and in one case it was close to the lane center (Figure 29). In almost all cases, it appeared the loss was in areas where water could accumulate and retain under the pavement for a longer time compared to some other areas of the pavement. This observation probably is an indication that the chip loss is connected to the presence of water below the fabric, contributing to separation of the chip seal from the fabric. Intrusion

and contribution of water to this effect is most probably true because the fabric of the spots with lost chip seal appeared to have bubbled up, an indication of a pressure pushing the fabric upward. Another evidence is that in most cases these spots were found in the wet areas of the pavement, as this visit took place after rain had occurred prior to the visit. It should be noted that most of the emulsion had come off the fabric along with the chips. Since these lost chip spots formed a line in the longitudinal direction, it is also possible that underlying PG 70-22 tack binder had not been adequately applied (maybe due to nozzle problems) and the material was subsequently susceptible to loss under water due to a weak bond.

Figure 22. Spots of chip loss and the bubbled up exposed geofabric.

These chip loss spots were reported, and the contractor conducted the repair of all. The project technical liaison visited the job site after the repair and reported the problem areas were fixed satisfactorily.

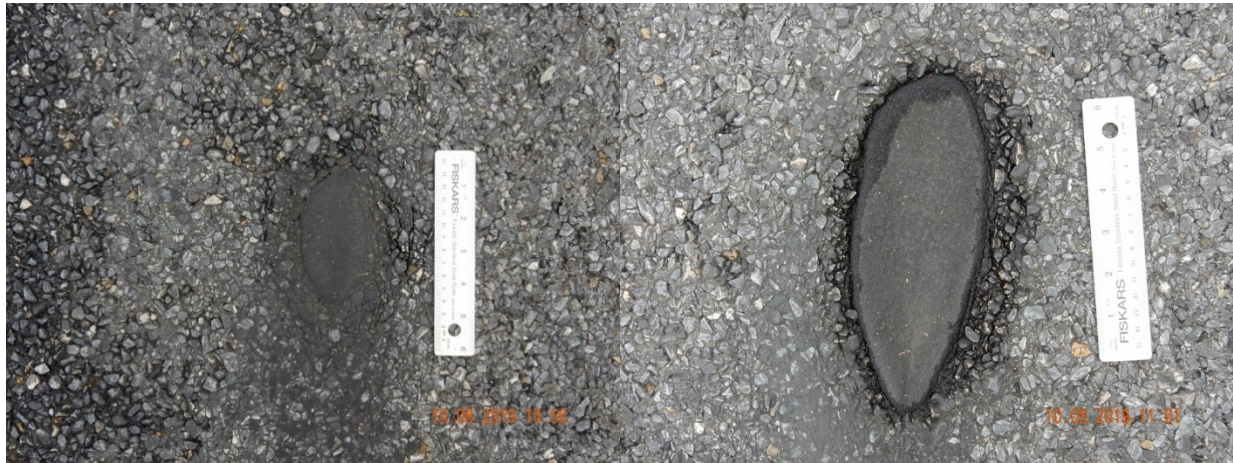
Figure 23. Additional spots of chip loss and the bubbled up exposed geofabric.

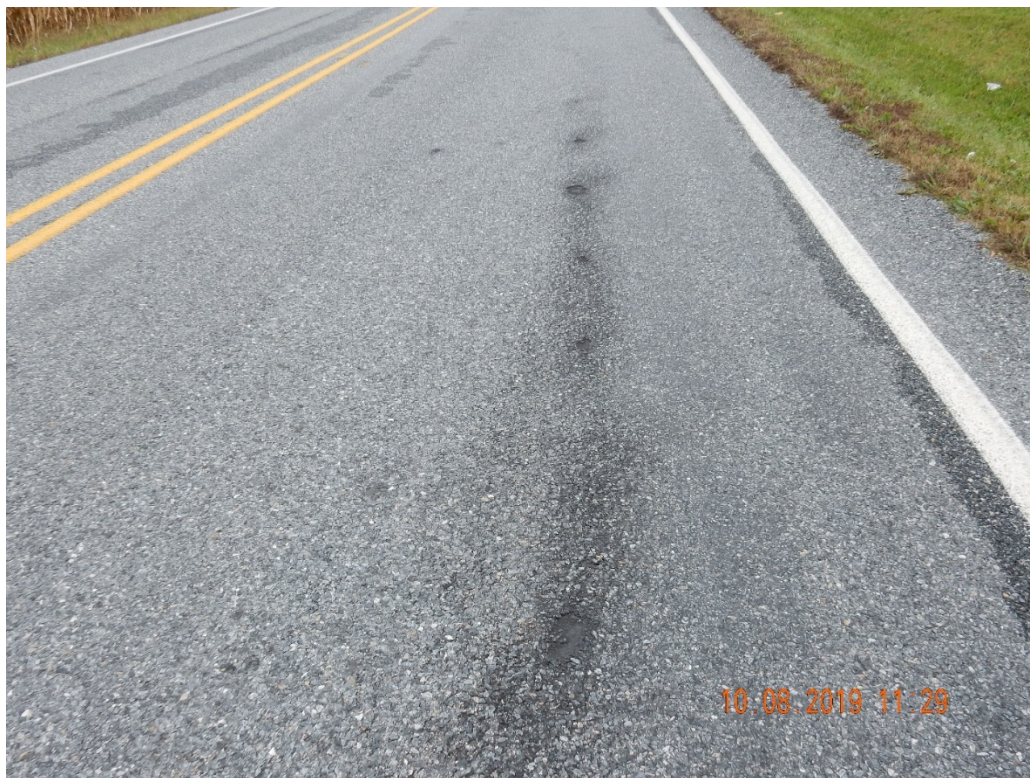
Figure 24. Spots of chip loss to the right of the mat center.

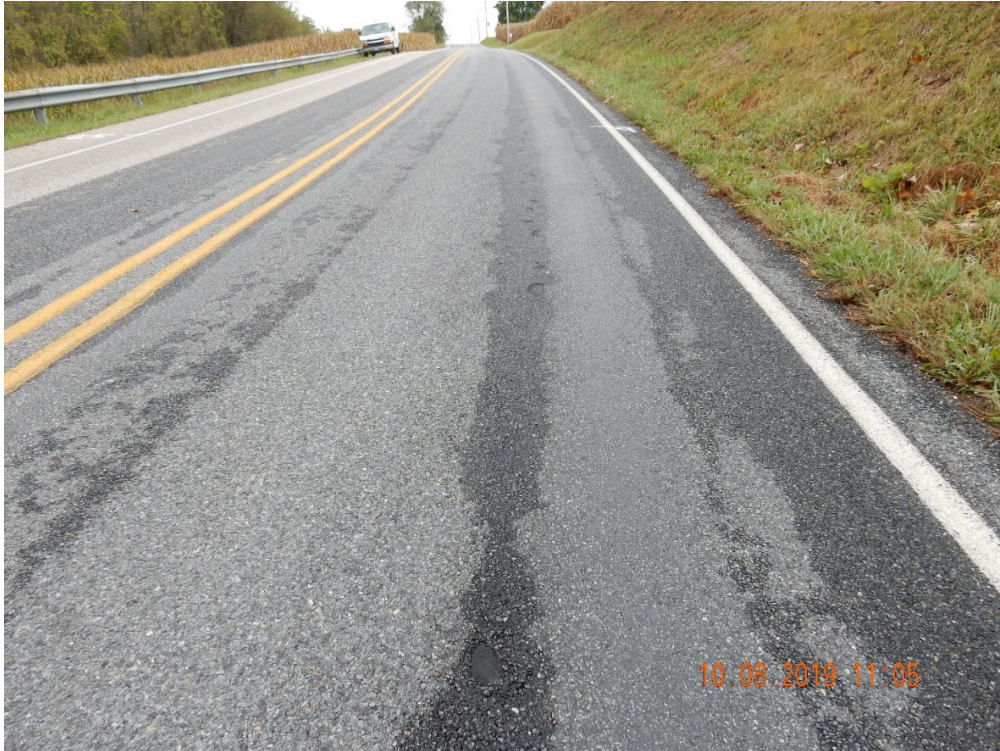
Figure 25. Spots of chip loss to the right of the mat center on the northbound.

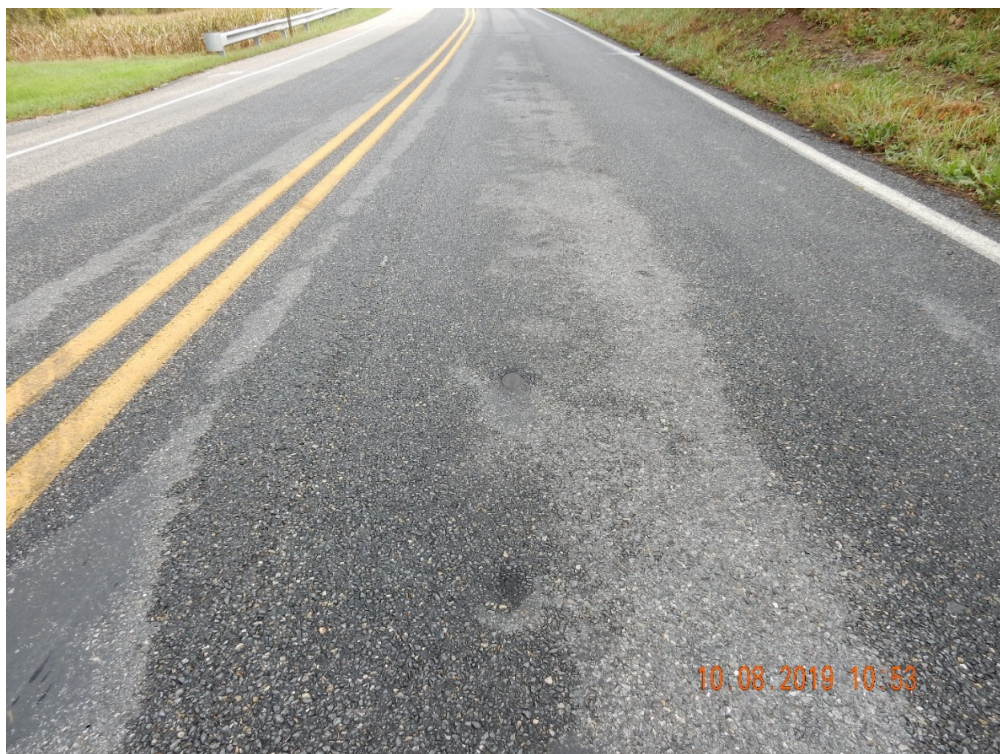
Figure 26. Spots of chip loss to the left of the mat center on the northbound.

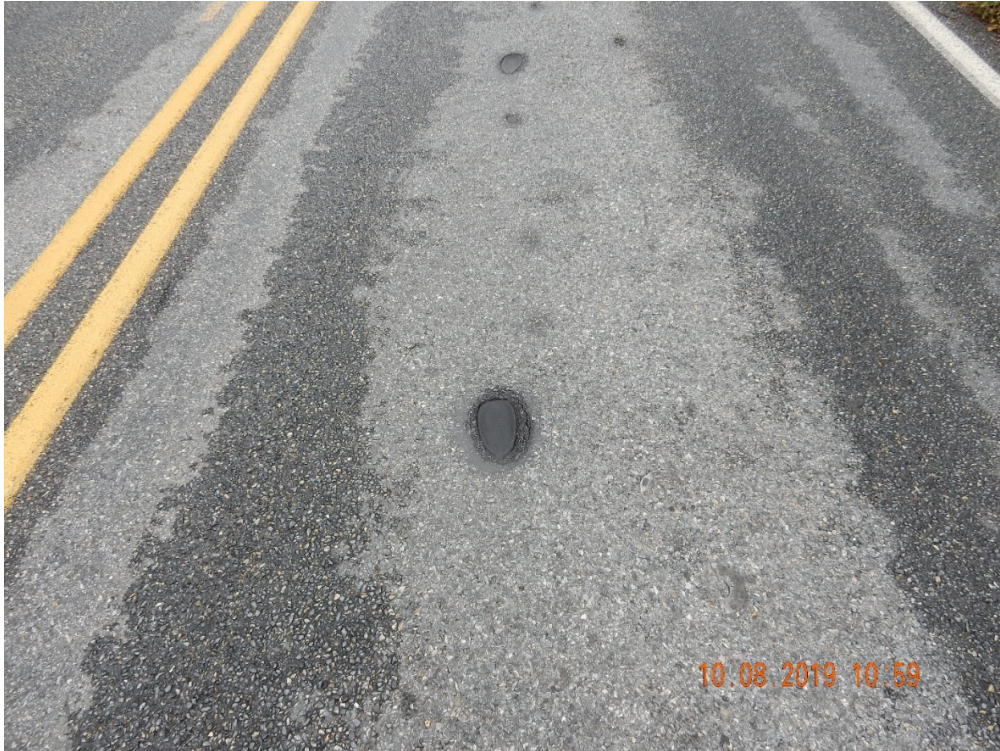
Figure 27. Spots of chip loss to the left of the mat center on the northbound.

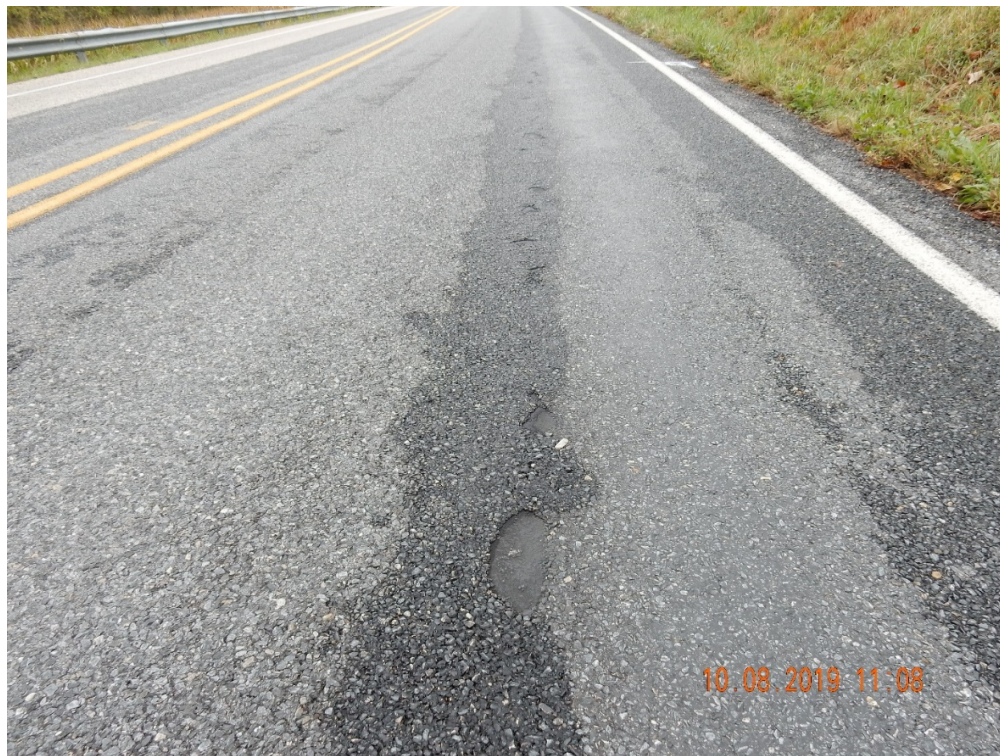
Figure 28. Spots of chip loss to the right but close to the mat center on the northbound.

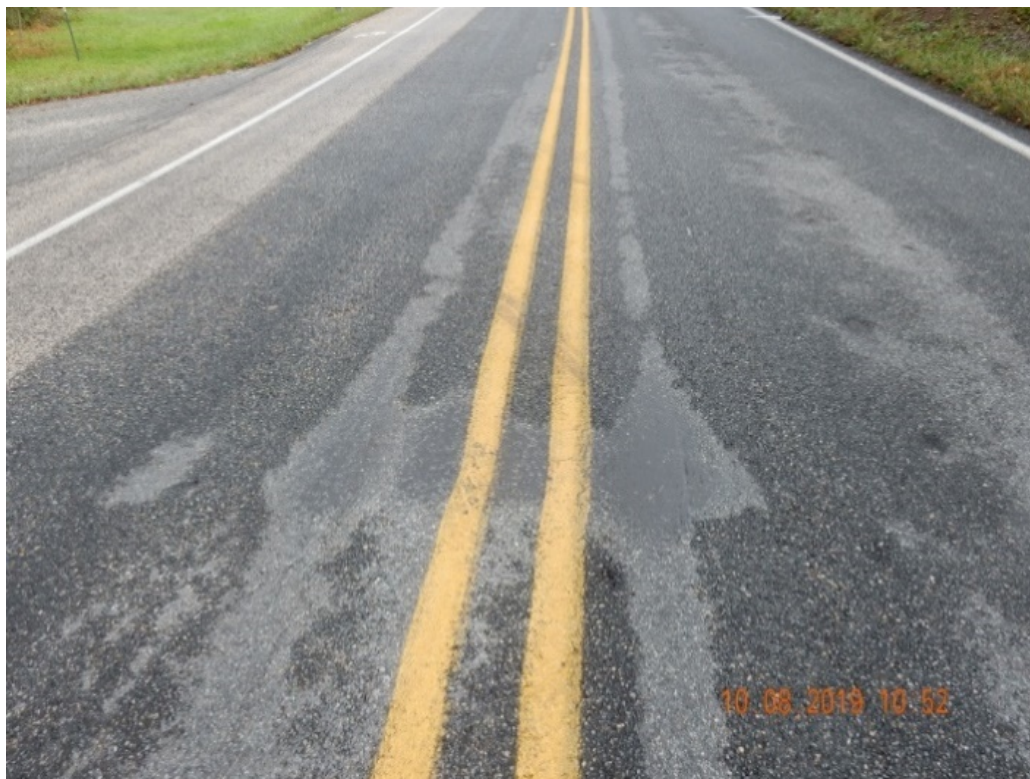
It was noticed that more areas of minor bleeding have occurred since the visit of October 2019. Across from the 1501 Butter Road mailbox was an entrance to a farm; that section of the road had areas of aggregate loss and bleeding. This could easily be attributed to vehicles entering the road from the farm road, causing dislocation of the chips. There were areas of bleeding along the right wheel path and white paint line near the 730-ft mark, and it appears the bleeding and chip dislocation actually shoved the white paint line toward the shoulder by a few inches. From the 818-ft to 832-ft marks, there were more small areas of aggregate loss along the right wheel path. At the 949-ft mark, bleeding was noticeable across the entire road surface. Bleeding was also observed along most of the northbound lane at the left wheel path (Figure 30).

Figure 29. Surface bleeding in the left wheel path.

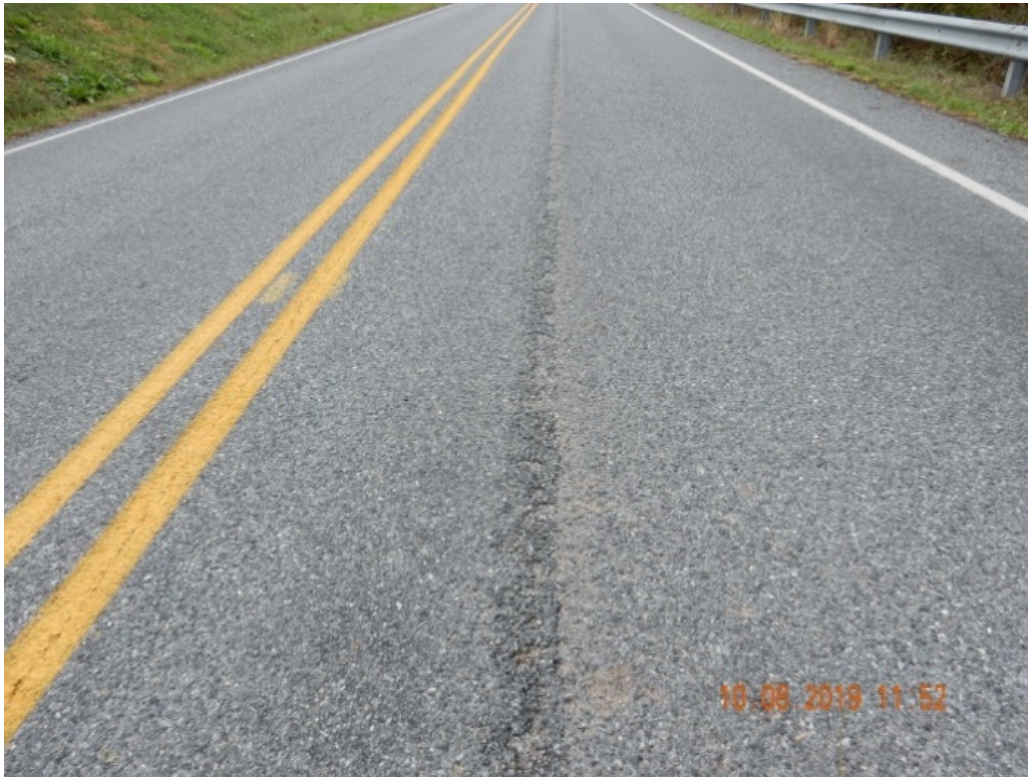
Figure 30. Minor chip loss at the chip seal joint.

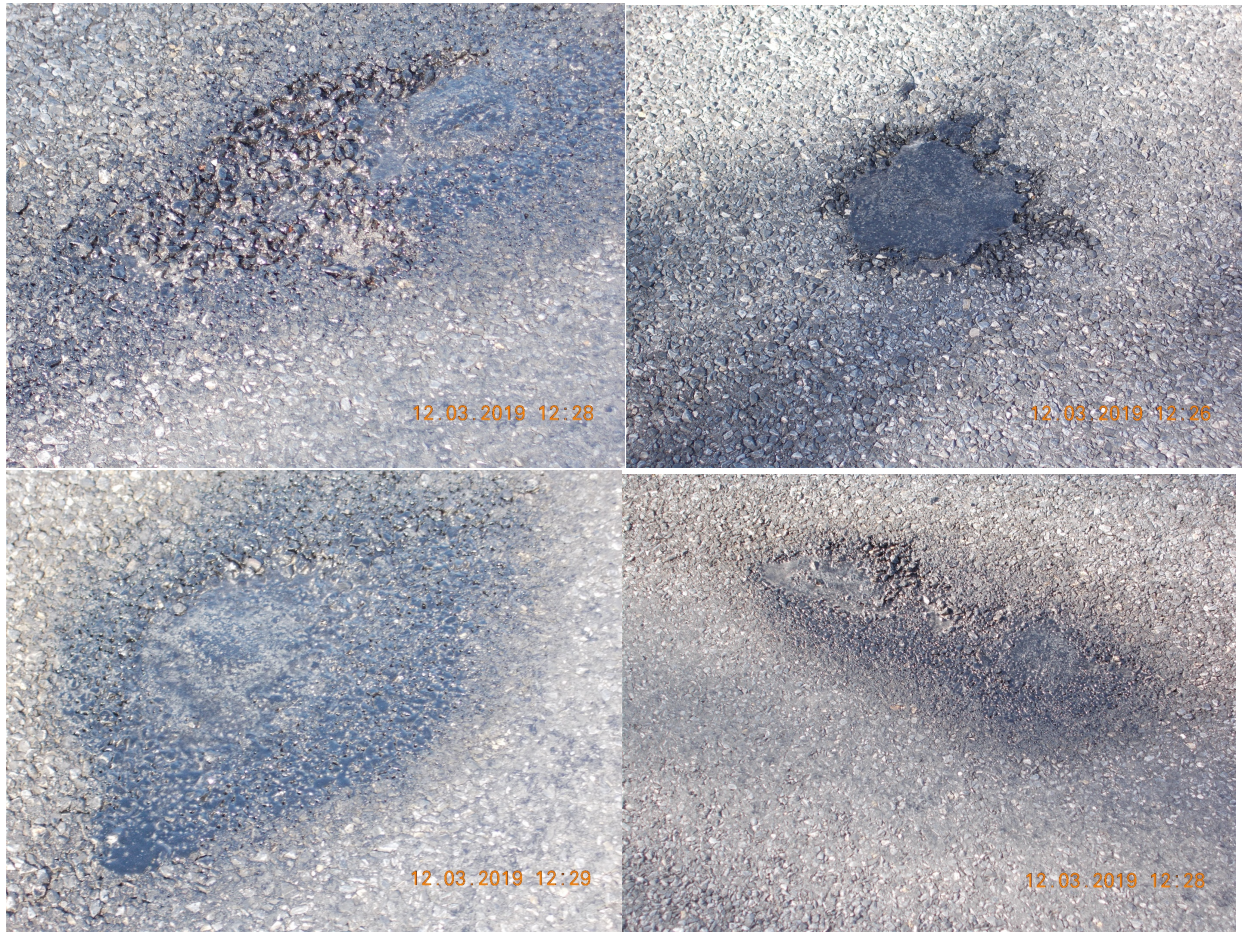
This visit was made by the project technical liaison. The research team from Penn State was not involved with this evaluation. The purpose of the visit was to evaluate the condition of the repairs that were applied to the spots of aggregate loss observed during the visit of October 2019 (Figure 32). The technical liaison reported that the spots in question were sealed and the completed work was neat and satisfactory.

Figure 31. Repaired spots of chip loss.

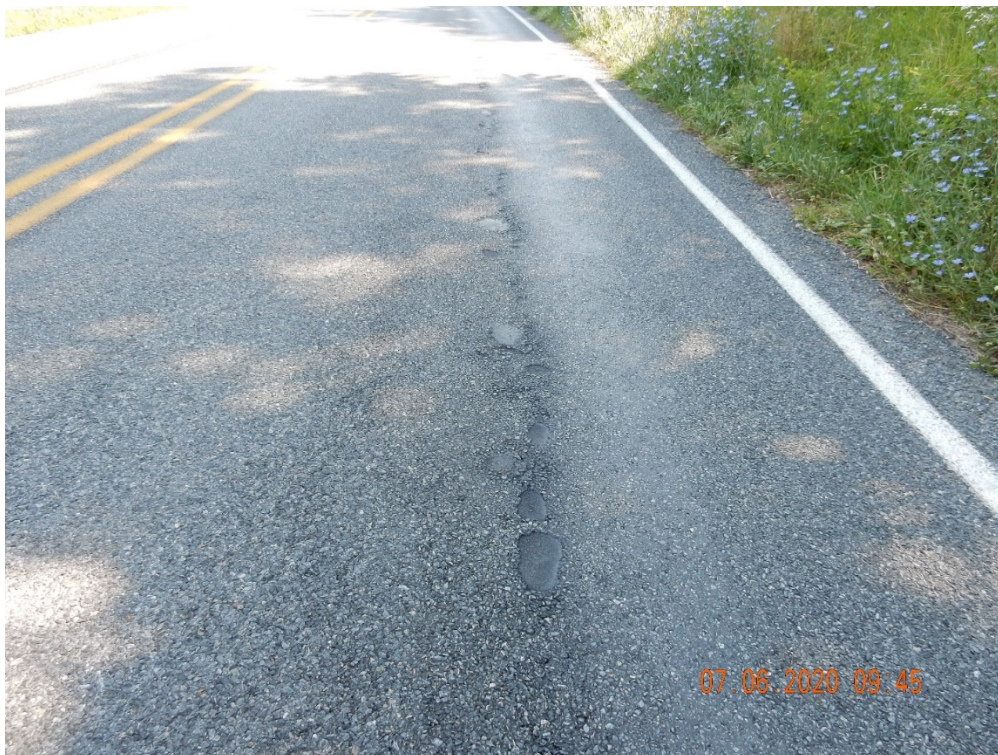
It was noticed that the delaminated spots discussed previously during the site visit of October 2019 were repaired. However, there was one localized area on the northbound, close to the mat center, where severe loss of aggregate and exposed fabric was observed (Figures 34 and 35). The phenomenon appeared similar to that observed during the visit of October 2019, but at a limited occasion and closer vicinity of chip loss

spots. Similarity of the problem to that of the October 2019 visit makes one believe that again water played a role in causing this problem.

Figure 34. The chip loss spots forming an almost straight line can be seen to the right of the center on the northbound.

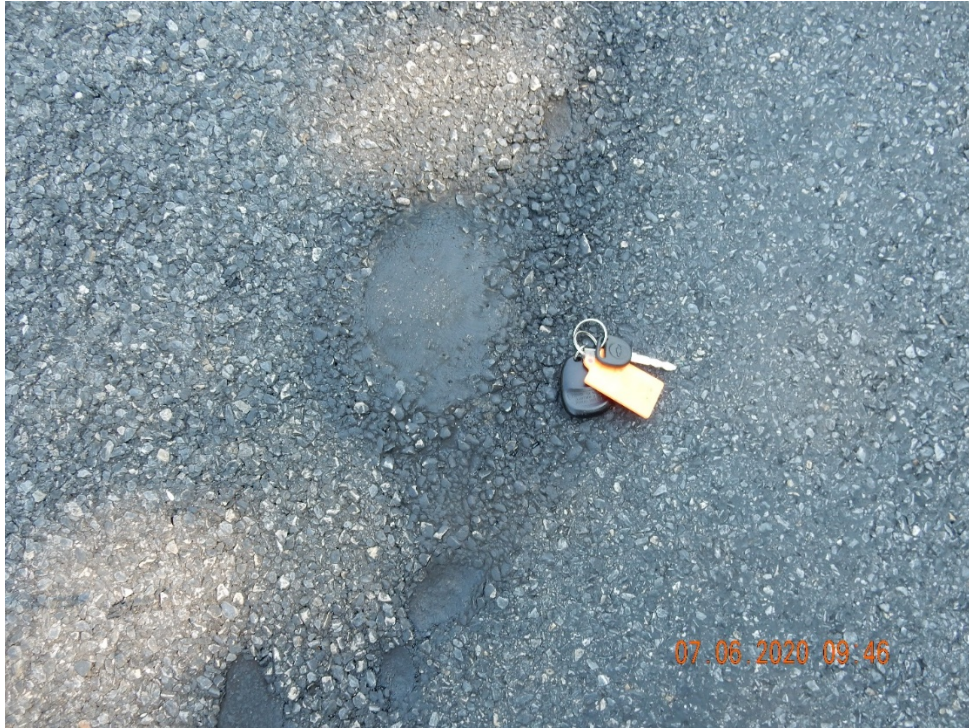
Figure 35. A closeup of the area with material loss and exposure of fabric.
