**Research Project # 2003-053
Evaluation of Post – Consumer Shingles in HMA**

**Final Report
November 2009**

**Evaluations and Research Section
Engineering Technology and Information Division
Bureau of Construction and Materials**

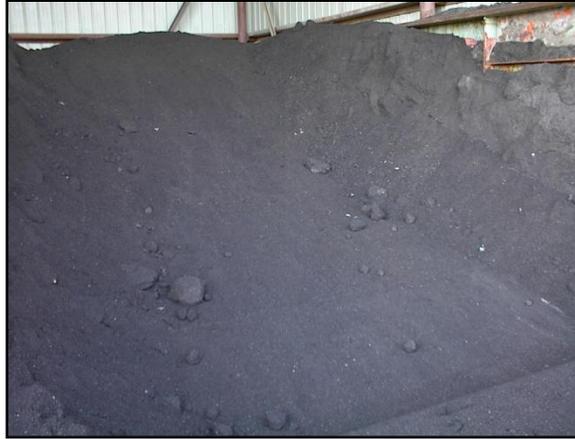
Photo 1, The pulverized shingles were stockpiled at the H&K, Bechelsville Plant under roof. The material resembled coarse black sand.

The stockpiled pulverized shingle material looked like coarse black sand (Photo 1). The consultant construction inspection staff from Site Engineers was briefed on what to expect that was different with this experimental asphalt shingles mix:

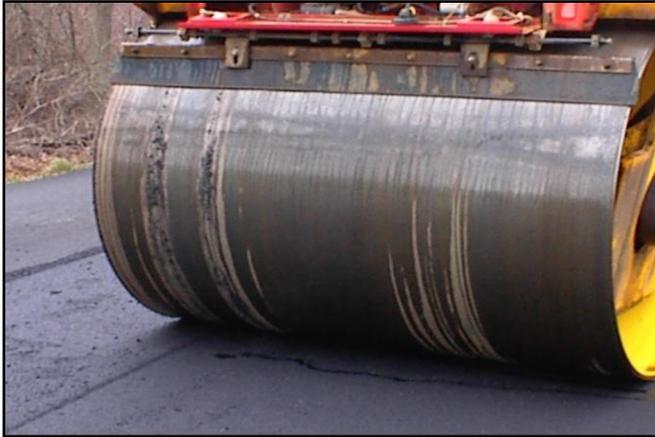
On the first day of paving, the project inspection staff was advised to ensure that the drums on rollers were wet prior to getting on the shingles mix because it may pick up. During placement of the 4th load of the Experimental Mix B the break down roller began picking up the asphalt (Photo 2) due to a dry spot on the drum (Photo 3). This was the first time that this incident was observed. The contractor took immediate action to correct the problem. The drum was scraped clean and ample water distribution to the drum was restored.

Photo 2, The dry areas on the roller drum picked up the 9.5mm Superpave mix with 5% pulverized shingles material.

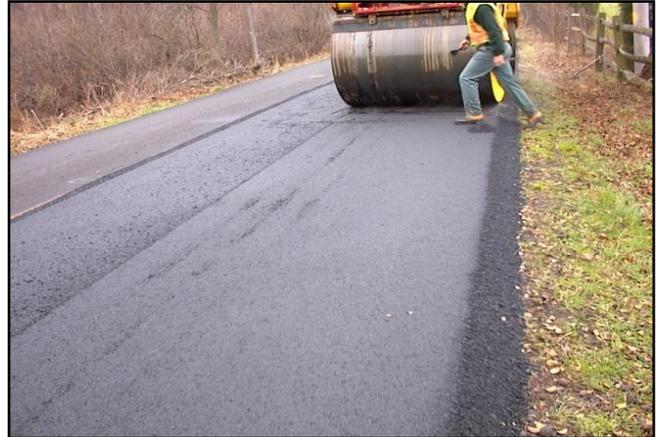
Photo 3, The marred surface of the pavement mat.

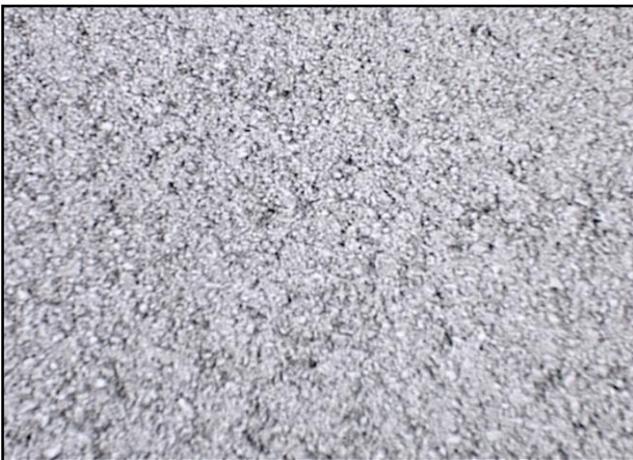
The mat of the placed Experimental Mix B appeared to look like a dry mixture, as exhibited by Photo 4 and Photo 5, note the open texture.

Photo 4, Before compaction pavement mat.

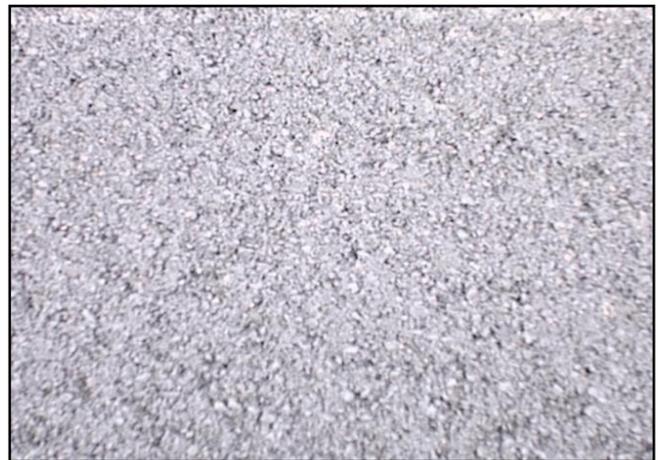
Photo 5, After compaction pavement mat.

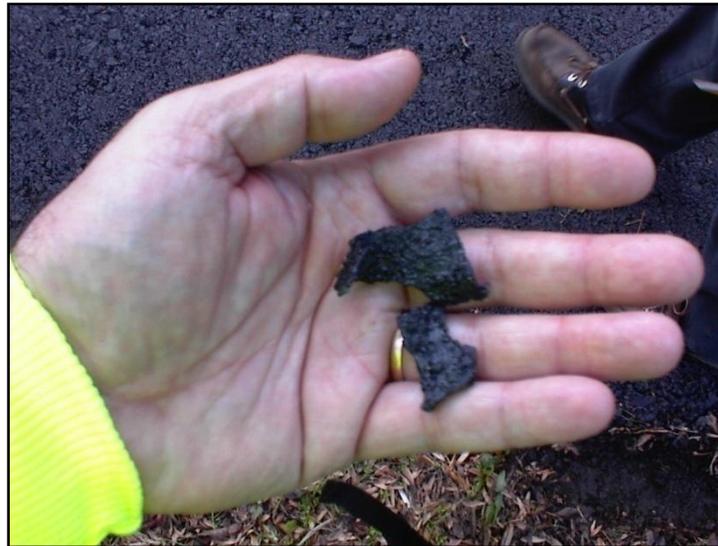
The consultant field inspectors discovered scraps of rubber roofing membrane (Photo 6) in the mat after the asphalt was placed. Additional pieces of this rubber roofing membrane material were observed in the loaded bed of the dump truck carrying the shingles mix. These scraps of shredded rubber did not meet H&K's own specification for the shingles material regarding both size (gradation) and material composition. The scraps of rubber roofing membrane were a contaminant to the bituminous mix.

Photo 6, Pieces of shredded roofing membrane contaminant is removed during the paving operation.

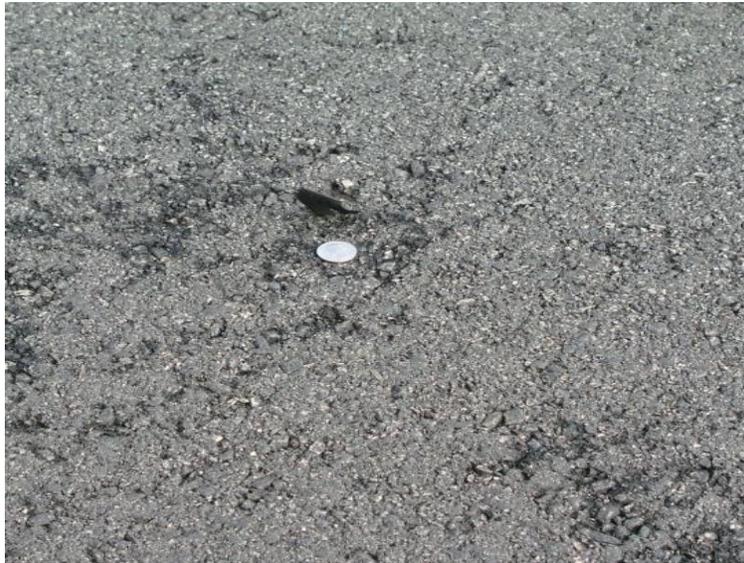
The photographs shown were taken (April 29, 2004) 5 months after placement of the asphalt pavement with the 5% post-consumer shingles. A concern of using post-consumer shingles was contaminants in the shingles that would jeopardize the quality of the pavement. A sample of shredded roofing membrane (Photo 7) was protruding from the finished pavement on the research section of the project.

Photo 7, Shredded roofing membrane protruding from the finished roadway.

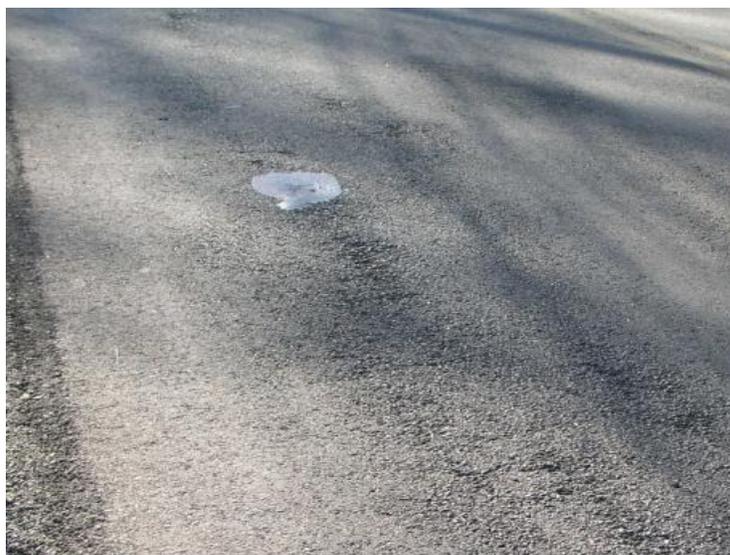
The research section that was paved on the last day appears to be raveling (Photo 8) when compared to the control section of the project. This means the asphalt surface of the roadway was starting to lose aggregate.

Photo 8, The asphalt road surface of the experimental section appeared to be raveling.

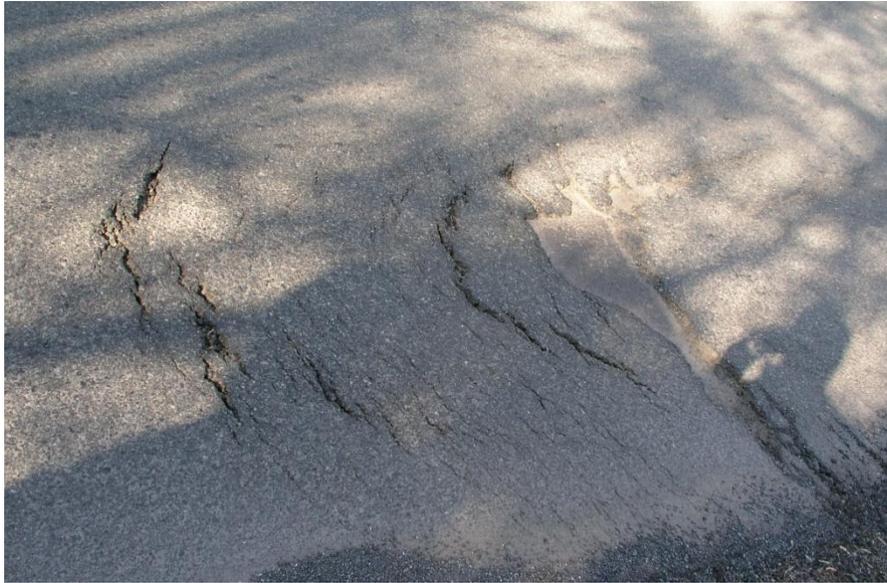
Apparently a vehicle accelerating from Finland Road (Upper Ridge Road) onto Allentown Road peeled back the asphalt mat, note the tears (Photo 9).

Photo 9, Peeled back asphalt mat at the intersection of Allentown Road and Finland Road.

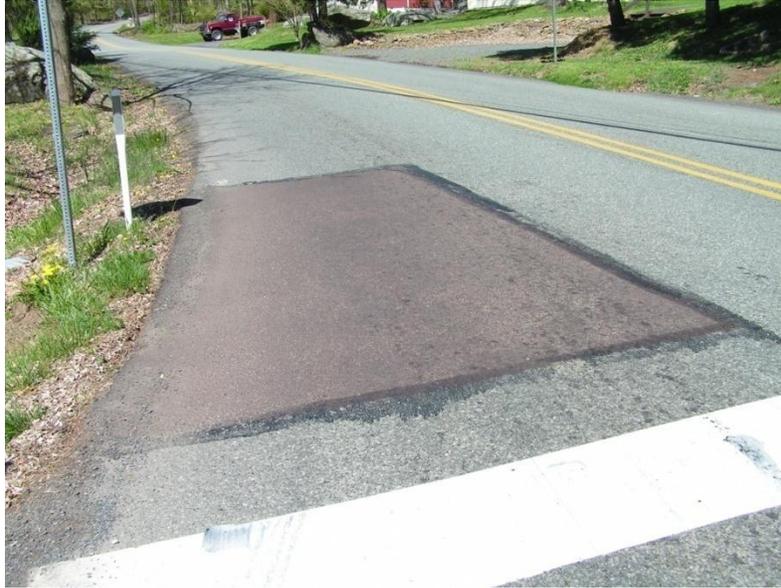
The field review 2 years and 5 months (April 28, 2006) after placement of the pavement found continued distress of the pavement in the research section. Photo 10 shows one of the distressed pavement areas that needed to be patched.

Photo 10, Distressed pavement needed to be patched.

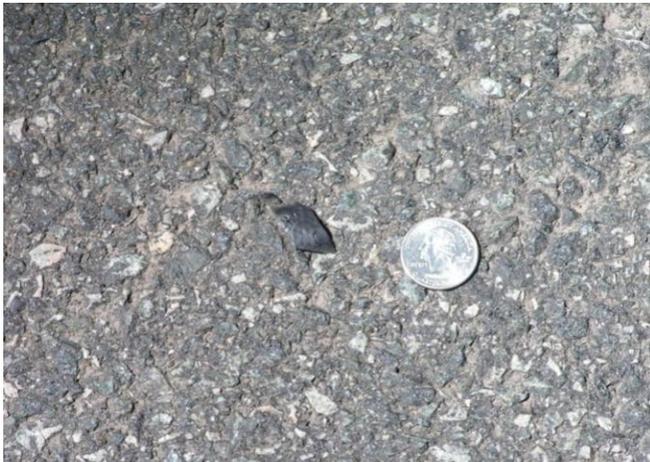
The quality control of the post-consumer shingles was a problem based on the amount of roofing membrane (Photo 11) and other contaminants (Photo 12) found protruding from the pavement. According to specification, the particle size of the grounded post-consumer shingles was to be less than three-eighths of an inch (3/8-in.). The ground post-consumer shingles did not meet specifications, since most of the contaminants discovered were larger than three-eighths of an inch.

Photo 11, Shredded roofing membrane protruding from the finished roadway.

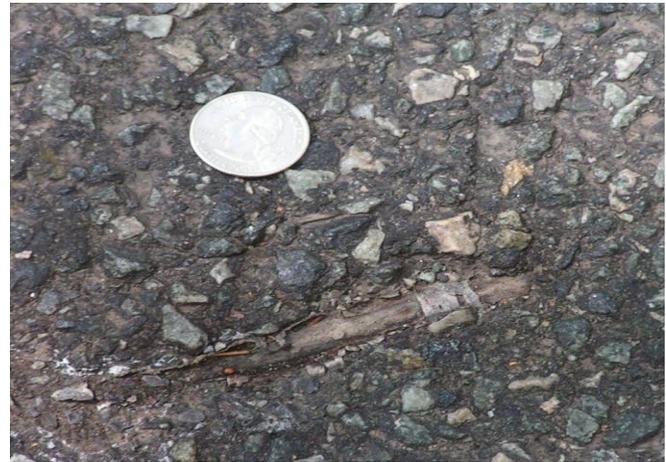
Photo 12, Contaminant in the surface of the pavement.

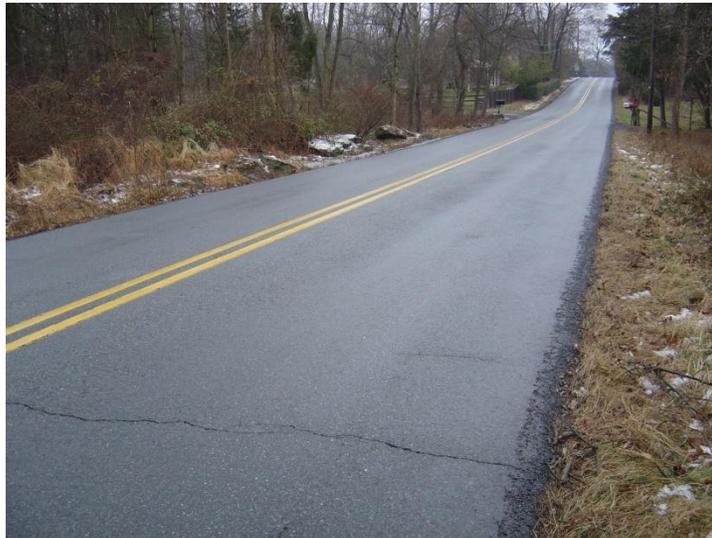
The field review 4 years (December 21, 2007) after placement of the pavement shows distress with a section of pavement with transverse cracking (Photo 13). Photo 14 shows continued deterioration with the pavement exhibiting alligator cracking and rutting.

Photo 13, The pavement is exhibiting transverse cracking.

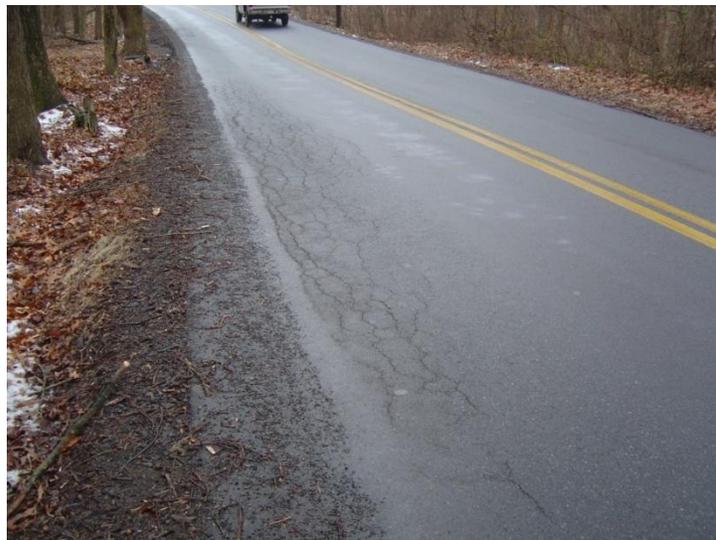
Photo 14, The pavement has additional alligator cracking and rutting.
