# Historic Bridge Rehabilitation Analysis Phase 1 SR 1002 (Skinners Falls Road) over Delaware River

BMS# 63-1002-0230-0739

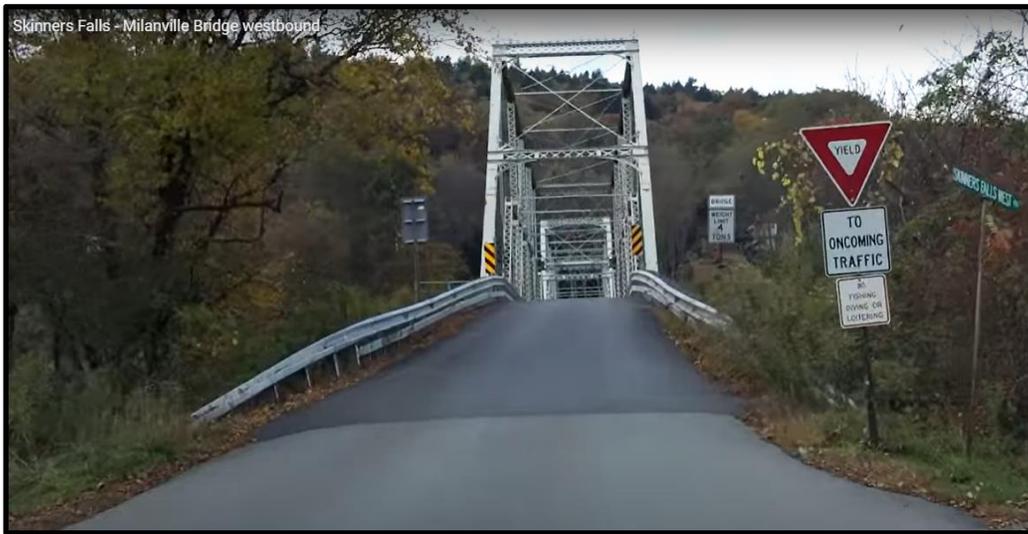
**Figure 2:** New York Approach geometry with a view west of the approach on the east (New York) side of the bridge.

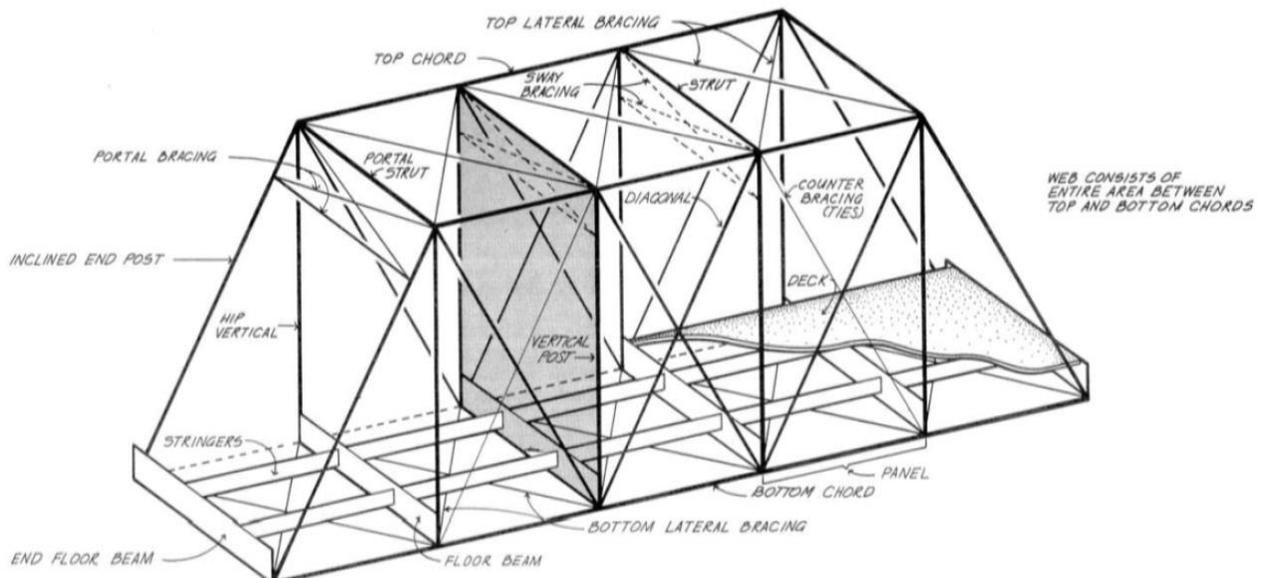
**Figure 3: Basic Truss Components (from PennDOT Truss Maintenance Manual, 2015)**

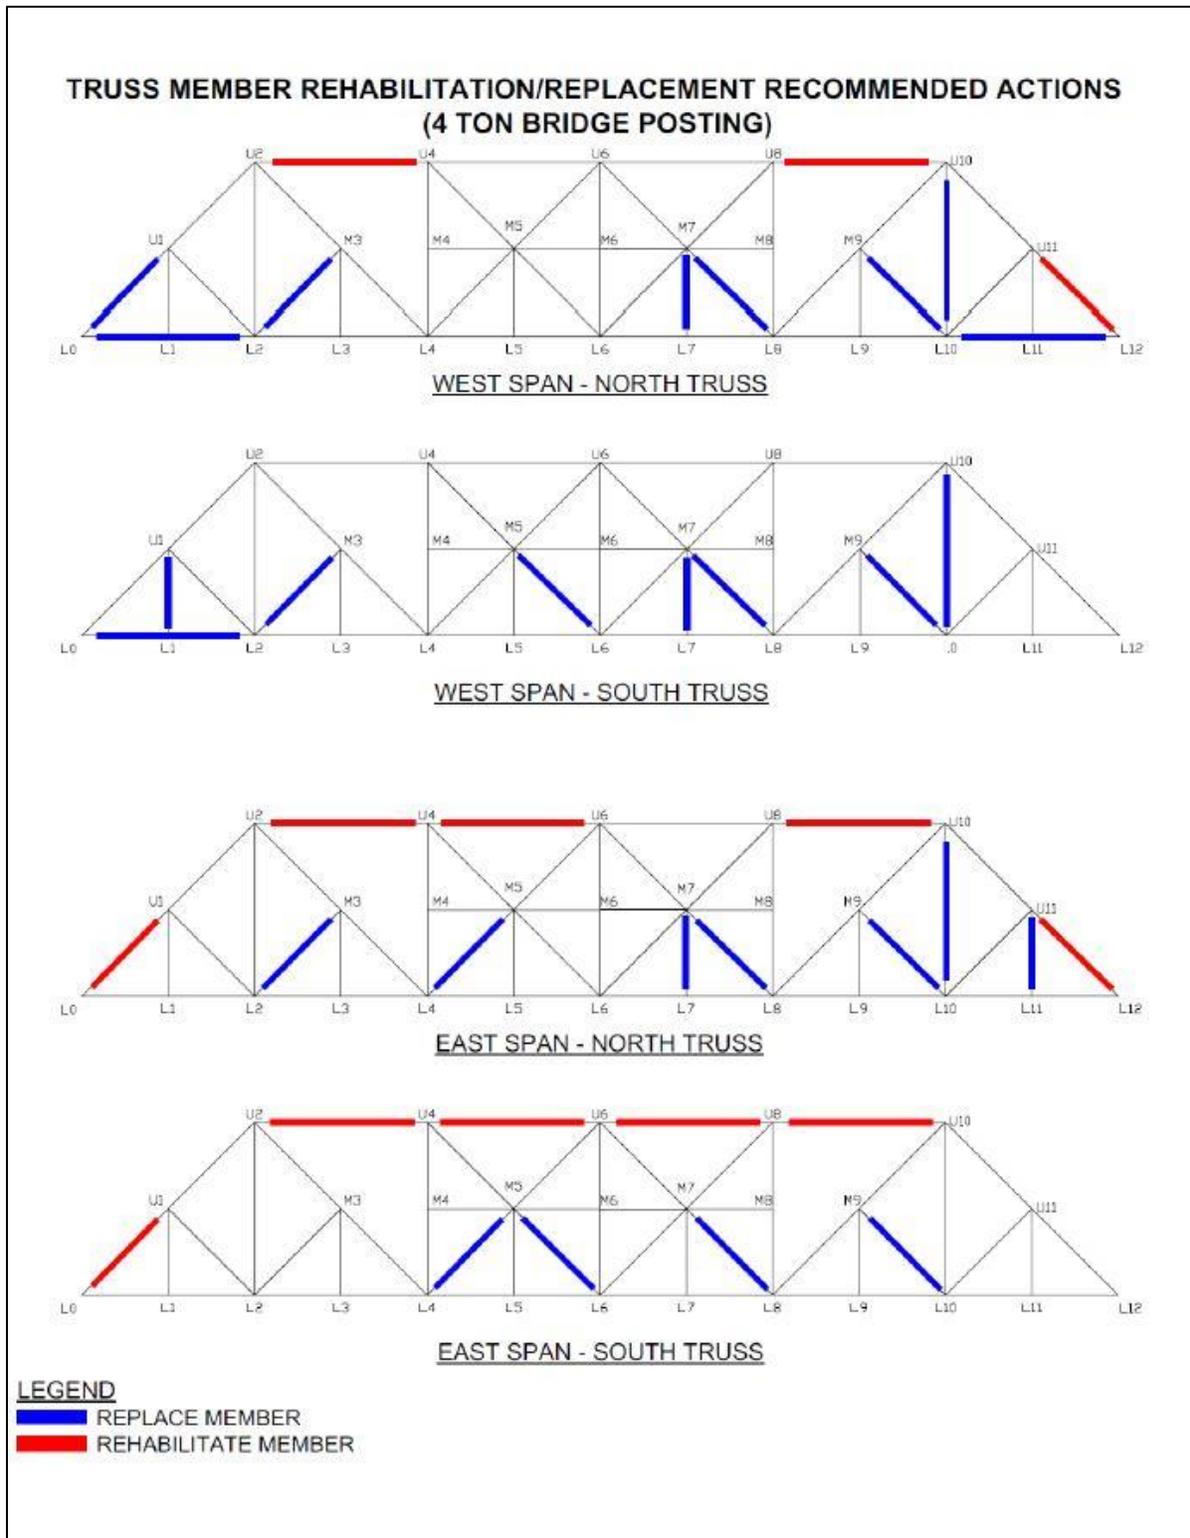
Figure 7: Minimum Rehabilitation (4-ton) Alternative

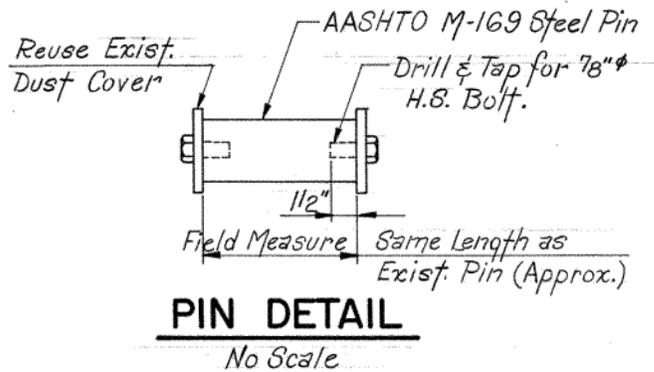
Figure 8: Existing Pin Detail, 1986 Rehabilitation Drawings

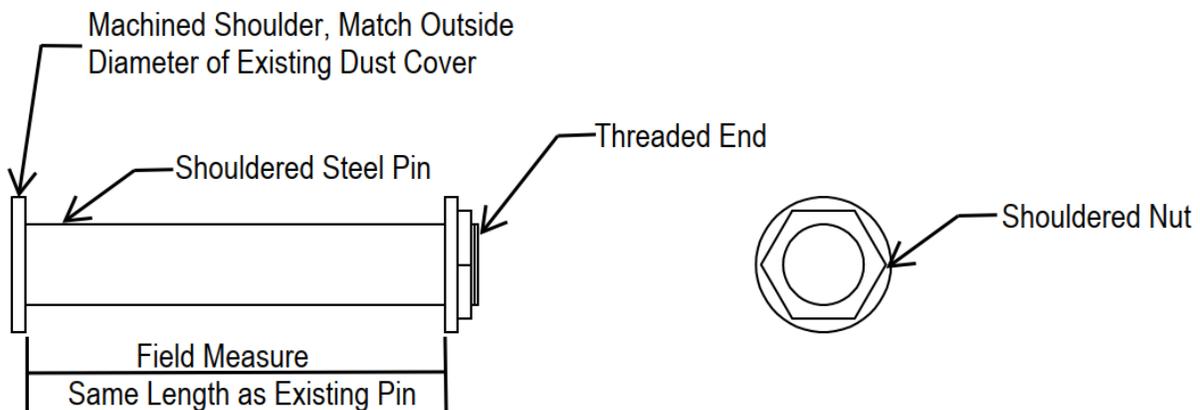
Figure 10: Proposed Shouldered Pin Detail and Shouldered Nut Detail

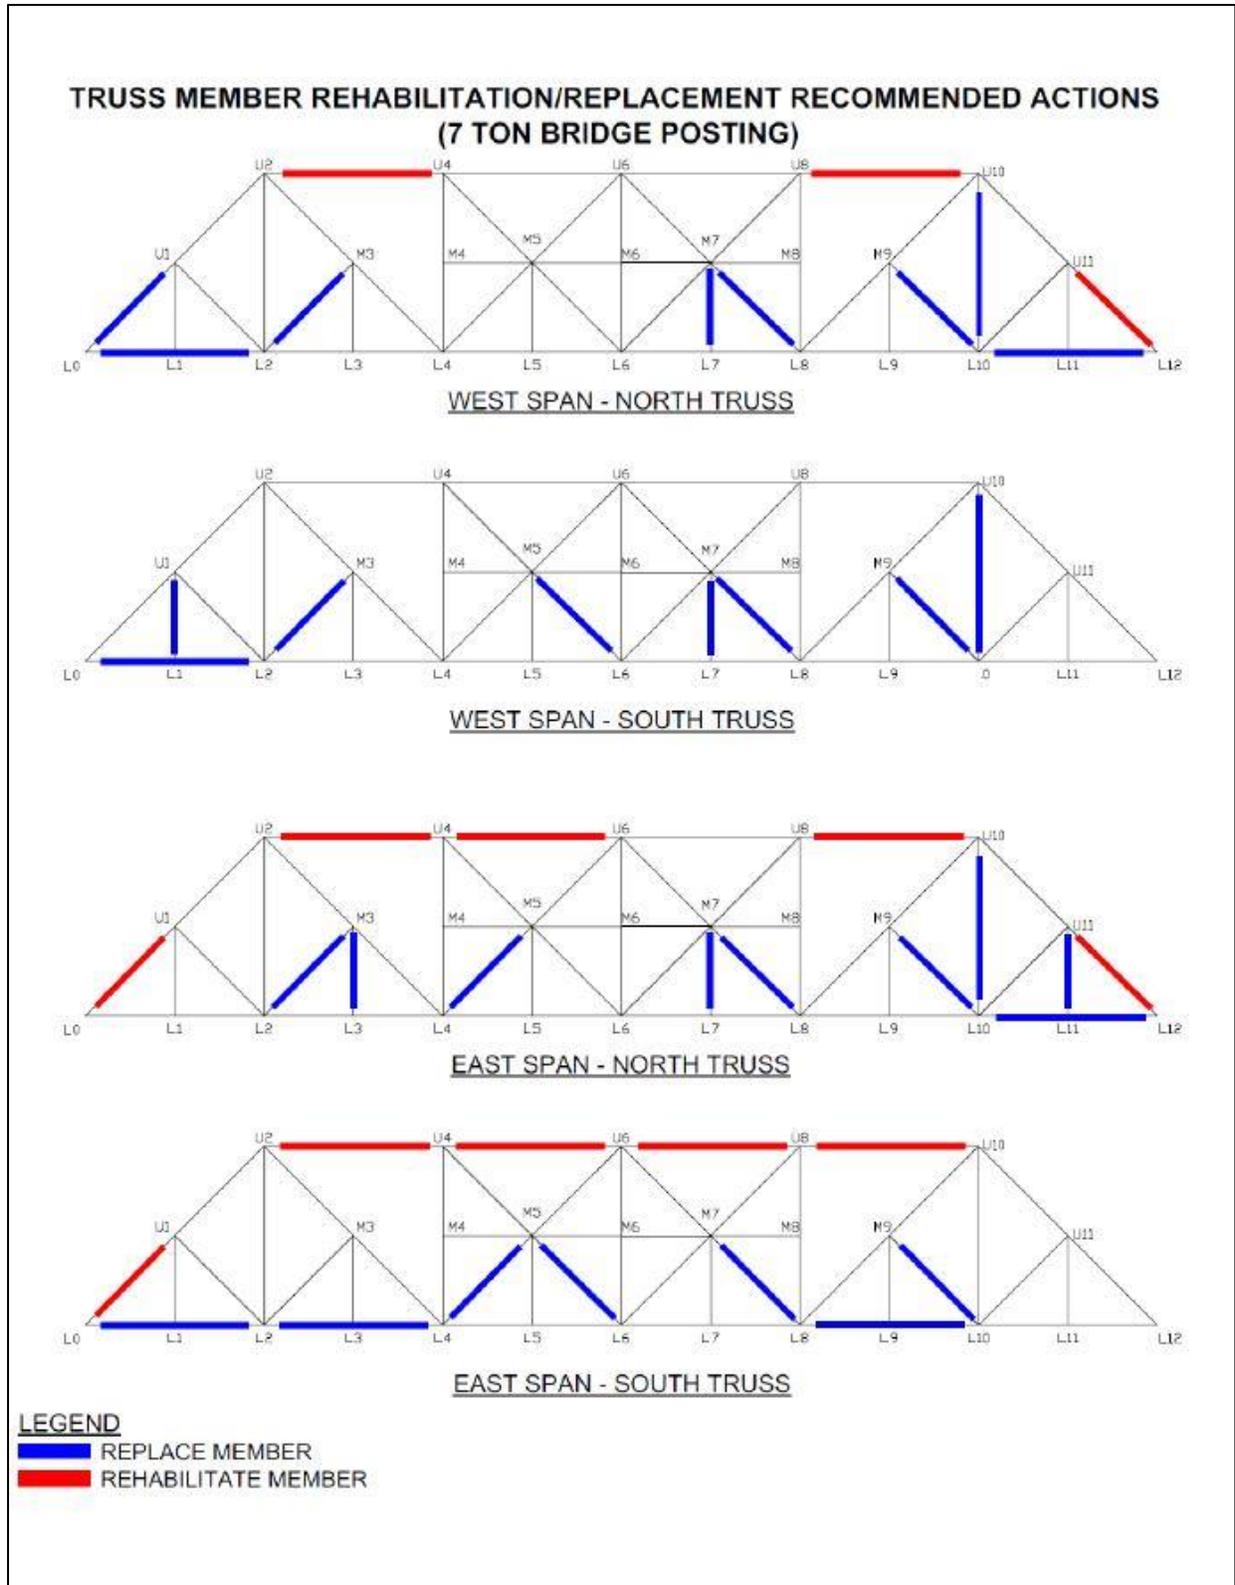
Figure 11: 7-ton Rehabilitation Alternative

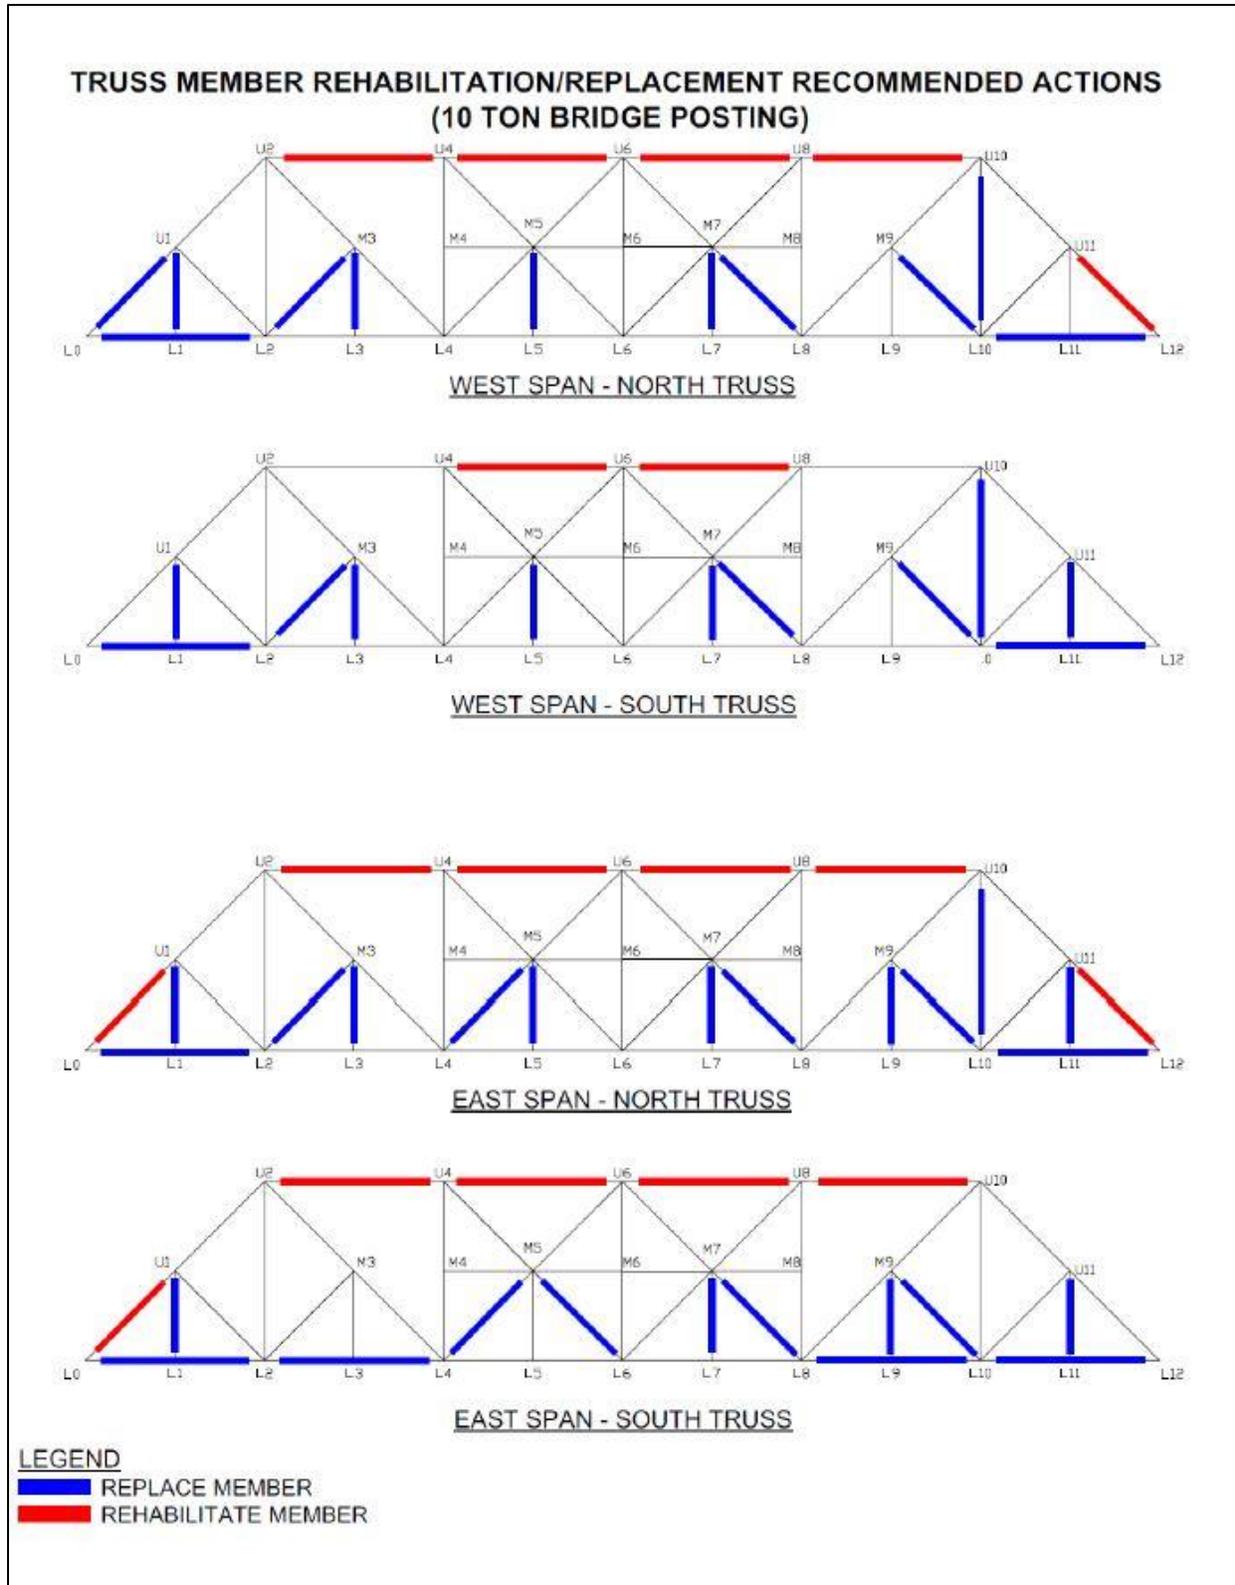
Figure 12: 10-ton Rehabilitation Alternative

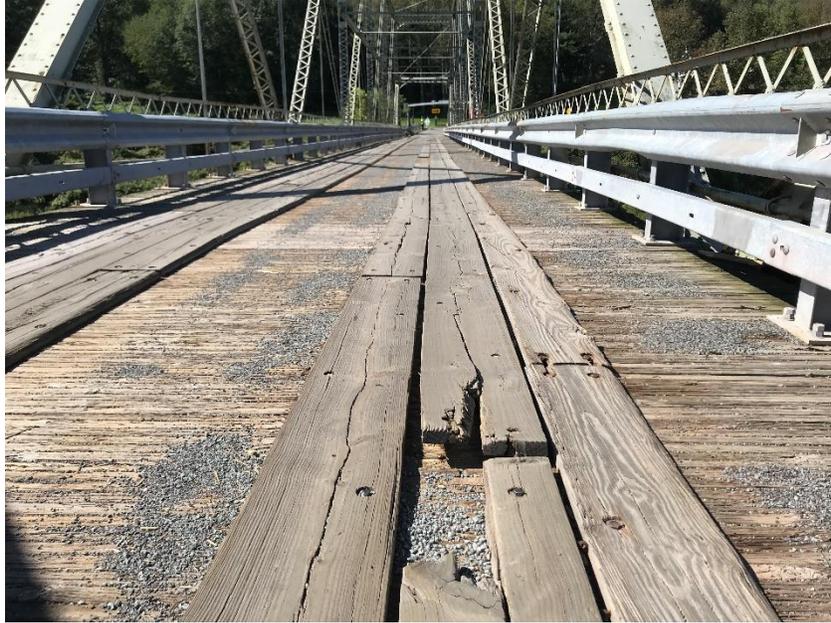
**Photo 5 - Skiners Falls Bridge: Timber Running Board Deterioration**

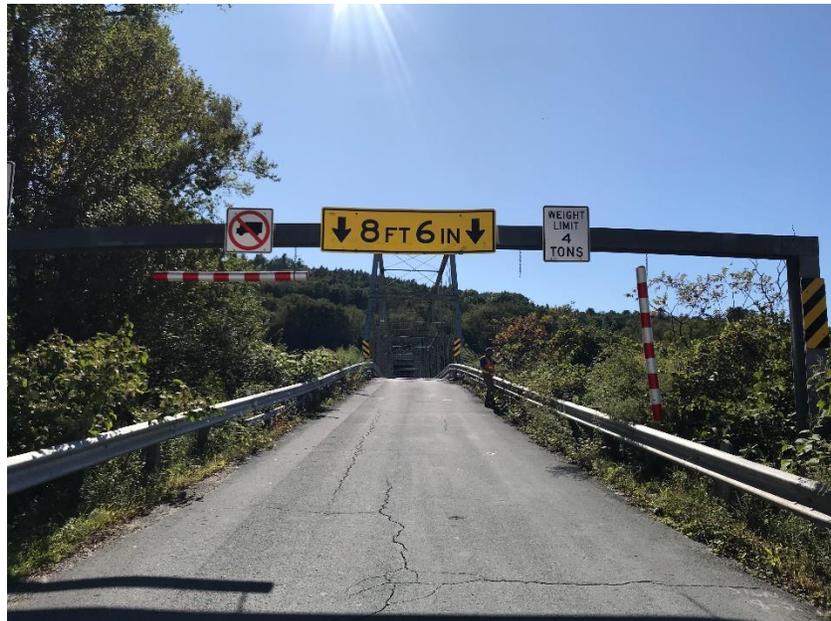
**Photo 6 - Skiners Falls Bridge: Headache Bar at NY Approach**

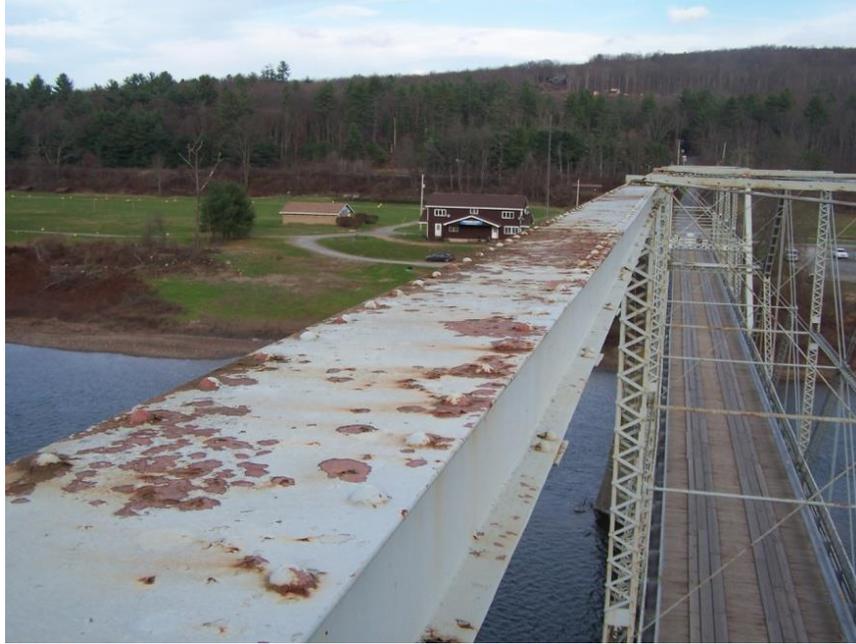
**Photo 9 - Skinnners Falls Bridge: Left Truss Top Chord flaking paint and minor surface rust**

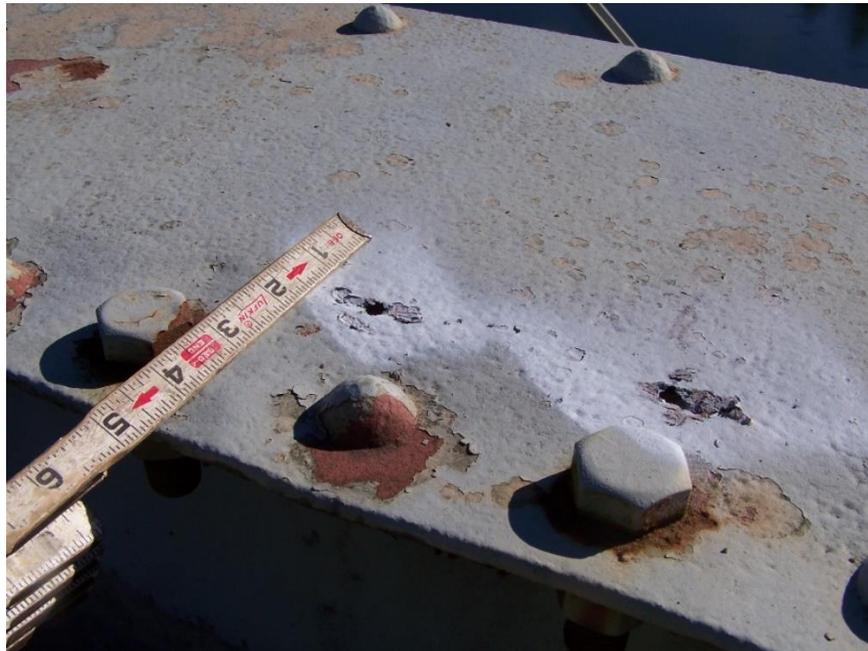
**Photo 10 - Skinnners Falls Bridge: Left Truss Top Chord section loss**

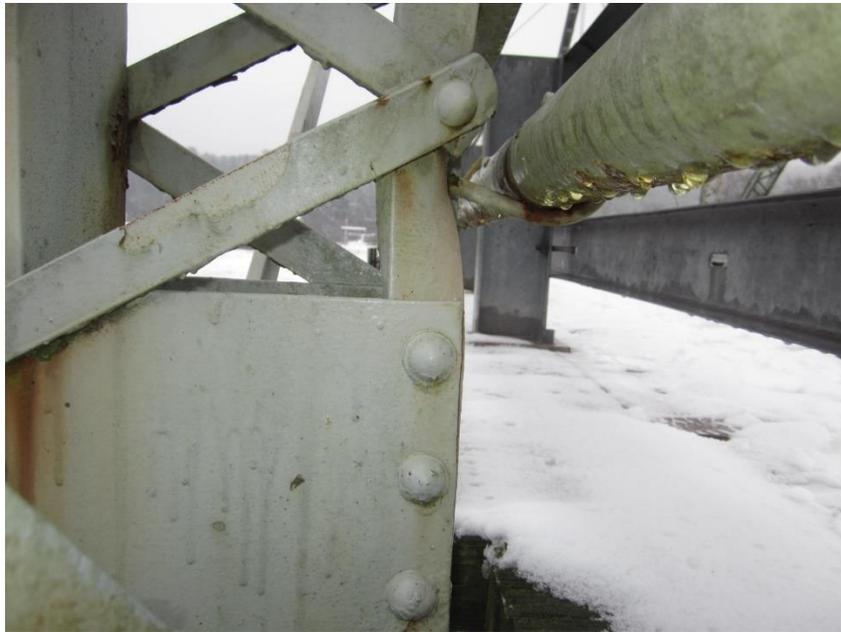
**Photo 12 - Skinners Falls Bridge: Collision damage to vertical members at deck level behind the bridge railing**

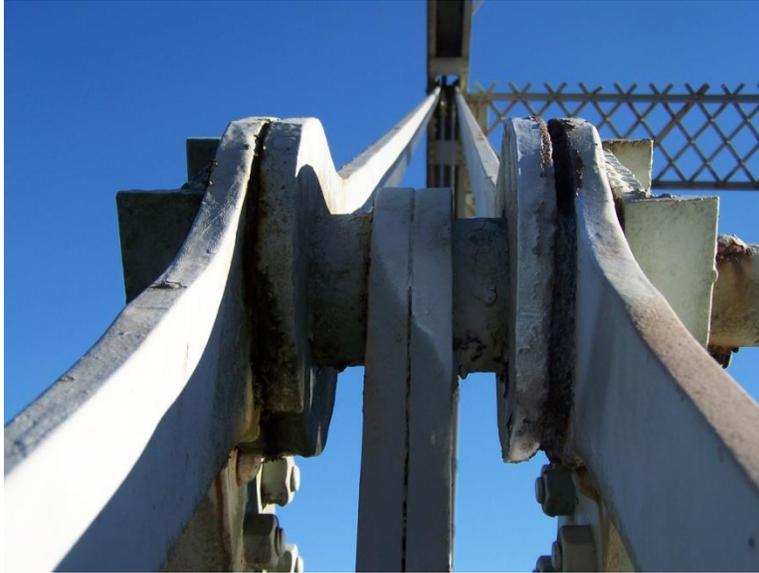
**Photo 13 - Skinners Falls Bridge: Typical losses to eyebar heads at middle panel points**

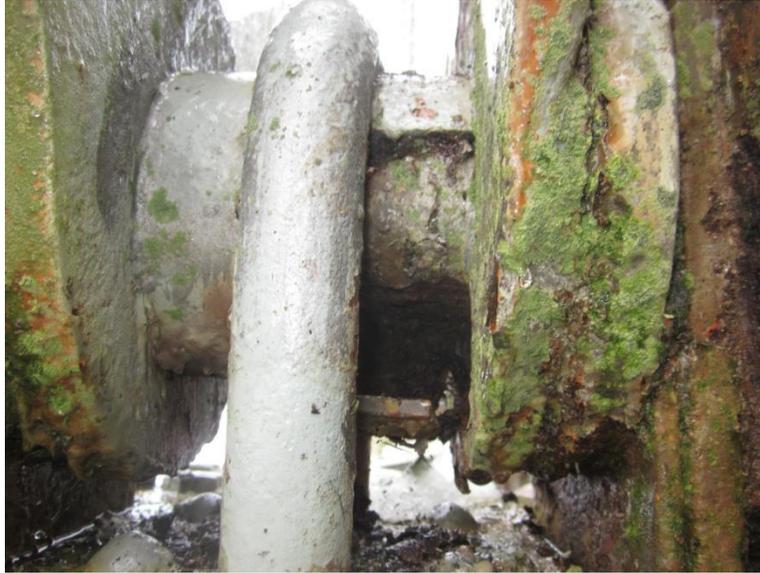
**Photo 17 - Skimmers Falls Bridge: Span 1, Left Truss, Panel Point L6 pin sleeve broken (Looking Ahead)**

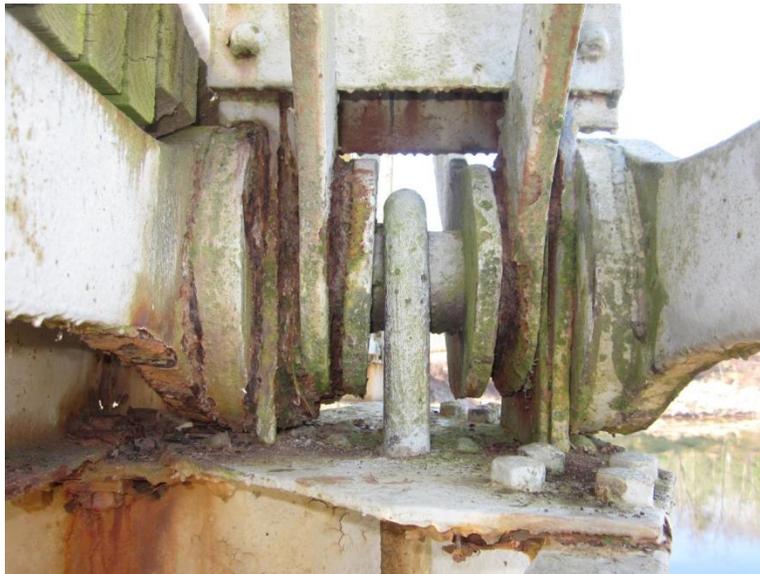
**Photo 18- Skimmers Falls Bridge: Span 2, Left Truss, Panel Point L6 extensive pack rust (Looking Back)**

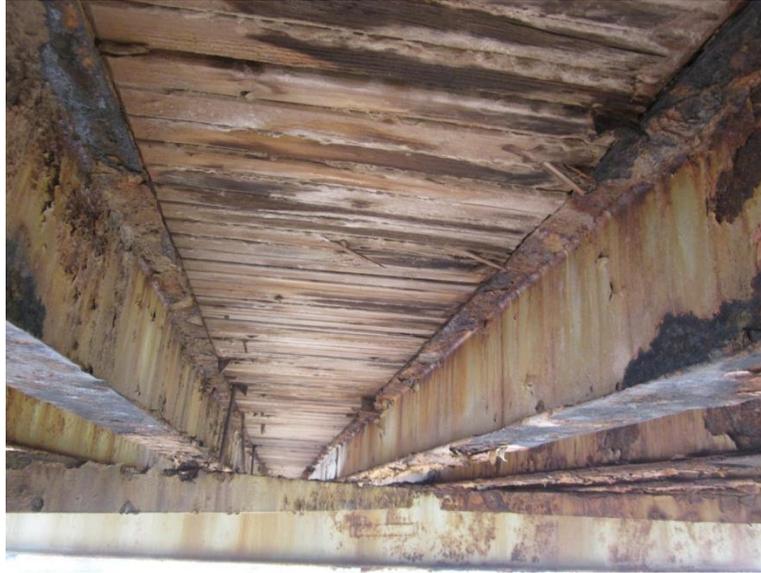
**Photo 19 - Skinners Falls Bridge: Typical deck underside condition. Note missing clips**

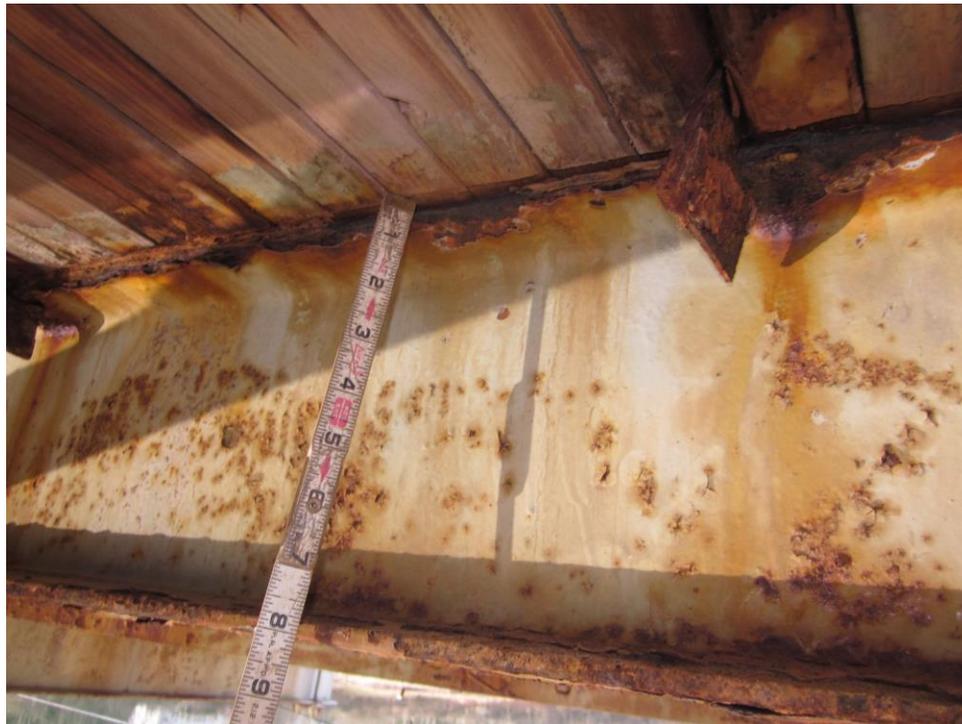
**Photo 20 - Skinners Falls Bridge: Gap between stringer and deck due to section loss**

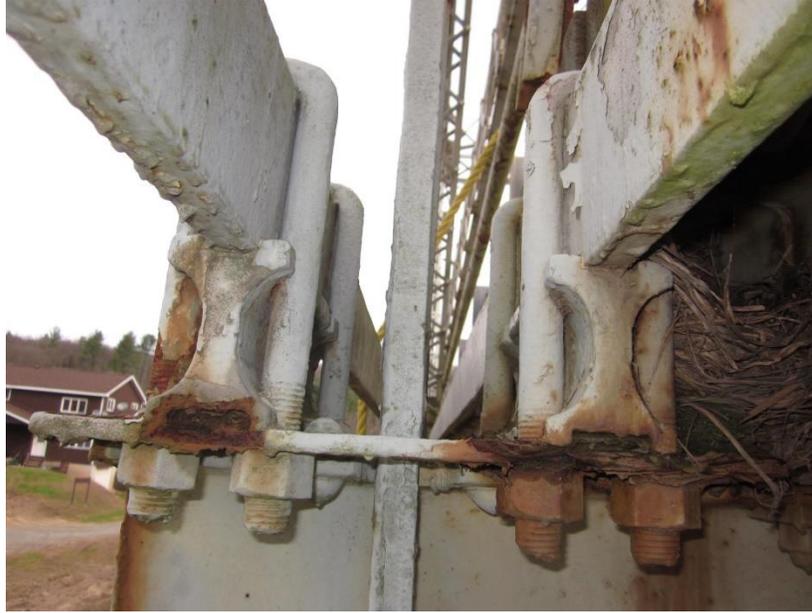
**Photo 21 - Skinnners Falls Bridge: Floor Beam Support deterioration**

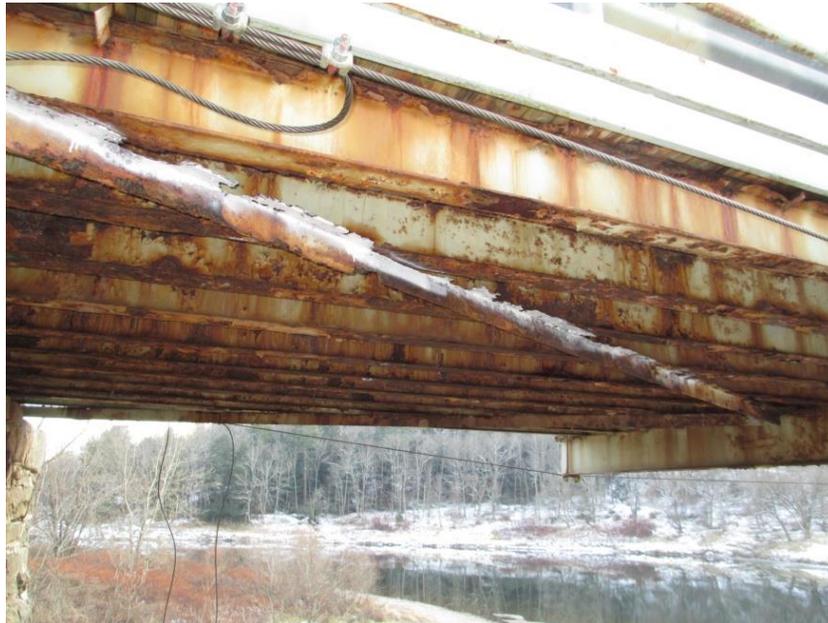
**Photo 22 - Skinnners Falls Bridge: Span 2, Floor Beam Bay 12, 100% section loss to bottom lateral bracing**

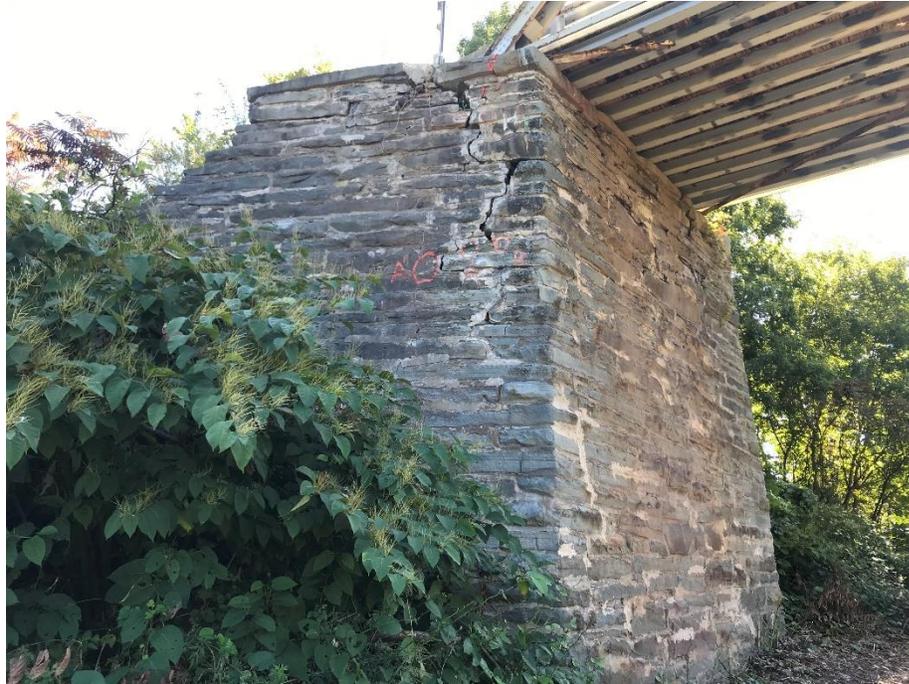
**Photo 23 - Skinners Falls Bridge: Far Left Wingwall with Crack Monitoring Points and Full Height Step Cracking**

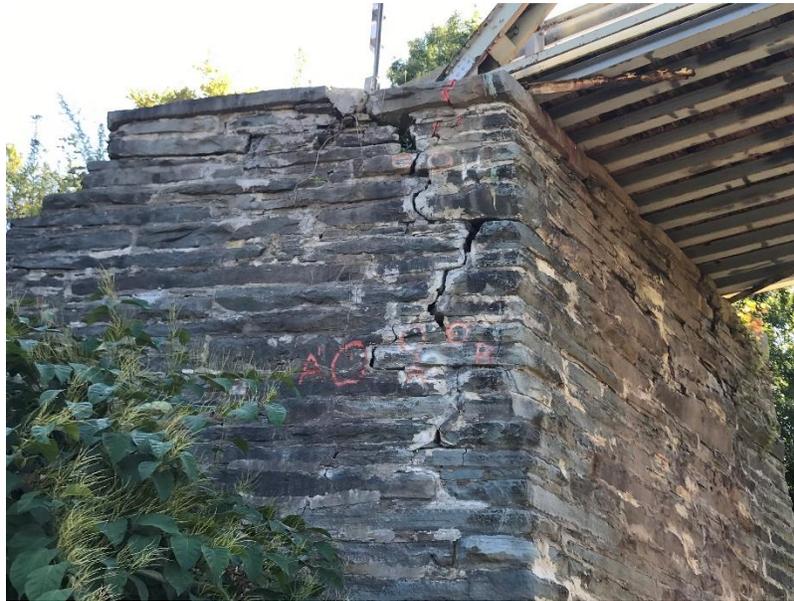
**Photo 24 - Skinners Falls Bridge: Far Left Wingwall with Crack Monitoring Points and Full Height Step Cracking**

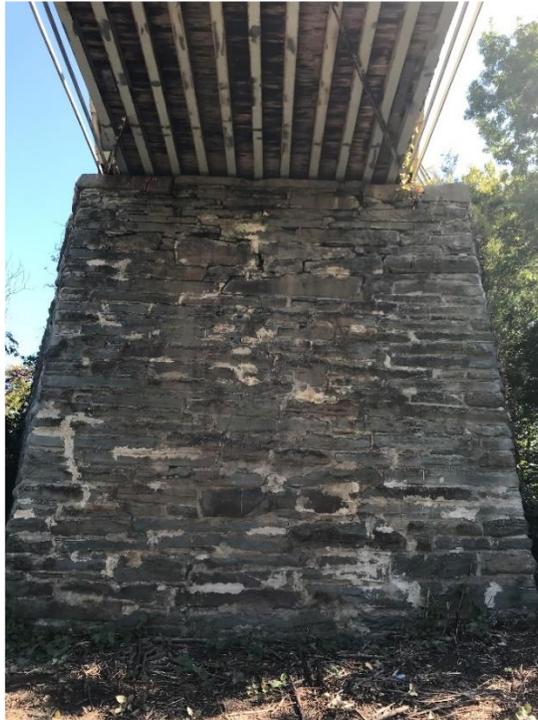
**Photo 25 - Skinnners Falls Bridge: Far Abutment with Crack Monitoring Points and Full Height Step Cracking**

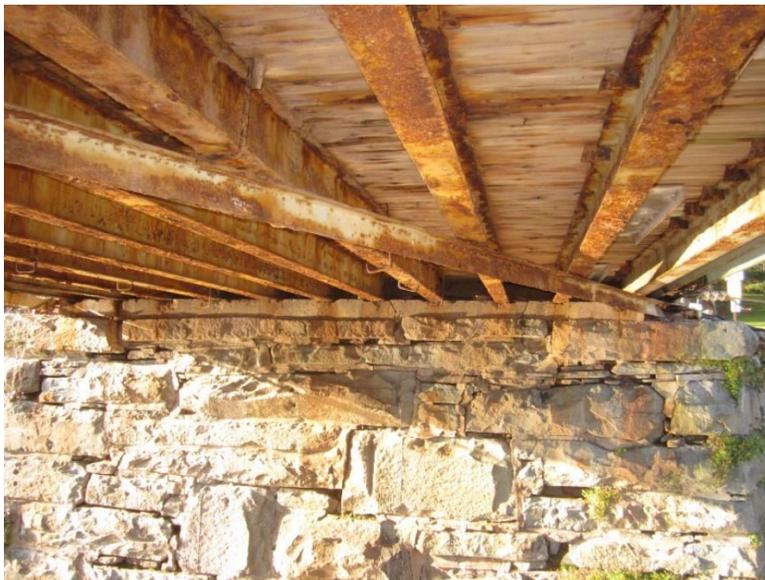
**Photo 26 - Skinnners Falls Bridge: Near Abutment with wide mortar joints with deep voids at the top half**

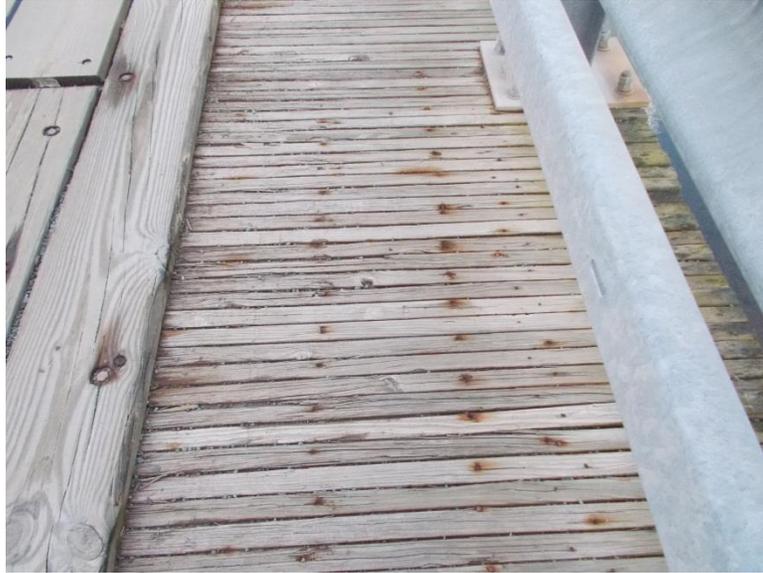
**Photo 33 - Skinners Falls Bridge: Typical Deterioration of Left Edge of Deck.**

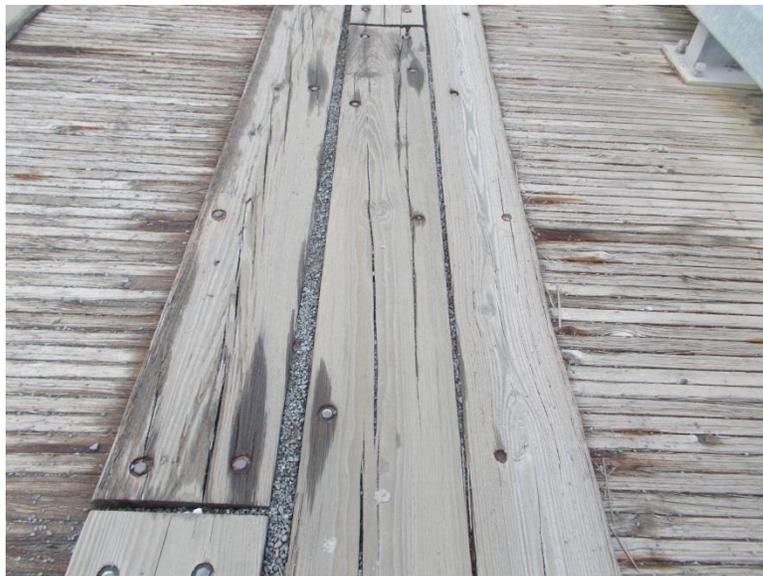
**Photo 34 - Skinners Falls Bridge: Typical Cracks and Splitting Throughout Left Tread**

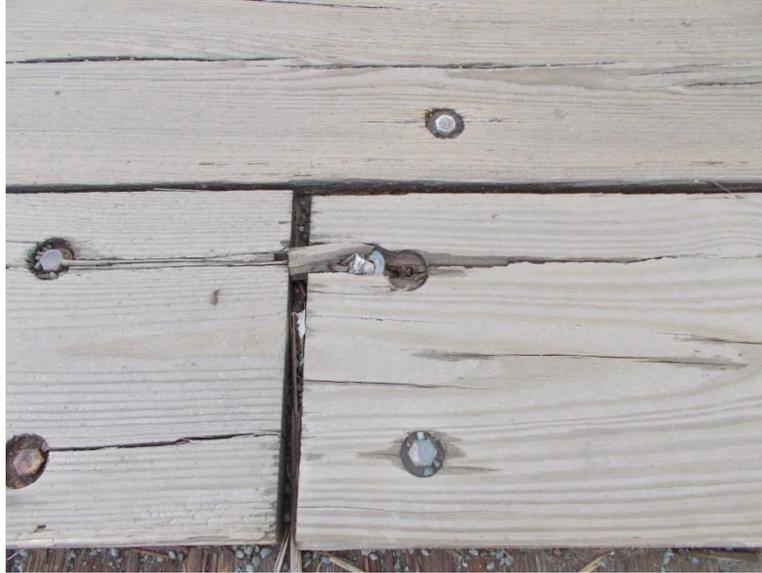
**Photo 35 - Skinners Falls Bridge: Typical Damaged Tread Connection (Span 2 Shown)**

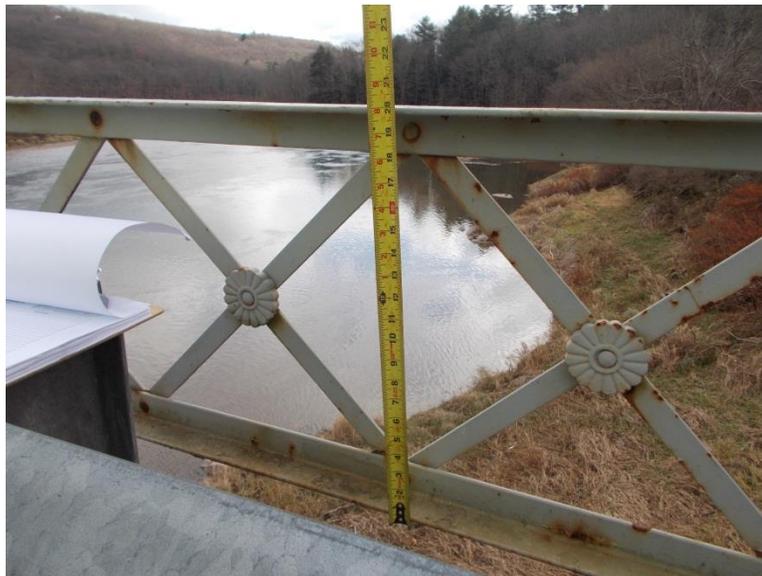
**Photo 36 - Skinners Falls Bridge: Typical View of Decorative Railing**

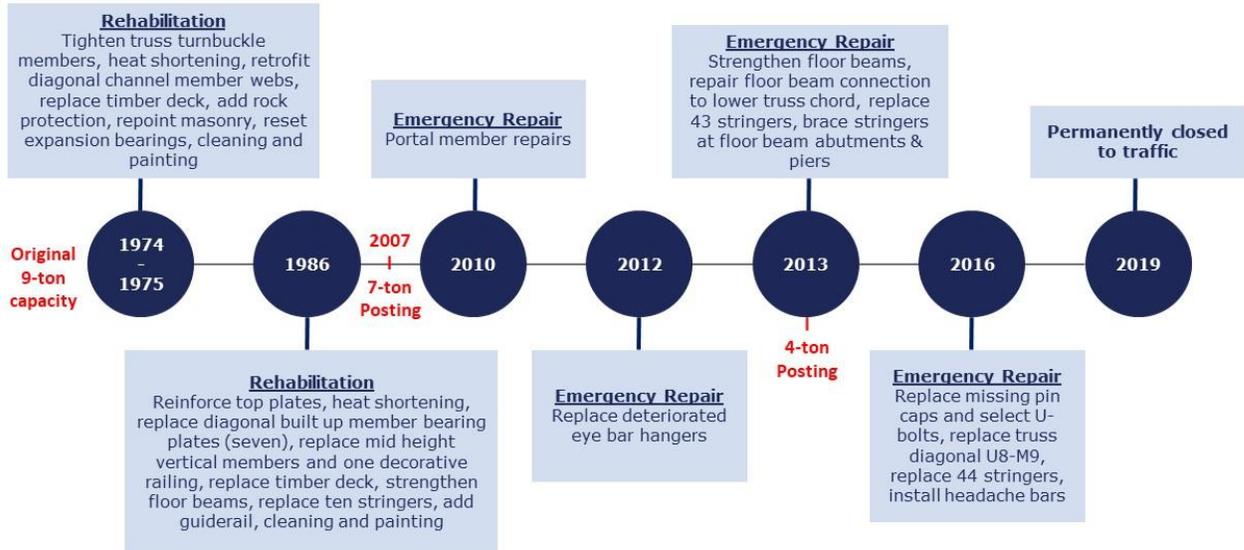
Plans for the rehab conducted in 1974-1975 were developed in 1971
