EXISTING CONDITIONS

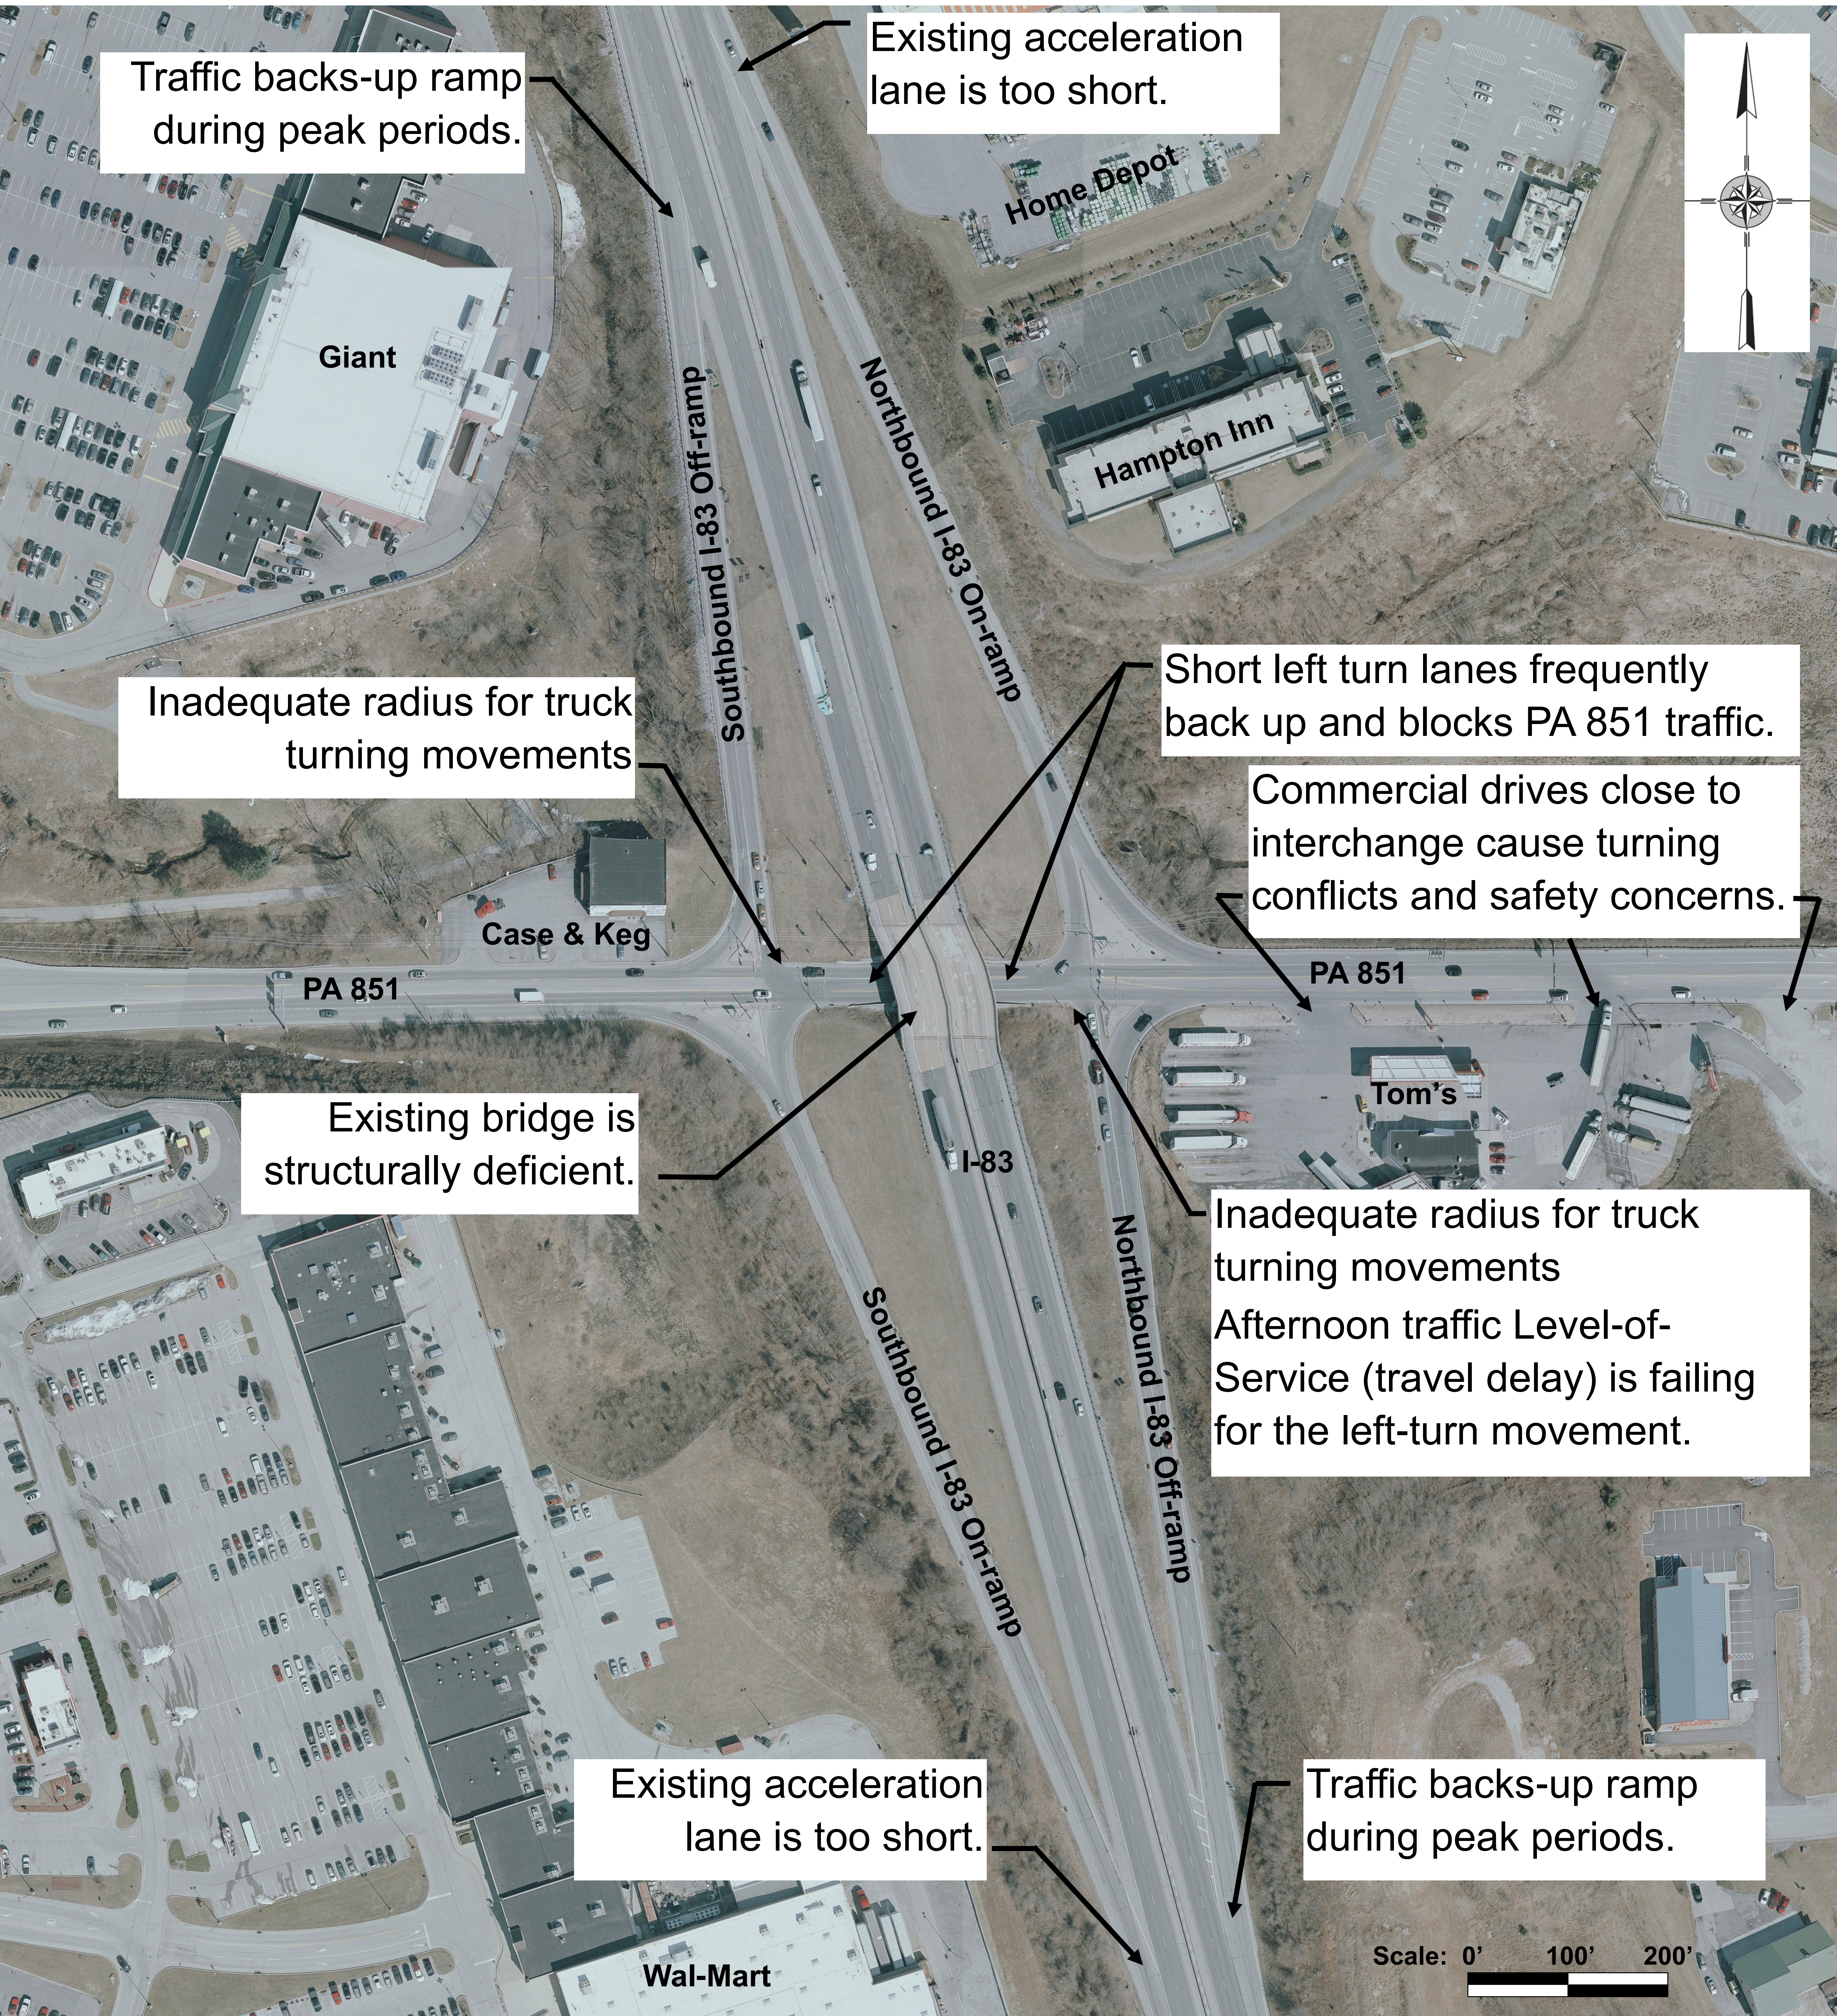
Traffic backs-up ramp during peak periods.

Existing acceleration lane is too short.

Inadequate radius for truck turning movements

Short left turn lanes frequently back up and blocks PA 851 traffic.

Commercial drives close to interchange cause turning conflicts and safety concerns.

Existing bridge is structurally deficient.

Inadequate radius for truck turning movements
Afternoon traffic Level-of-Service (travel delay) is failing for the left-turn movement.
