pennsylvania

Bridge Resiliency in Rain Events

FINAL REPORT

ATLSS Research Center
Lehigh University

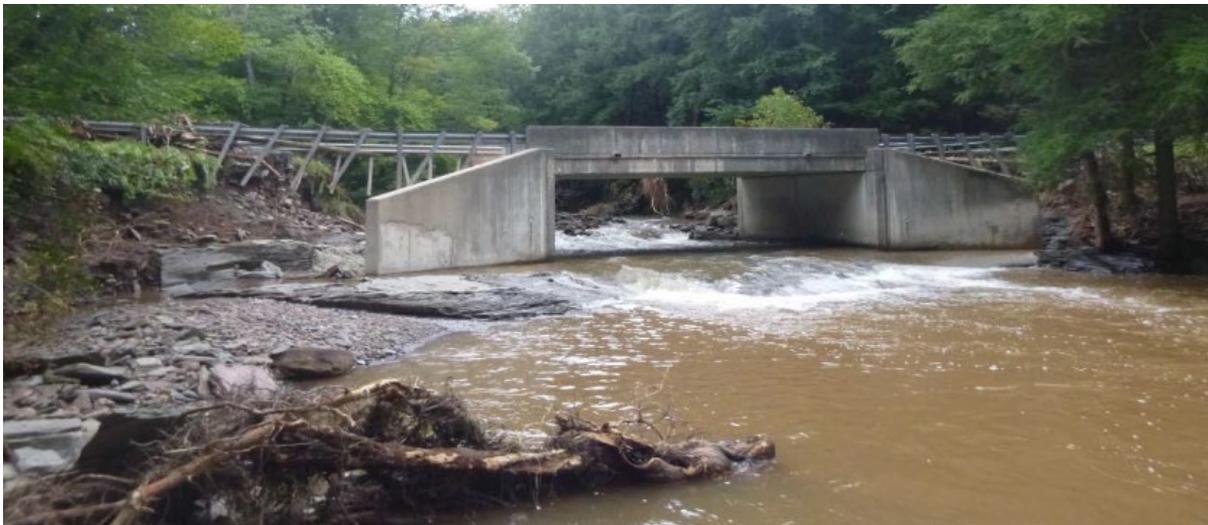
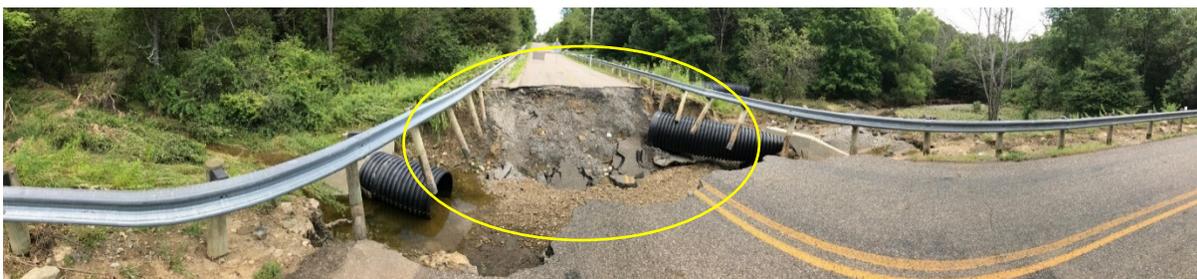
Figure 1.2 Erosion of backfill material and culvert failure caused by overtopping (courtesy of PennDOT)

Pennsylvania State Climate Summaries report that precipitation, especially extreme precipitation, have been increasing during the last two decades in Pennsylvania (Frankson et al., 2017). The temperatures in Pennsylvania have also risen in the winter and spring (Frankson et al., 2017; Reidmiller et al., 2017). More frequent precipitation and higher temperatures have led to an increase of snowmelt in Spring, which results in an increased risk for extreme floods. Extreme floods can lead to overtopping of bridge embankments when the flow exceeds the capacity of the bridge opening or for cases where the openings may be obstructed due to debris. Cases of erosion of backfill material around a bridge abutment due to intense flood events and overtopping have been observed throughout Pennsylvania in recent years (Figure 1.1 and Figure 1.2).

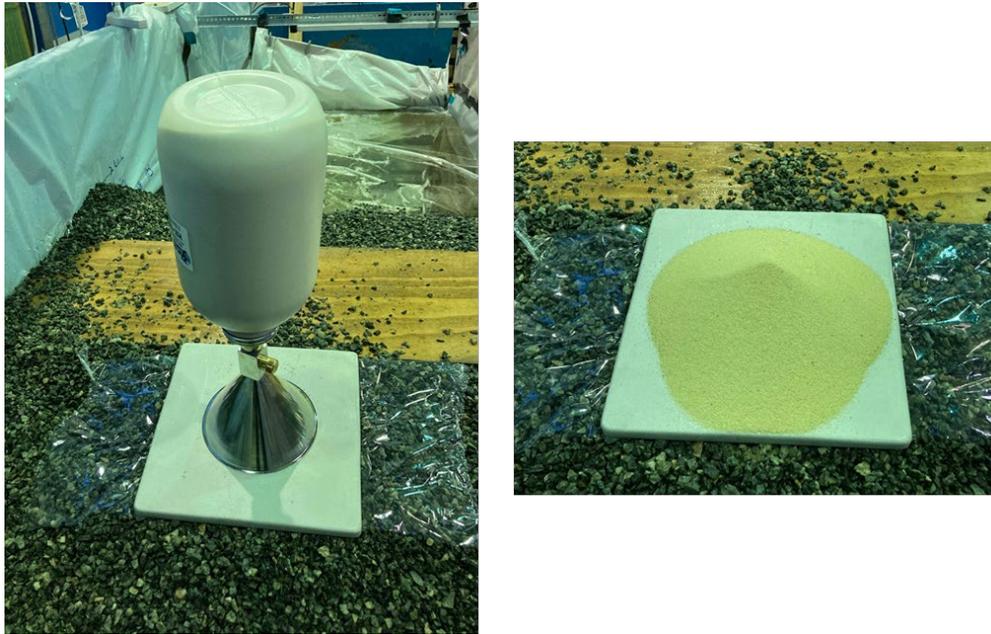
Figure 5.9 Sand cone test determining the unit weight of #8 coarse aggregate

kN/m³) was determined. This material was placed by raining down the embankment material as recommended by PennDOT from a height of 16 inches in lab. *On average this achieved 90% of the maximum proctor density.*

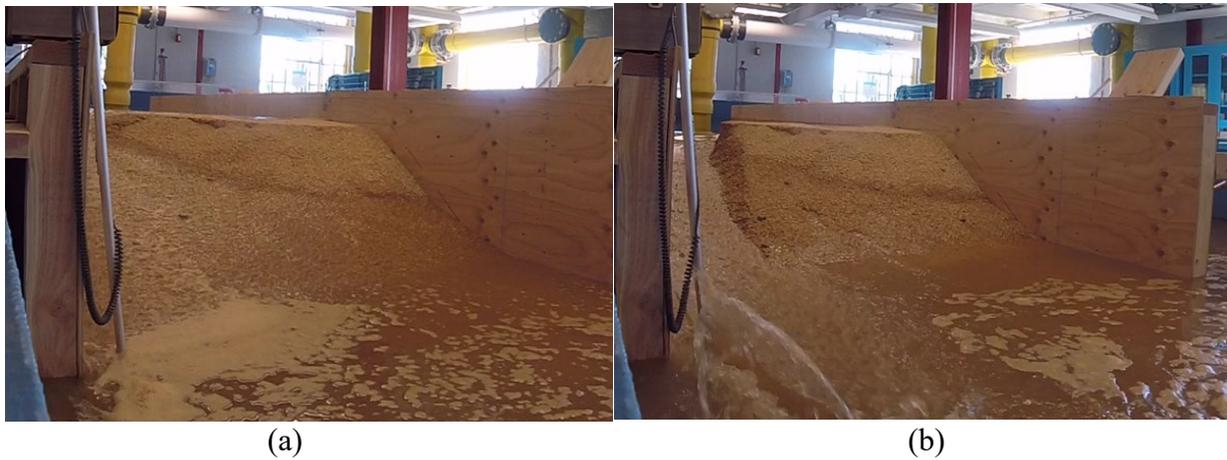
Figure 2.9: (a) Continuous slope failure, and (b) global failure

In test 3, piping and localized surface instability were observed when the water head difference was at 3 in. when the flow rate was at 0.10 CFS. The continuous slope failure (Figure 2.9a) was then observed and the global failure (Figure 2.9b) was followed when the flow rate was at 0.415 CFS. This occurred prior to overtopping.

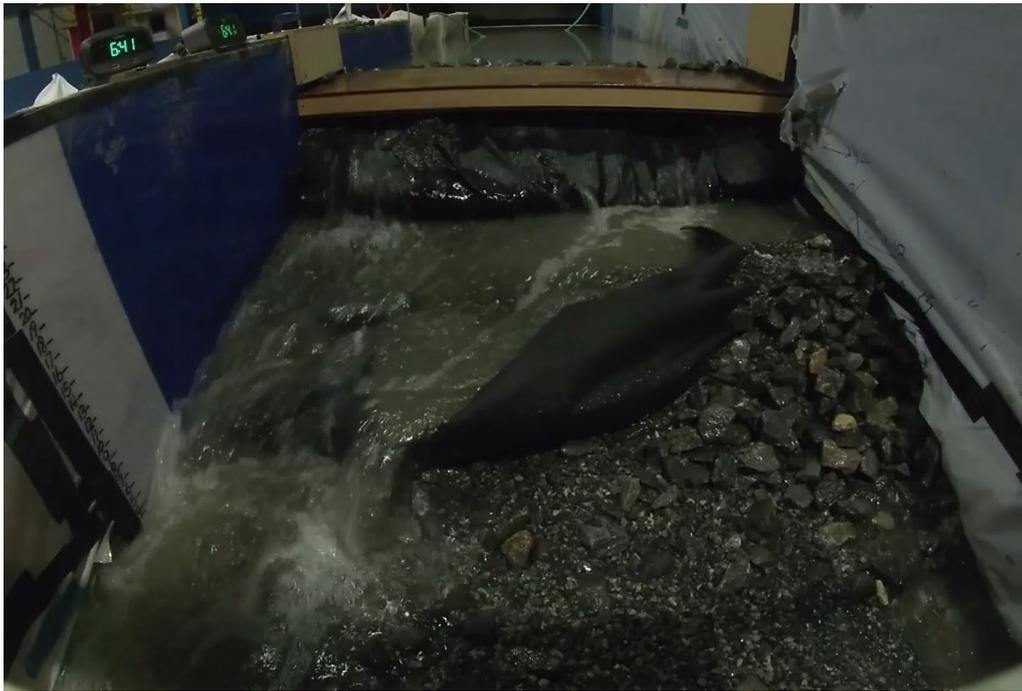
Figure 2.34: (a) Slope failure before overtopping, (b) top layer Geotextile unwrapping, and (c) the embankment when the test was over

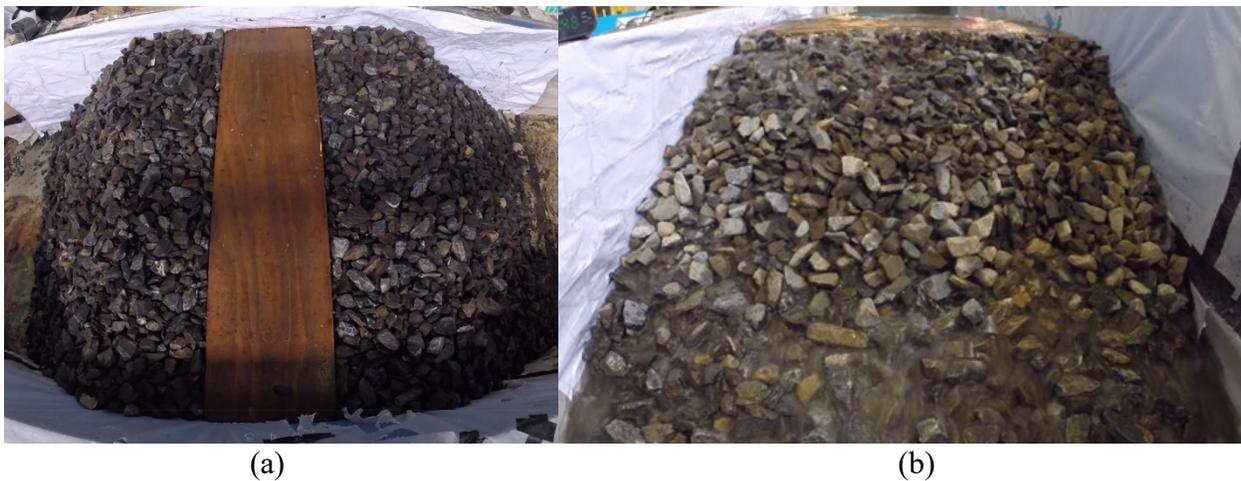
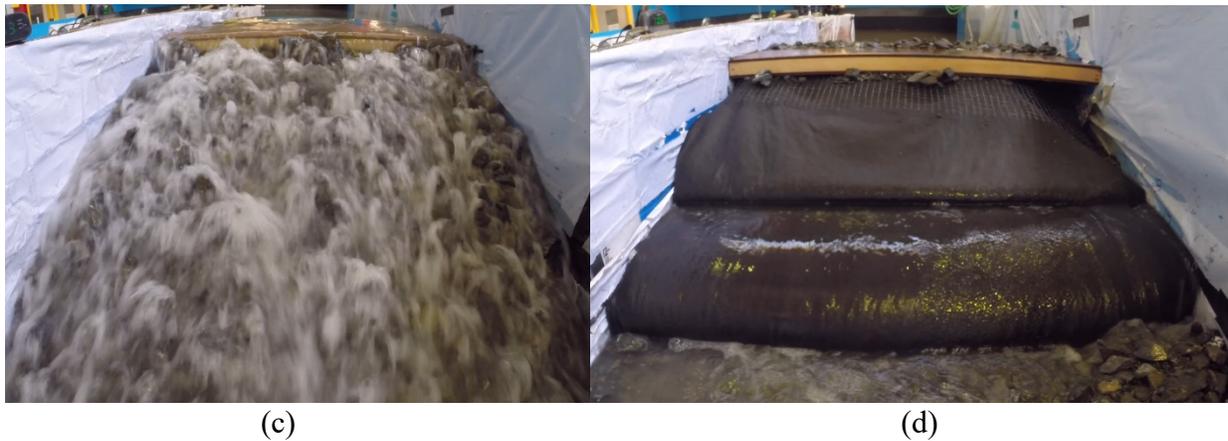
Figure 2.43: (a) Enlarged embankment, (b) Slope failure after overtopping, (c) Surface erosion under high flood, and (d) Geosynthetics reinforced core part of the embankment stayed safe under the extreme flood

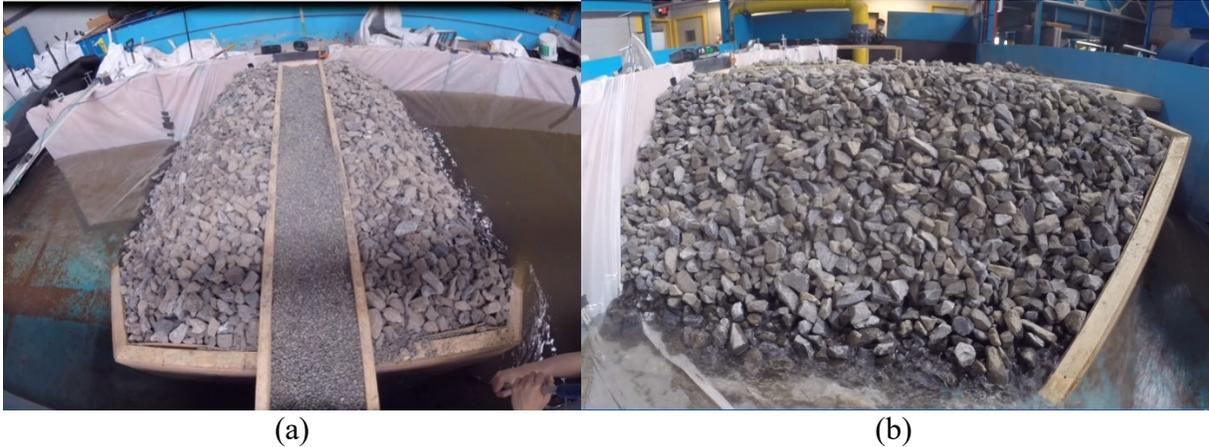
Figure 2.48: No failure from (a) top view and (b) downstream view

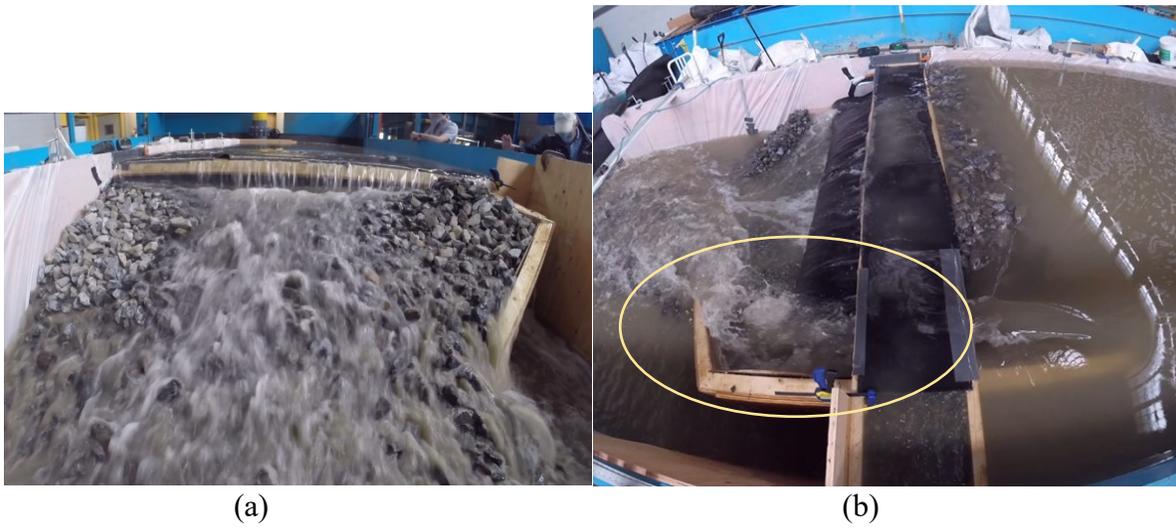
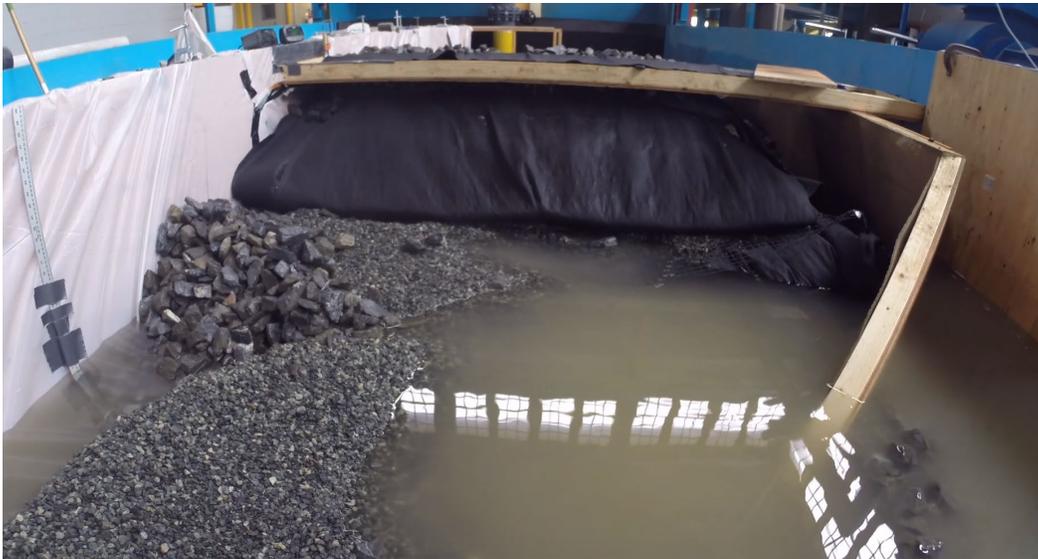
Figure 2.49: (a) Slope failure at the overtopping, (b) Geotextile at the corner of the wingwall was unwrapped under the high flood, (c) global failure after the Geotextile unwrapping, and (d) the embankment when the test was over

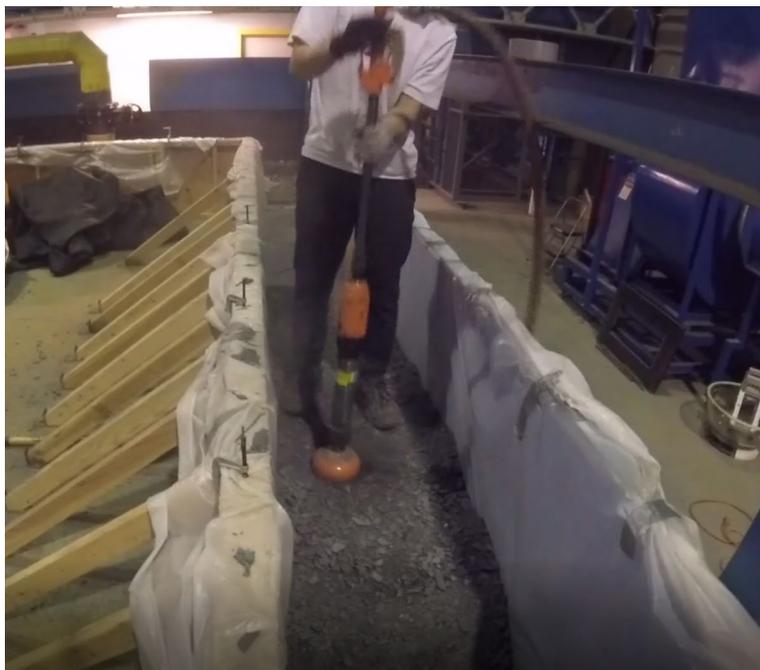
Figure 71: No.2A coarse aggregate compacted to non-movement using a backfill tamper

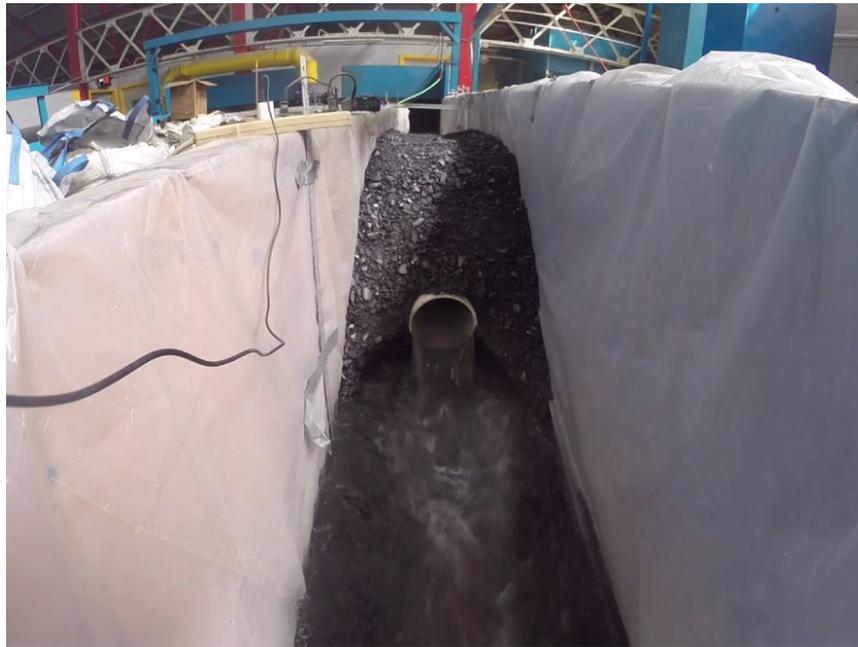
Figure 72: Scour of the backfill material under the pipe culvert

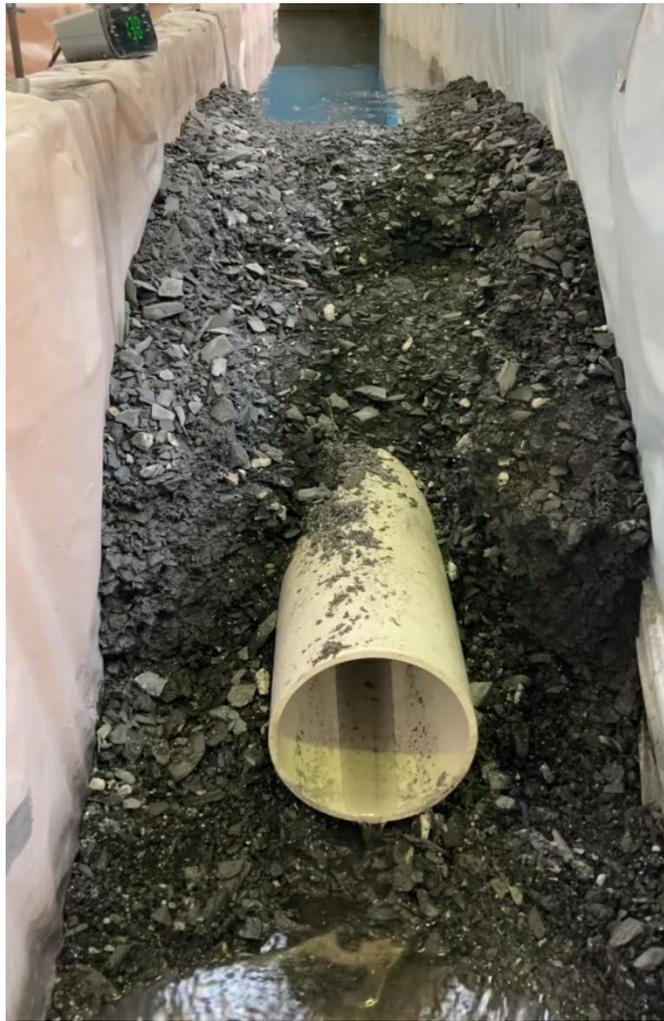
Figure 75: Outlet view prior to overtopping indicating no piping through the embankment

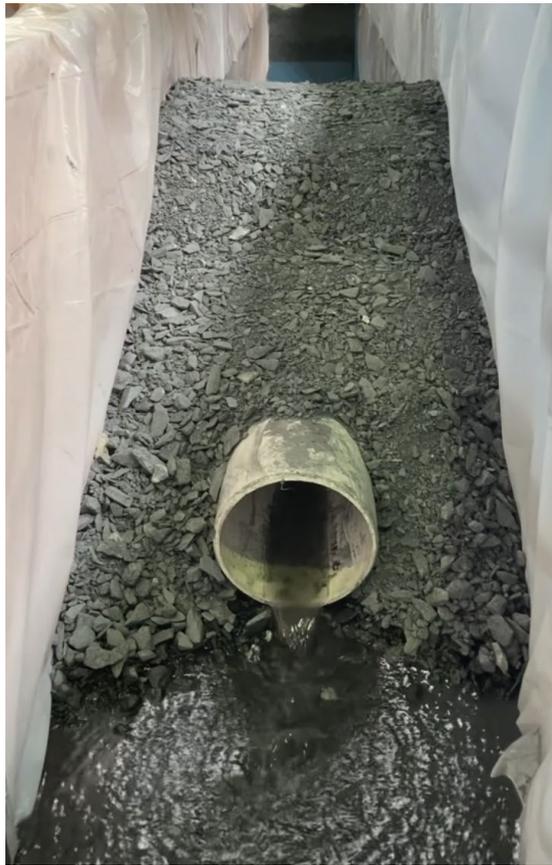
Figure 77: Bedding material scour under outlet

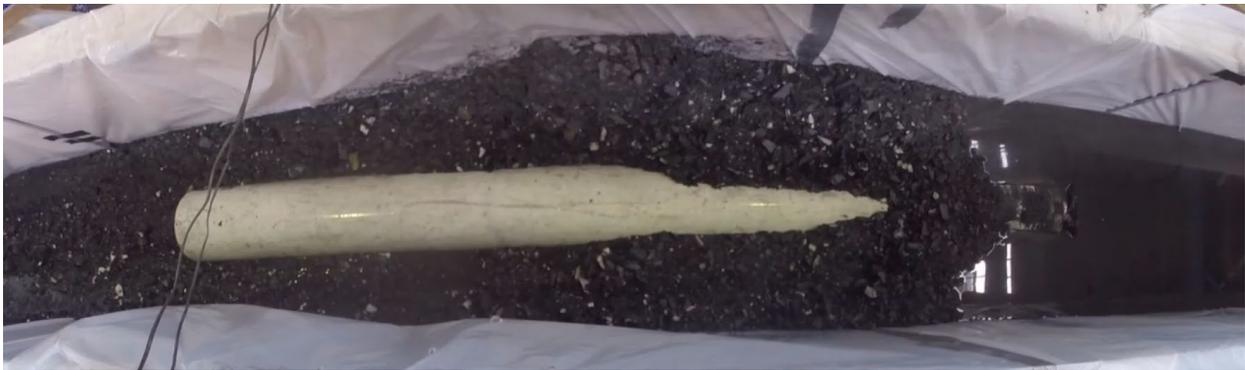
Figure 80 Erosion condition after completion of test
