DEPARTMENT OF TRANSPORTATION

Evaluation of Bridge Cleaning Methods on Steel Structures

FINAL REPORT

University of Pittsburgh

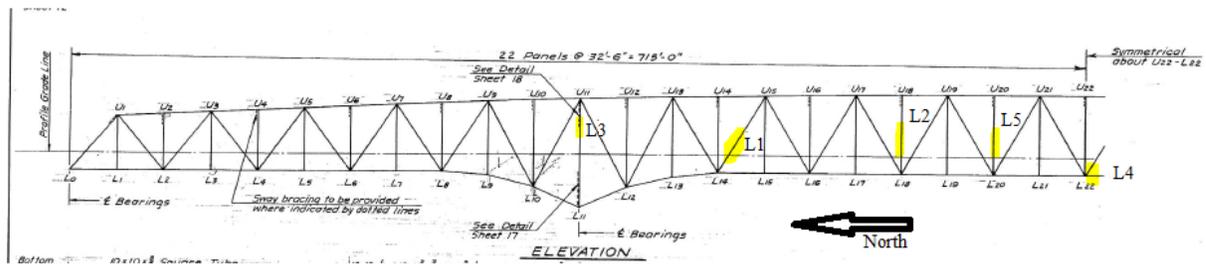
Figure 1: Vanport Bridge Testing Locations

used for washing. In a later project observed for this study the pressure was observed to be 1500 psi (10.3 MPa) and the contractor indicated that this setting had not changed. In a given shift, only a very small portion of the water in the truck is used. This is consistent with the estimated flow rate of 7.5 liters (2 gallons) per minute determined from the contractor interviews discussed in the literature review. Five locations were selected for testing on the bridge. The first location was the underside of a diagonal truss member above the bridge deck. The second location was the roadside face of a vertical truss member with intact coating. The third location was the underside of a horizontal member approximately 6.5 m (21.5 feet) above the roadway. The fourth location was a bottom chord gusset plate on the inside of the truss. The fifth and final location was the roadside face of a vertical truss member, in which the coating had failed and it was exhibiting a significant amount of corrosion. These locations are highlighted in Figure 1.

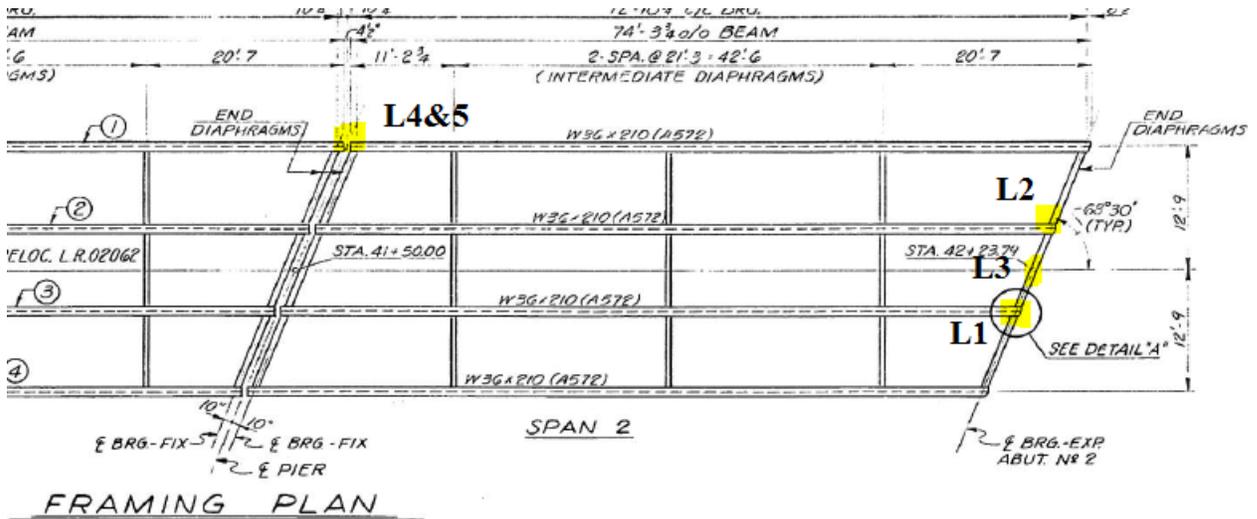
Figure 2: Hassam Road over Montour Run Testing Locations

Similar to the Vanport Bridge, there were five locations selected for testing. The first location examined was a connection between a diaphragm beam and a bearing plate stiffener beneath a leak in the expansion joint. The second location was the adjacent connection between a diaphragm beam and bearing plate stiffener, in which the expansion joint was intact and not leaking. The third testing location was the topside of the bottom flange near mid-span of the diaphragm beam between locations one and two. There were signs that the expansion joint was leaking above this test location. The fourth location was the web of the fascia beams near the central pier expansion joint. The final location was the topside of the bottom flange of the fascia beams near the same expansion joint. The locations are marked on the plans in Figure 2.

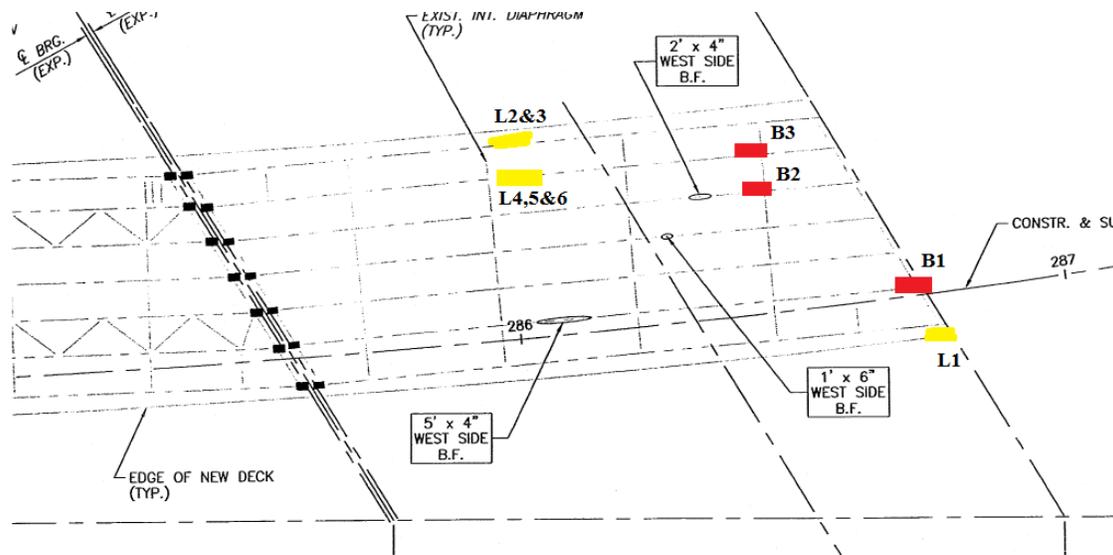
Figure 3: I79 over Thoms Run Road Testing Locations

A total of six locations were tested before and after washing. Location 1 was on the bearing stiffener on the eastern fascia beam at the abutment. Location 2 was on the topside of the bottom flange of the western fascia beam above the westbound traffic lane on Thoms Run Road. Location 3 was on the web of the western fascia beam directly above location 2. Location 4 was on the underside of the bottom flange of an interior beam above the westbound traffic lane on Thoms Run Road. Location 5 was on the web of the beam above location 4. Location 6 was the topside of the bottom flange web above Location 4. These locations can be seen in Figure 3. The buckets were hung to collect water from wash water runoff at three different locations, marked B1, B2, and B3 on Figure 3.

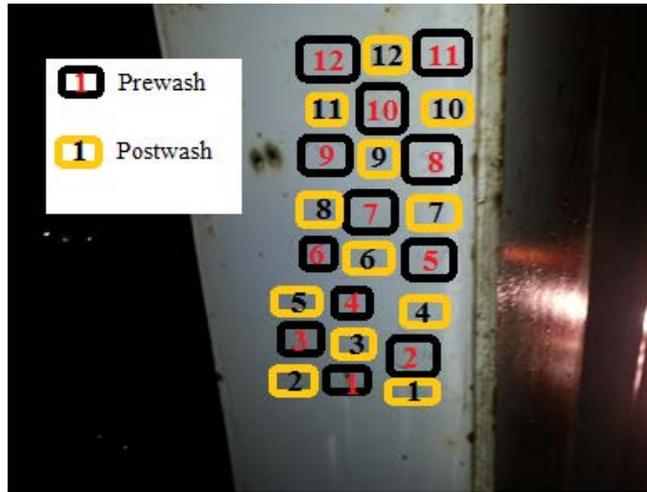
Figure 4. Bridge, Location 1: Underside of Diagonal Truss Member.

Location 1 - The first location tested, the underside of a diagonal truss member, was chosen because it was hypothesized that this area receives tire spray containing salt during deicing season, but is sheltered from rain. This area was also used to evaluate the salt concentration before and after washing. To do this, twelve measurements were taken before and after washing at this location. The measurements were taken in a staggered row pattern. After washing, the pattern was reversed and the tests were performed in the gaps between the pre-wash test locations. This pattern was established to provide testing conditions before and after washing that are as similar as possible. These patterns can be seen in Figure 4. The test locations marked in black with red labels were tested before washing, and those marked in gold with black labels were tested after washing. Staggering the test locations was essential because the meter removes all the salt from the substrate in the tested area. Tests were always performed from the bottom of the pattern first, such that water released from the chamber did not affect later tests. The results from the tests at this location are shown in Table 6. These results were checked for normality by creating a normal probability plot of the residuals using the statistical software package Minitab. Surface salt concentrations before and after washing are shown in Figures 5 and 6, respectively.

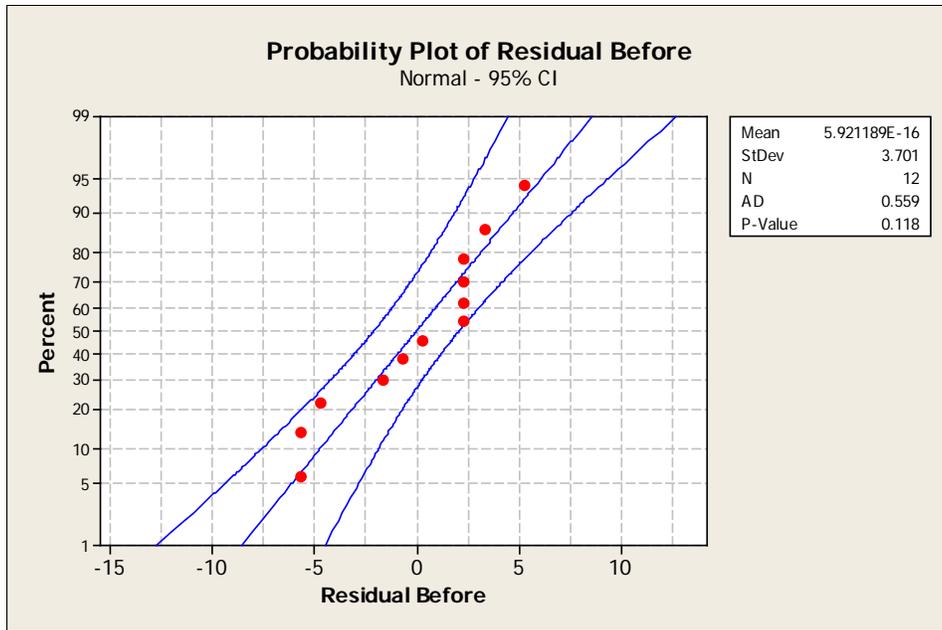
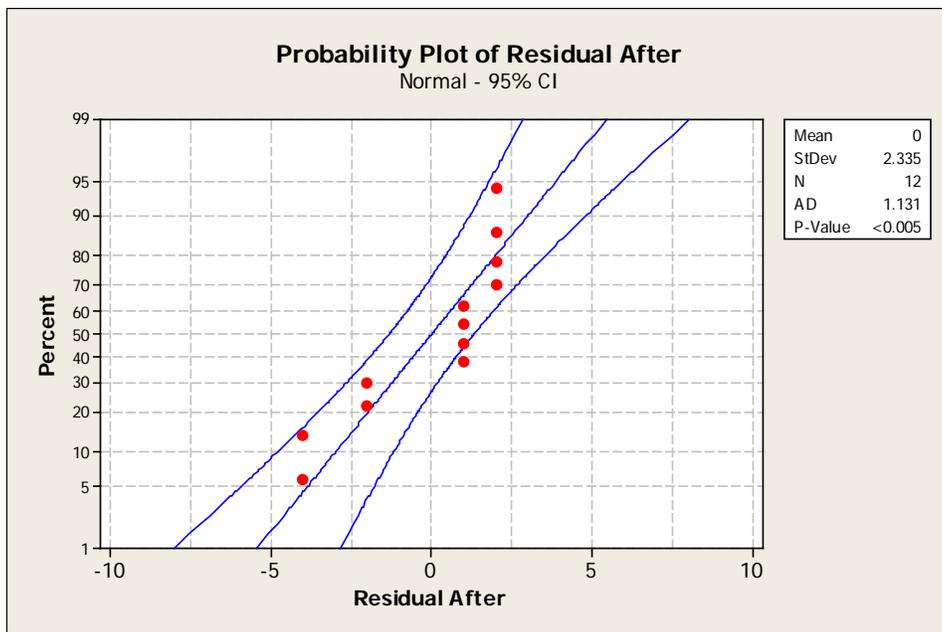
Figure 5: Probability Plot of Residuals Pre-wash

Figure 6: Probability Plot of Residuals Post-wash

It can be seen from Figures 5 and 6 that the surface salt concentrations before and after washing closely follow normal probability distribution. There is one data point that is slightly out of the normality envelope at a 95 percent confidence interval; however, it appears that the approximation of normality is valid for areas with an intact coating for

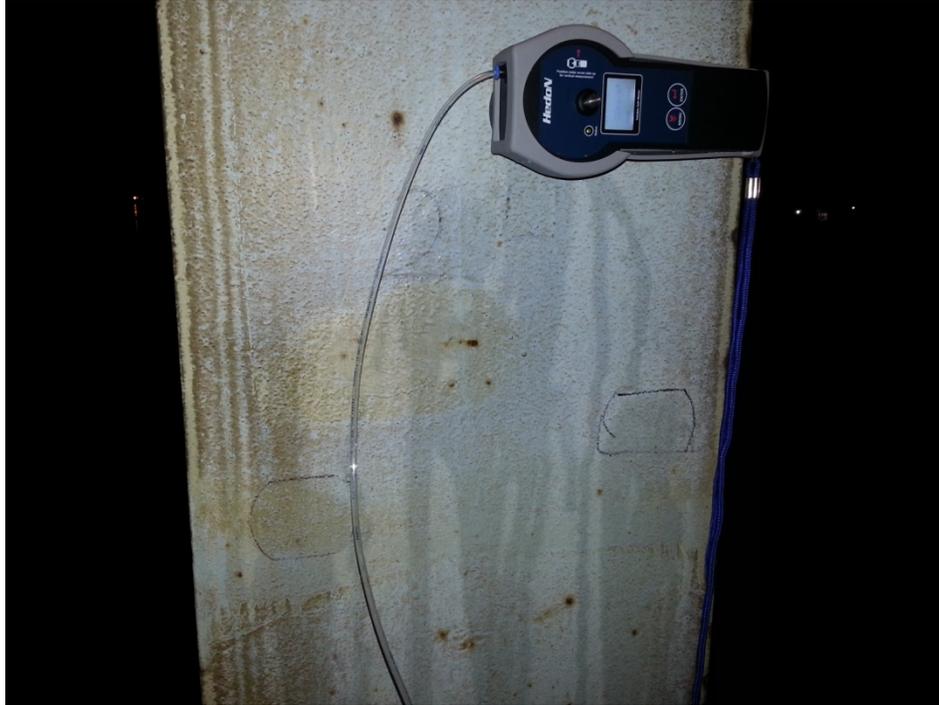
Location 2 - The second location tested was the roadside face of a vertical truss member. This location is exposed to more salt than location one as it faces the salt spray from tire splash directly. However it is also more exposed to rain, which could reduce the salt concentration on the member between wash cycles. Three measurements were taken in this location before and after washing. The test locations were selected such that the meter could be placed on a flat section of steel so that before and after tests could be made adjacent to each other without testing on visible rust. The testing locations before washing are shown in Figure 7. The darker color shown on the left side of the member is not due to corrosion but a simple discoloration of the coating.

Figure 7: Vanport Bridge, Location 2: Inside of a Vertical Member

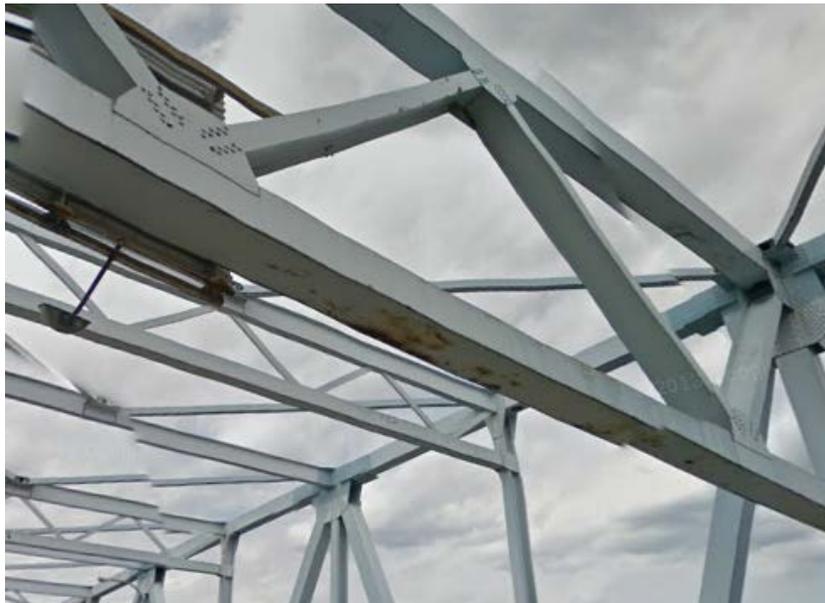
the bottom flange of this beam is approximately 6.5 m (21 feet) above the bridge deck. Neither the current Bridge Maintenance Manual (Publication 55) nor the project specifications require horizontal members above the roadway to be cleaned, and therefore this beam was not washed by the contractor. The underside of the beam exhibits visible signs of corrosion (Figure 8) and therefore the pre-wash salt concentration of this beam was measured for comparison with the other locations. Although the visible corrosion was above the westbound passing lane three tests were taken at the centerline of the eastbound truck lane due to traffic control concerns. The mean surface salt concentration at Location 3 was 31 mg/m^2 ($44 \times 10^{-3} \text{ grains/ft}^2$), with a standard deviation of 5.9 mg/m^2 ($8.5 \times 10^{-3} \text{ grains/ft}^2$).

Figure 8: Vanport Bridge Location 3, Horizontal Member above Roadway.

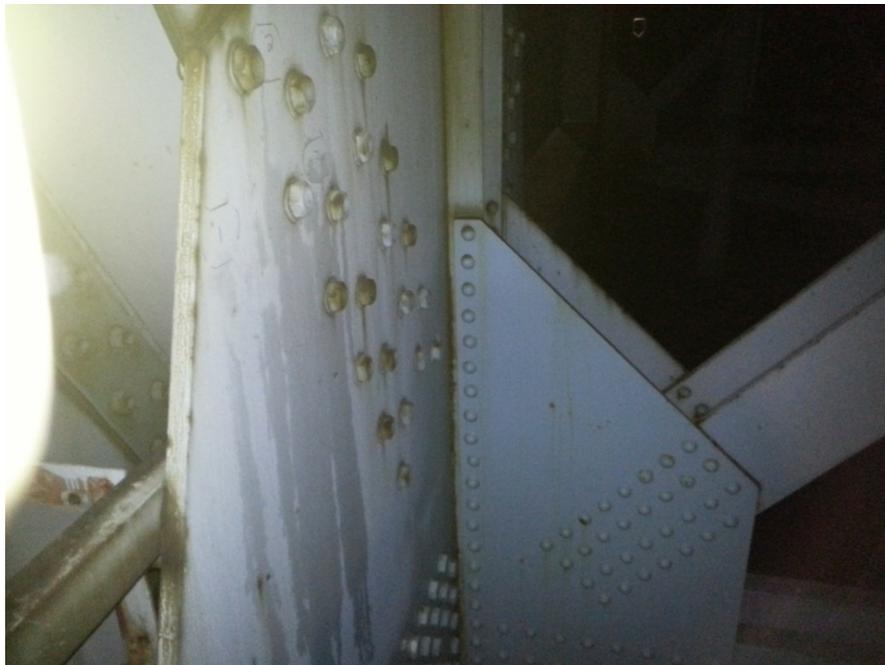
Location 4 - The fourth location sampled was a gusset plate on the inside face of the bottom chord of the truss. The gusset plate tested appears to have been recently renovated. The coating is mainly intact and the rivets, which are prevalent in most of the structure, have been replaced by bolts as can be seen in Figure 9.

Figure 9: Vanport Bridge, Location 4, Gusset Plate on Inside of Lower Chord

This particular gusset plate was tested because it was the only gusset plate accessible from the catwalk. Several other gusset plates were in much worse shape, and had visible signs of corrosion. The contractor provided a bucket of rusted steel, which they had scraped from the deteriorated gusset plates but was not sure about the exact location of the gusset plate where the rusted steel was removed.

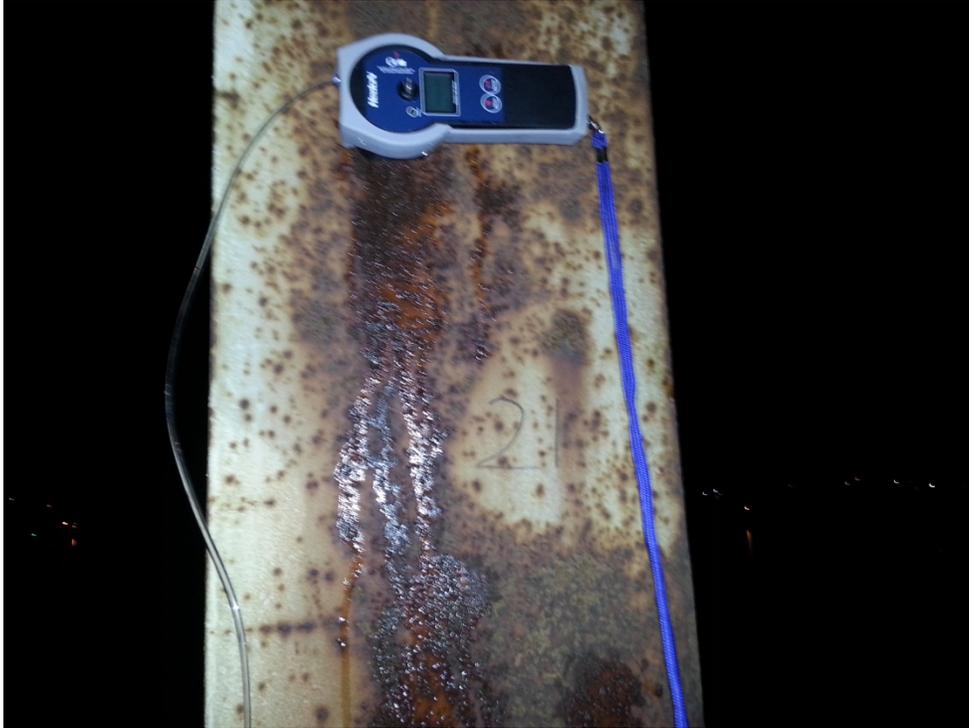
Location 5 - The final location tested is a similar to Location 2, in that it was the inside face of a vertical truss member. The main difference between the two locations is that the protective coating in Location 5 was deteriorated and visible rust covered the entire testing area (Figure 10). This area was tested for two reasons: (a) to determine if the pre-wash salt content of the rusted areas is higher than similar areas which did not exhibit rust (i.e., salt concentration may have contributed to the premature failure of the coating in this area) and (b) to determine if a standard pressure washer is capable of lowering the surface salt concentration on a rough, corroded surface.

Figure 10: Vanport Bridge, Location 5: Vertical Surface with Significant Corrosion.

The visual characteristics of the member support the hypothesis that salts contributed to the failure of the coating. In Figure 10, many individual round areas of rust are visible. This is consistent with the failure mechanism which occurs when salts ingress beneath the coating and cause osmotic blistering. However, the pre-wash surface salt concentration readings did not support this hypothesis. As discussed for Location 4, the pre-wash surface salt concentration at Location 5 was not significantly higher than the surface salt concentration at Location 2. The mean pre-wash surface salt concentration was 27 mg/m^2 ($39 \times 10^{-3} \text{ grains/ft}^2$) and the standard deviation was 3.1 mg/m^2 ($4.4 \times 10^{-3} \text{ grains/ft}^2$).

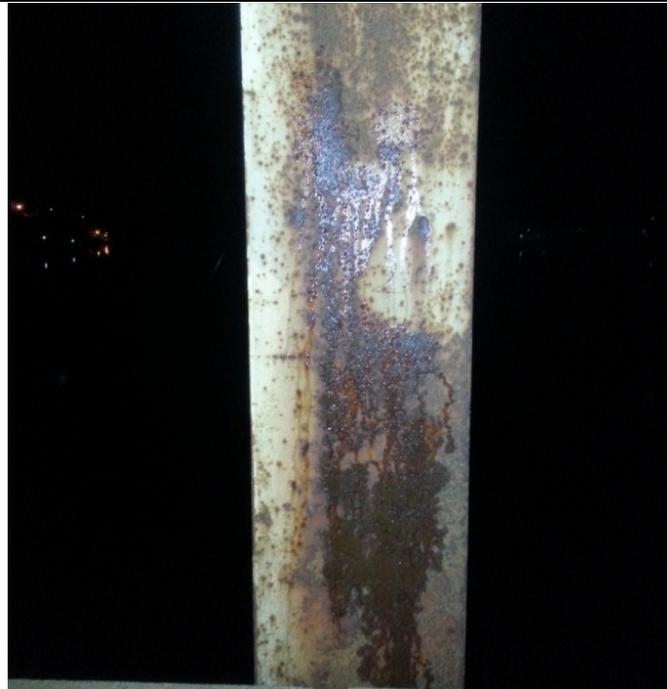
Figure 11: Vanport Bridge, Location 5: Rusted Area Post-wash

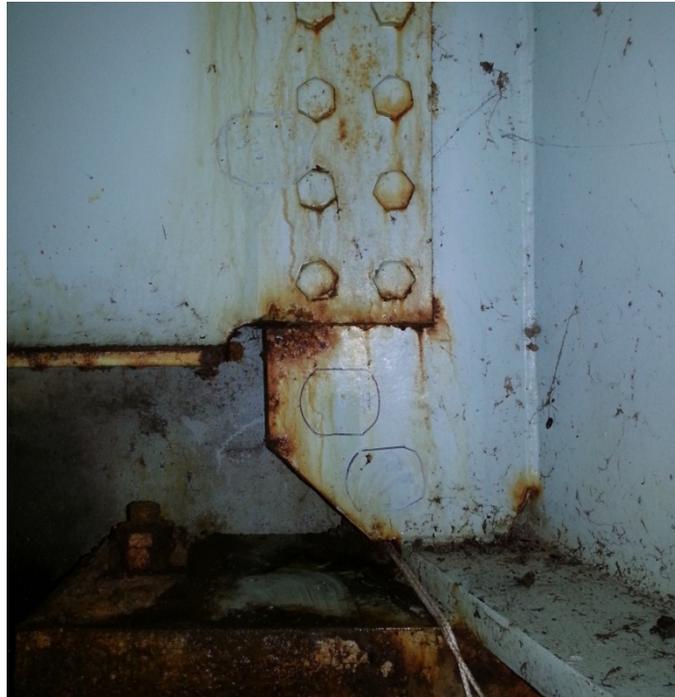
of the diaphragm beam where several orange stains, apparently from dripping rusty water, are visible at the connection. In addition, the bearing plate is visibly very corroded. Unfortunately, the corrosion has made the surface of the bearing plate so rough that the SSM could not bond to the surface. Therefore, testing was performed on the bearing stiffener and the diaphragm beam where it is connected to the stiffener. The first two tests before and after washing were taken on the stiffener itself, and the third test taken on the end of the diaphragm beam as shown in Figure 12.

Figure 12 Hassam Road, Location 1, Bearing Stiffener Exhibiting Rust

The surface salt concentration at this bearing was significantly higher than at any location on the Vanport bridge, except the rusted area after washing. The mean surface salt concentration before washing was 250 mg/m^2 ($358 \times 10^{-3} \text{ grains/ft}^2$) with a standard deviation of 84.2 mg/m^2 ($120.7 \times 10^{-3} \text{ grains/ft}^2$). After washing, the mean surface salt concentration was 36 mg/m^2 ($52 \times 10^{-3} \text{ grains/ft}^2$), with a standard deviation of 13.0 mg/m^2 ($18.7 \times 10^{-3} \text{ grains/ft}^2$). The estimated salt removal was 85 percent. A two sample t-test with surface salt measurements before and after washing revealed that they are significantly different at the 95 percent confidence level, with an estimated difference of 213 mg/m^2 ($305 \times 10^{-3} \text{ grains/ft}^2$) and a p-value of 0.049.

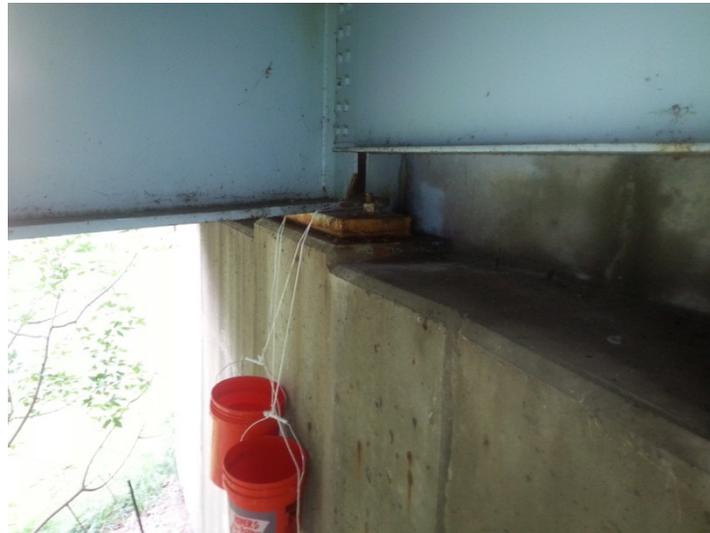
Location 2- The second location tested was similar to the first, except that the expansion joint above the connection showed no signs of leaking. The tests were taken in the same manner with two tests taken before and after washing on the bearing stiffener, and one test taken before and after washing on the web of the diaphragm beam at the connection. The bearing plate at this location did still show some signs of coating failure, but was not nearly as corroded as the bearing plate in Location 1. Figure 13 shows the same beam bearing location, though the testing was actually performed on the other side of the beam.

Figure 13: Hassam Road, Location 2: Bearing Stiffener Not Exhibiting Rust

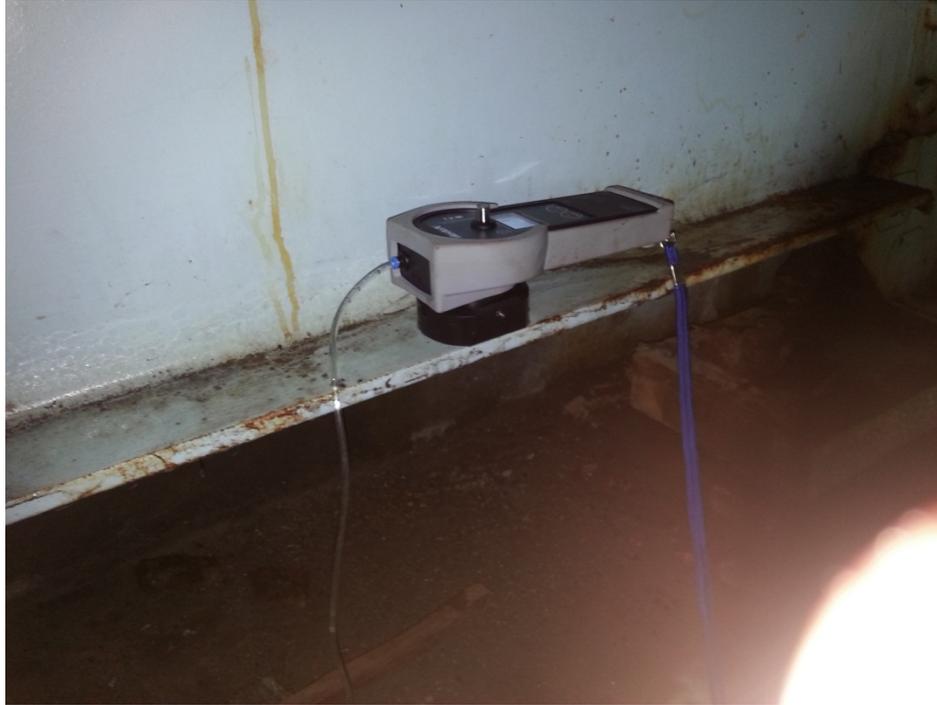
Location 3 - The third location sampled was the topside of the bottom flange at mid-span of a diaphragm beam. As can be seen in Figure 2 the beam tested was between Locations 1 and 2. The mid-span of the beam was beneath the section of the expansion joint, which was leaking. A visible stain from dripping rusty water can be seen in Figure 14. According to Ms. Gina Russell, a PennDOT bridge engineer for District 11, the diaphragm beams are usually the first locations to exhibit rust. The topside of the bottom flange of the beam was soiled with a layer of debris, which was too thick to allow the use of salt meter. A bench broom was used to sweep off the visible dirt while trying to maintain the majority of the soluble salts on the surface. It should be noted that some of the soluble salts may have been removed with the sweeping. This was a necessary step in order to perform readings at this critical location. The cleaned area shown on Figure 14 was the test area.

Figure 14: Hassam Road, Location 3: Bottom Flange of Diaphragm Beam

The mean surface salt content at Location 3 was 1133 mg/m^2 (1624×10^{-3} grains/ft²), with a standard deviation of 398 mg/m^2 (570×10^{-3} grains/ft²) and was the highest measured surface salt content in this study. The large salt content could be a combination of the effect of the debris, which holds water and the soluble salts. Also, the bottom flange is a place where drips of water carrying salts from the face of the beam pool cyclically deposits salts after drying. After washing, the mean soluble salt content was 59 mg/m^2 (85×10^{-3} grains/ft²), with a standard deviation of 22.8 mg/m^2 (32.7×10^{-3} grains/ft²). A two sample t-test shows a statistically significant surface salt concentration decrease with a p-value of 0.043. The estimated salt removal efficiency was around 95 percent. However, the surface salt concentration was still relatively high after washing, with an estimated mean higher than anywhere on the Vanport Bridge before washing. It is possible that more salt would have been removed if lift equipment were available and the pressure washer could have sprayed directly on the bottom flange of the diaphragm. From the angle which the pressure washer sprayed, most of the water which hit the bottom flange would have been reflected from the diaphragm web, thereby greatly reducing its pressure.

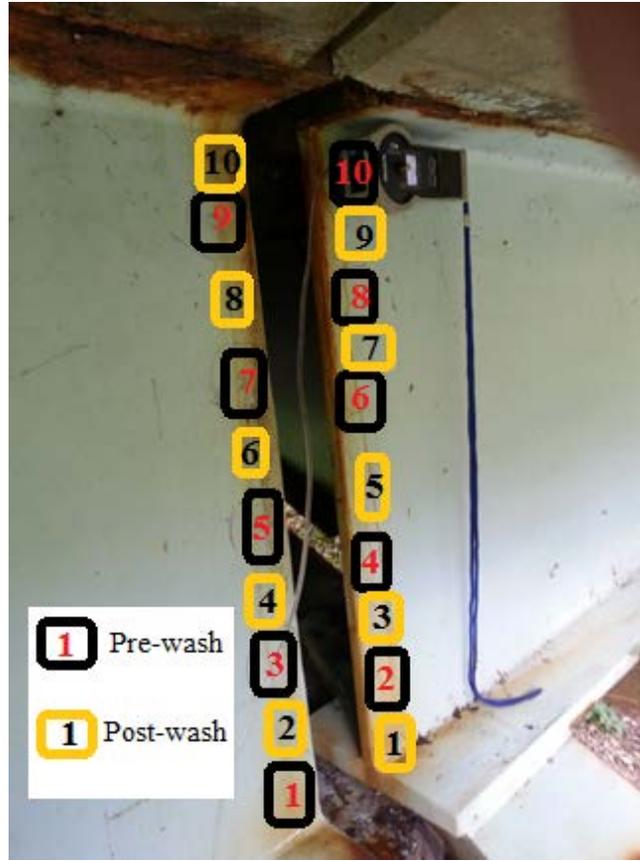
Locations 4 and 5 - The fourth and fifth locations selected for testing were the web and topside of the bottom flange of the fascia beams on each side of the central pier. Location 4 is on the web and Location 5 is the topside of the bottom flange. There is an expansion joint between the two piers. The deck expansion joint above this location is showing signs of leaking. There are orange streaks on the web the topside of the bottom flange on each side of the expansion joint. Ten tests were performed at Location 4. The tests were taken in a “zipper” pattern. Before washing, test 1 was performed at the bottom of the web on the spillway side of the expansion joint and test 2 was performed slightly above on the stream side; other test locations followed this “zipper” pattern. After washing, the testing pattern was mirrored, with the first test being taken on the bottom of the stream side of the expansion joint, and the second test being taken slightly higher on the spillway side of the joint. The testing patterns before and after washing can be seen in Figure 15. The testing locations marked in black with red labels were tested before washing, and the locations marked in gold with black labels were tested after washing. There was a small amount of dirt on the spillway side of the joint beneath test 7, which could not be removed with a light sweeping with a bench broom. Two tests were performed before and after washing at Location 5. Before washing, one test was done adjacent to the joint on the spillway side, and another one was done approximately 15 cm (6 in) from the joints on the stream side. After washing, the pattern was reversed with one test done approximately 15 cm (6 in) from the joint on the spillway side, and the other test done adjacent to the joint on the stream side.

Figure 15: Hassam Road, Locations 4 and 5: Fascia Beam Web and Bottom Flange at Expansion Joint

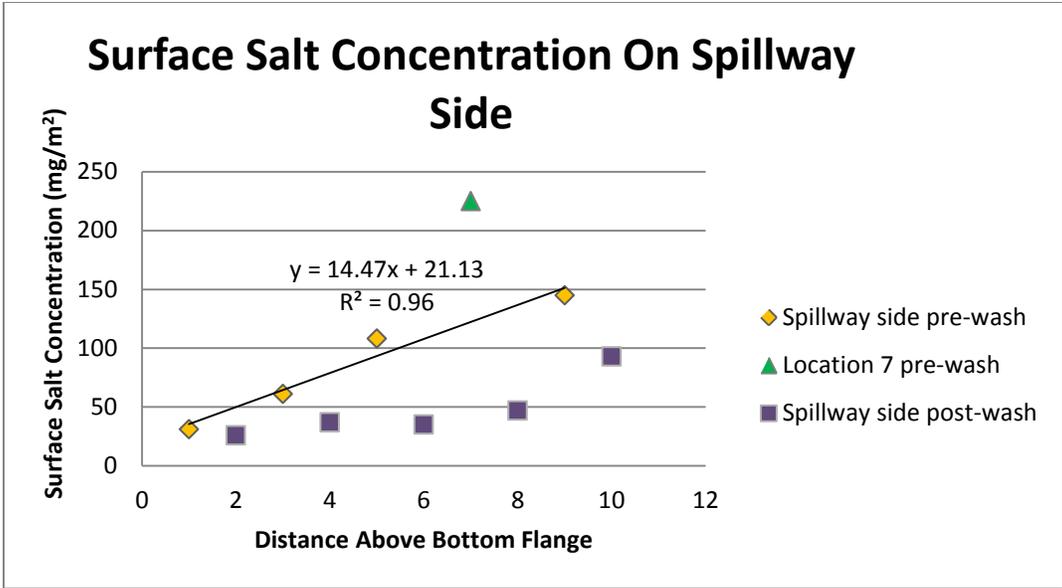
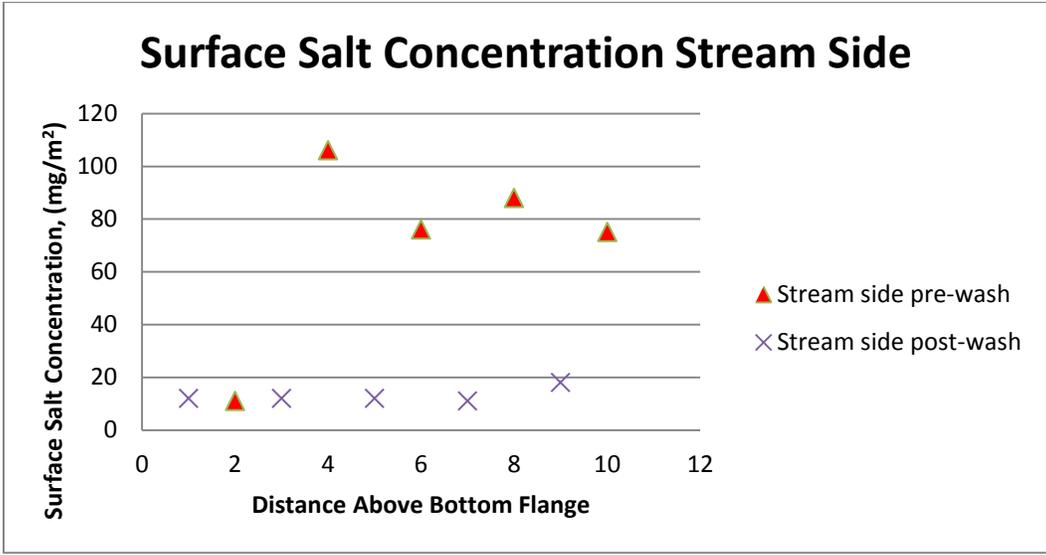
Unlike Location 1 of the Vanport bridge, the pre-wash salt concentration at Location 4 of the Hassam Road bridge was not normally distributed. In fact, there appears to be a linear trend with the surface salt concentration increasing towards the top of the beam. On the spillway side of the beam, this trend is very defined. Test 7 did not follow this trend, most likely due to the dirt that was present on the beam. When Location 7 was omitted, the pre-wash salt concentrations followed a linear trend with an R^2 of 0.96, as can be seen in Figure 16. On the stream side of the joint, the trend was not as defined; however, it appears that the surface salt concentration at the top of the beam is larger than the salt concentration at the lower end of the beam, as can be seen in Figure 17.

Figure 16: Hassam Road, Location 4: Testing Results, Spillway Side

Figure 17: Hassam Road, Location 4: Testing Results, Stream Side

From Figures 16 and 17, it can be seen that washing appears to be effective at lowering the surface salt concentration for most of the beam on both sides of the joint. It is worth noting that the top reading on both sides of the joint after washing was higher than the other post-wash readings. On the spillway side of the bridge, the average post-wash surface salt concentration for tests 2, 4, 6 and 8 was 36 mg/m² (52x10⁻³ grains/ft²)

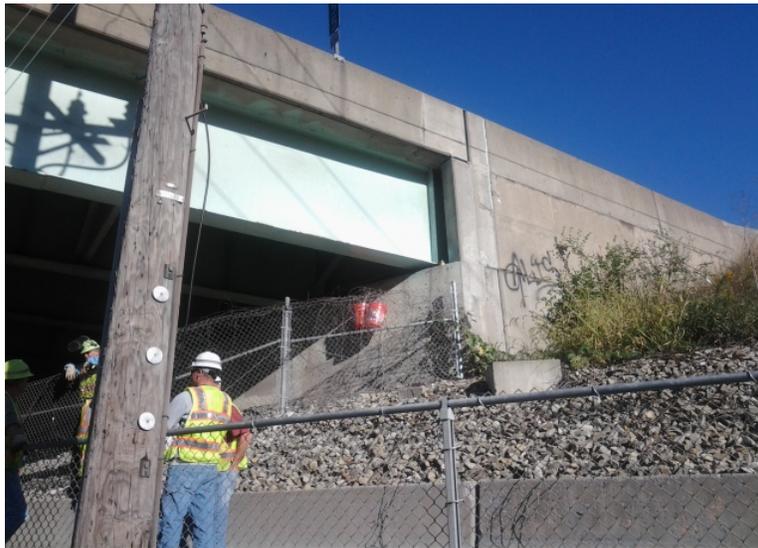
Location 1 - The first location tested on the I79 bridge over Thoms Run Road was on the bearing stiffener of the eastern fascia beam at the northern abutment. The expansion joint near these stiffeners does not appear to be leaking as there were no signs of corrosion on the beam. However, there was a significant amount of debris on the topside of the bottom flange, as can be seen in Figure 21. Ten tests were performed before and after washing. The first test was done near the bottom of the stiffener and the tests were distributed evenly throughout the height of the beam from bottom to top. After washing, tests were performed in the gaps of the pre-washing test pattern. This ensured that the tests before and after washing are taken in similar areas.

Figure 18 I79 Over Thoms Run, Location 1: Fascia Beam Bearing Stiffener

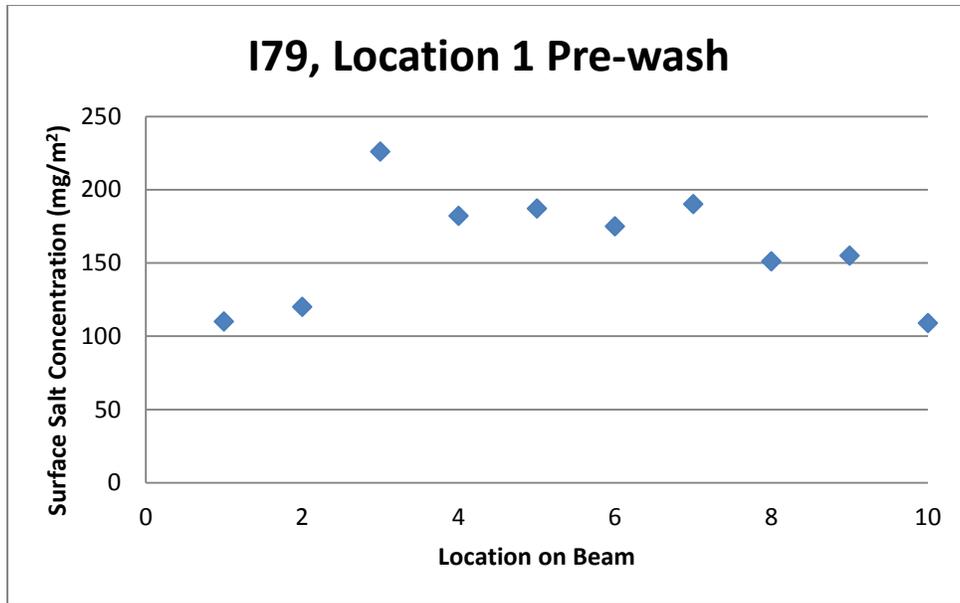
Unlike the Hassam Road bridge, where most of the salt was introduced via a leaking expansion joint, there does not appear to be a mechanism for salty water to reach the beam directly from the bridge deck. The pre-wash salt concentration did not show the increasing trend with elevation that was seen on the Hassam Road Bridge. If anything, it appears that the salt concentration was the highest near the center of the beam and lower toward the top and the bottom, as can be seen in Figure 19.

Figure 19: I79 Over Thoms Run Road: Location 1 Pre-wash Soluble Salt Concentration

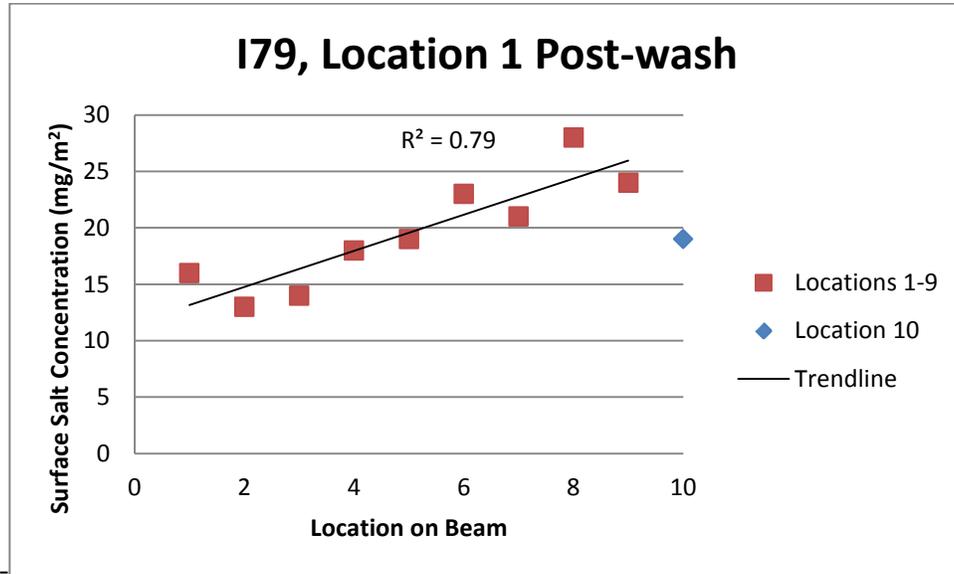
despite the apparent trend that washing the top portion of the beam was not as efficient as washing the lower portion of the beam.

Figure 20: I79 Over Thoms Run Road, Location 1: Post-wash Soluble Salt Concentration

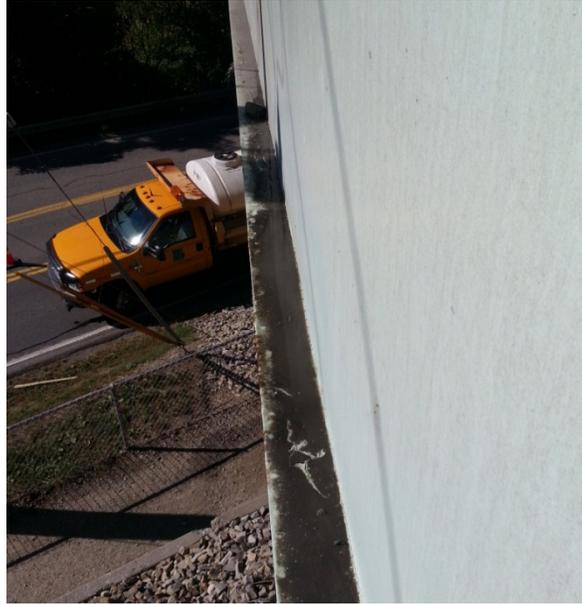
It should also be noted that while it was possible to clean the bearing stiffener from the ground, the bottom flange of the beam still had a lot of visible debris present after washing, as can be seen in Figure 21. Although surface salt concentration testing was not performed on the bottom flange, it appears that washing the topside of the bottom flange was not effective from the ground.

Figure 21: I79 Over Thoms Run, Topside of Bottom Flange Near Location 1.

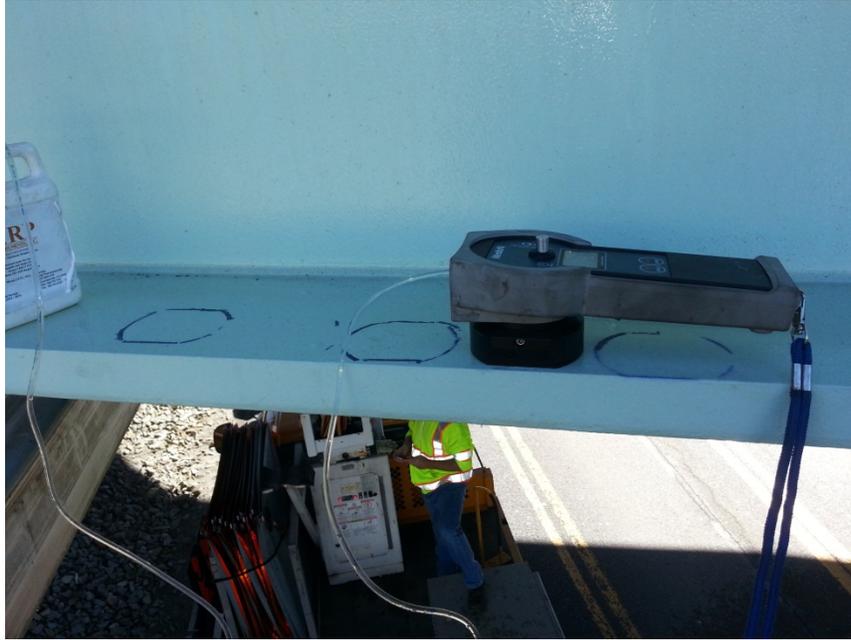
Location 2 - The second location tested was the topside of the bottom flange of the western fascia beam. The testing was performed above the Thoms Run Road westbound traffic lane. This flange was noticeably cleaner than the interior beams adjacent to it. Three tests were performed near the tip of the flange before and after testing, with the post-washing testing performed in the gaps of the pre-wash test pattern, as can be seen in Figure 22. This area was washed from a bucket truck, which allowed the pressure washer to spray down onto the topside of the flange.

Figure 22: I79 Over Thoms Run Road, Location 2: Topside of Bottom Flange of a Fascia Beam.

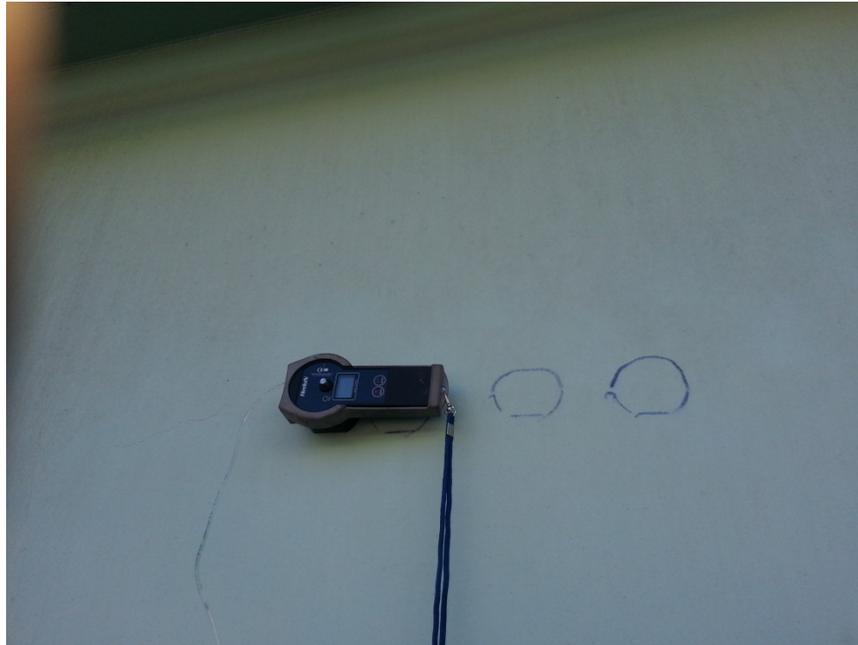
trapped in the layer of grime. Similar to Location 2, three tests were performed before and after washing with the post-wash tests performed in the gaps of the pre-wash testing pattern, as can be seen in Figure 23.

Figure 23: I79 Over Thoms Run Road, Location 3 Web of Fascia Beam

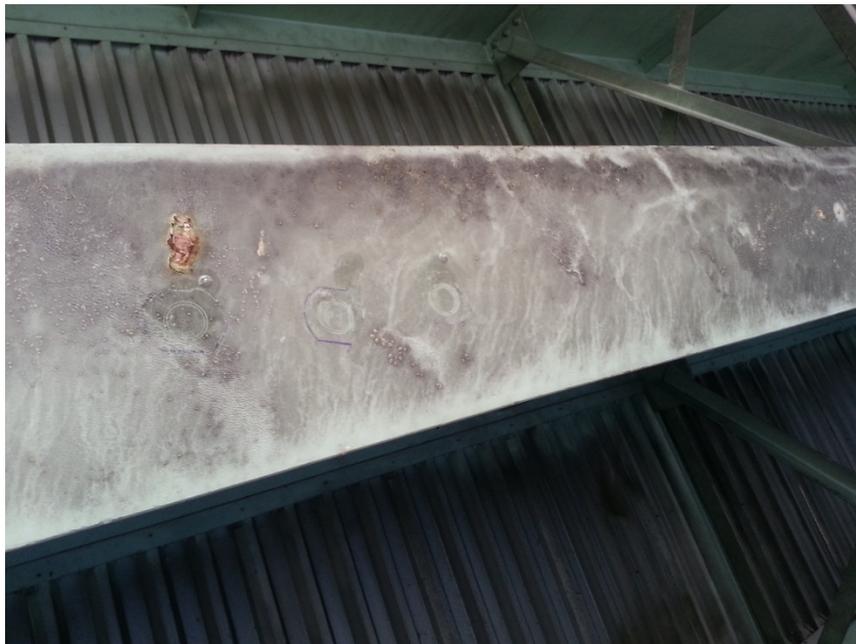
Location 4 - The fourth location tested was the underside of an interior beam. The bottom flanges of the interior beams were visibly dirty. The closer the beam was to the roadway, the dirtier the beam was visibly. It is also interesting to note that the second span of the bridge, which crosses Chartiers Creek instead of a road with vehicular traffic, was not visibly soiled. Upon closer inspection, the grime on the underside of the beam was an adhered discoloration and not a layer of grime, which could be removed with a dry rag. Three tests were performed on the bottom flange of the beam above the westbound traffic lane of Thoms Run Road before and after washing. It should be noted that this location, which was also tested for Locations 4, 5, and 6, is not defined as an area to wash in the PennDOT specification, but was washed for this study. Similar to other locations, the post-wash tests were performed in the gaps of the pre-wash test pattern. The test locations are shown in Figure 24, which also shows that the coating below these beams is exhibiting signs of failure due to osmotic blistering that might be attributed to possible high surface salt content.

Figure 24: I79 over Thoms Run Road, Location 3 Underside of Interior Beam

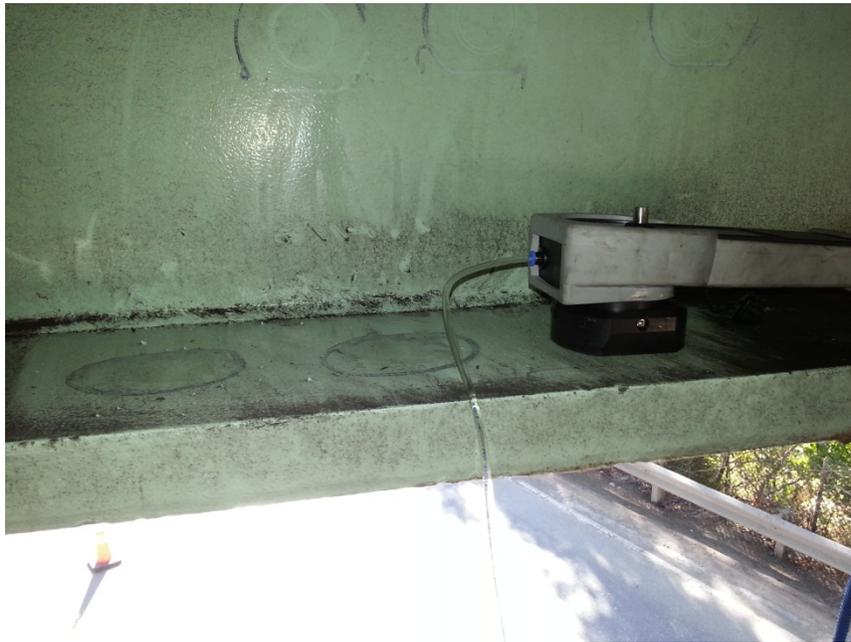
Location 6 - The final location tested was the topside of the bottom flange directly below Location 5. This location was covered in a thick layer of debris. This layer was wiped off with a dry rag before testing. The contrast between the wiped testing area and the unmodified adjacent area can be seen in Figure 25. This layer of debris did not extend to the second span above Chartiers Creek, indicating that it was most likely caused by the traffic flow below. Similar to Location 2, 3 tests were performed near the beam flange before and after testing, with the post washing tests performed in the gaps of the prewashing pattern.

Figure 25: I79 Over Thoms Run Road, Location 5 and 6 Web and Topside of Bottom Flange, on an Interior Beam

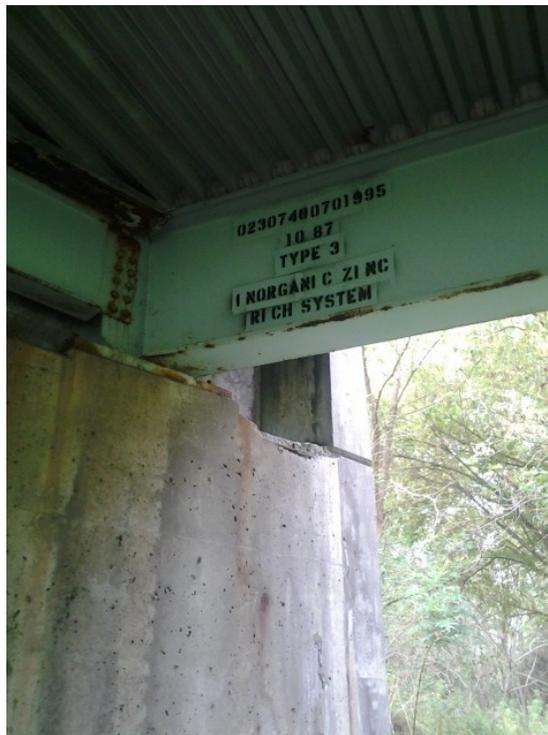
Figure 26: Hassam Road: Coating Label

The presence of some level of zinc ion is expected since most coatings in Pennsylvania are inorganic zinc rich systems. The coating at the Hassam Road bridge was labeled as a Type 3 inorganic zinc rich system, as can be seen in Figure 26. The concentration of zinc in the wash water would be diluted in the receiving water. Tables 12 and 13 show an estimate of the total zinc load in the wash water runoff and an estimate of the highest zinc concentration in the receiving contributed by the wash water

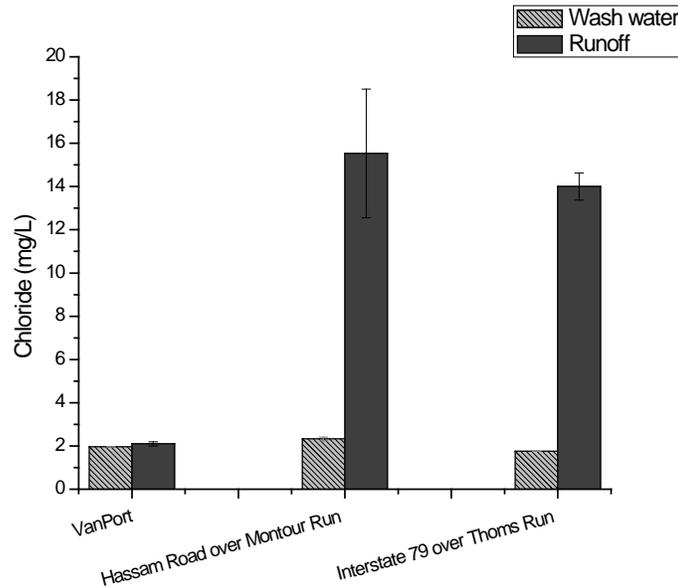
Figure 27 Concentrations in Wash Water and Wash Water Runoff

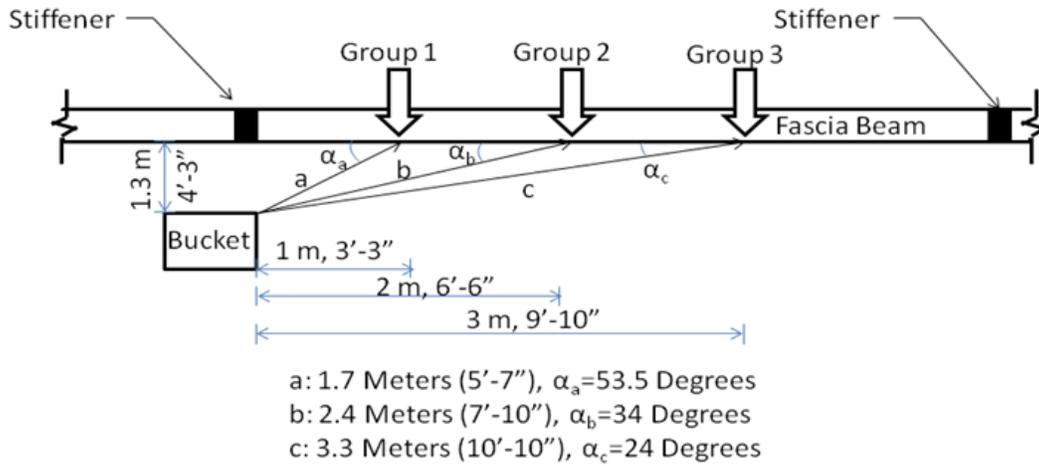
from that location to avoid a section of beam being washed from multiple distances and angles.

Figure 28: 40th St. Bridge, Test A: Sampling Locations

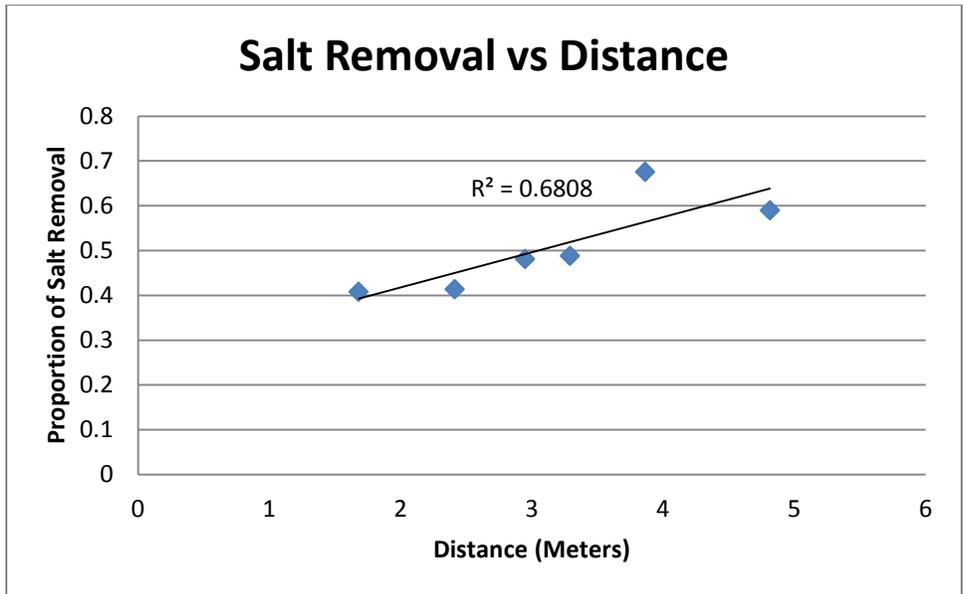
Figure 29: 40th St. Bridge, Test A: Salt Removal versus Distance

It appears that there is not a strong relationship between increasing distance between the washer and the target area being washed and decreasing effectiveness of the salt removal. This could be the result of either the salt concentrations were too low to show a significance or that the pressure used was significantly high that the distances selected were not sufficiently large to be statistically significant. The proportion of salt removal in locations 1 and 3 is plotted against the washing angle in Figure 30.

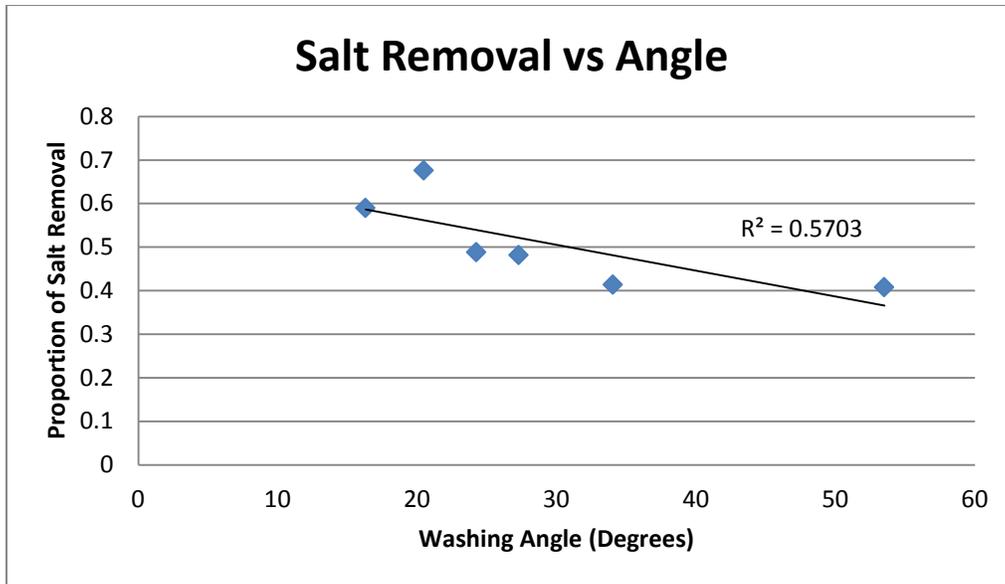
Figure 30: 40th St. Bridge, Test A: Salt Removal Versus Washing Angle
