DEPARTMENT OF TRANSPORTATION

Evaluation of Bridge Cleaning Methods on Steel Structures

FINAL REPORT

University of Pittsburgh

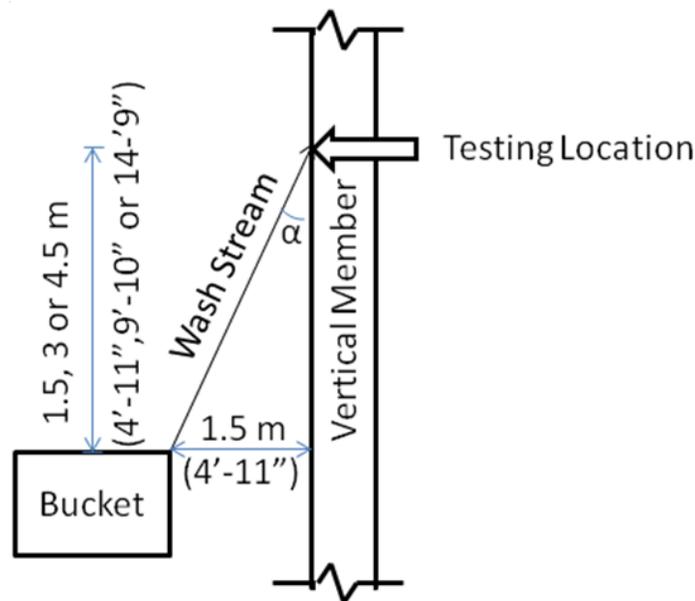
higher prewash soluble salt concentration. The vertical members were all tested where the ornamental arch intersected the member to ensure that the tests were performed at a constant distance below the deck. The prewash surface salt concentrations at these locations were also relatively small, below 20 mg/m^2 (29×10^{-3} grains/ft²), as shown in Table 15. The height of the nozzle of the pressure washer during cleaning was 1.5 m (4.9 feet) below the target area, which was at the intersection between the ornament and the arch, for the third vertical member. It was 3 m (9.8 feet) below the target area for the fourth vertical member on the span and 4.5 m (14.8 feet) below for the second vertical member. The contractor then washed the beams with the nozzle of the pressure washer approximately 1.5 m (4.9 feet) away from the vertical member in the horizontal direction. The pressure was maintained at a constant 10 MPa (1500 psi) for the duration of the cleaning. The setup is shown below in Figure 31.

Figure 31: 40th St Bridge, Test B: Side View of Sampling Locations
