Fibers in Micro Surfacing

FINAL REPORT

COMMONWEALTH OF PENNSYLVANIA
DEPARTMENT OF TRANSPORTATION

CONTRACT # E03718
WORK ORDER # 003

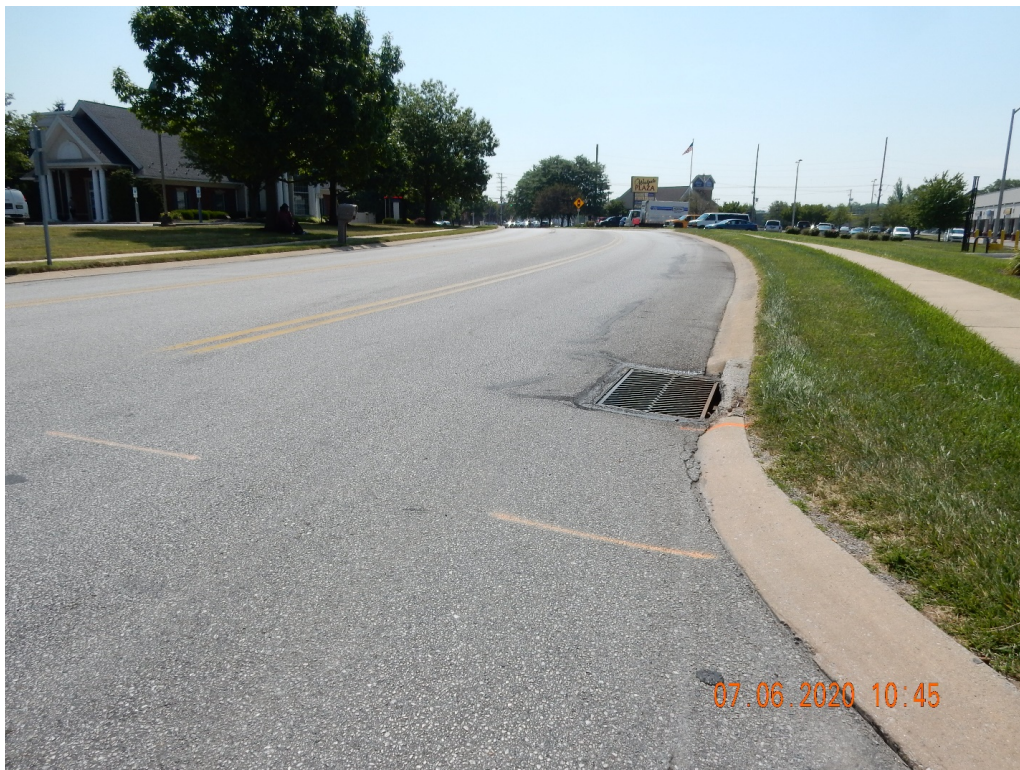
Figure 2. General view of the existing pavement (picture taken at intersection with Trolley Road).

The road for the pilot micro surfacing project was the Kenneth Road in West Manchester Township of York County, PA. Review of the existing pavement took place on July 6, 2020. Visit of the site took place by the principal investigator and the project technical liaison, who coordinated all research-related activities with the township and the contractor. The visual survey was conducted from the roadside with no traffic control or direct access to the road. The existing pavement appeared to be structurally sound. No visible signs of raveling or bleeding of the roadway were found. Rut depth was not measured but did not appear to be noticeable. There were areas of transverse and longitudinal cracks, all of which were recently sealed. Pictures were taken from the surface and mapping of the crack pattern was conducted as provided in Appendix A. Examples of the surface condition are presented in Figures 2 through 6. The road has annual daily traffic (ADT) of roughly 3,000.

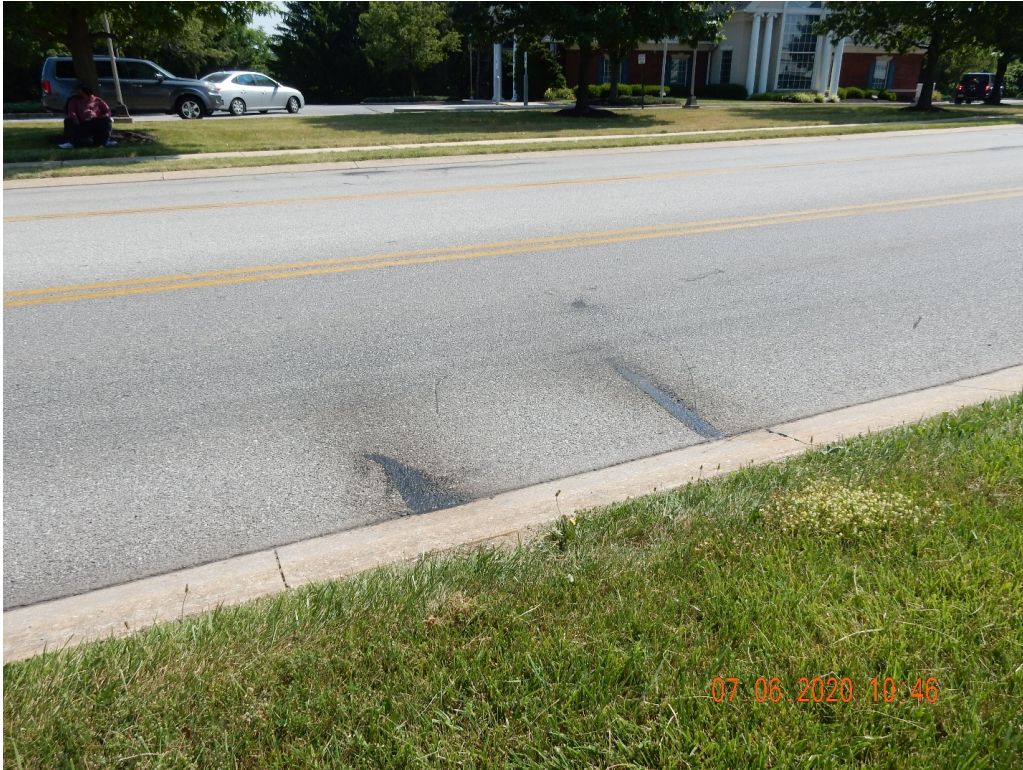
Figure 3. Southbound with sealed transverse cracks.

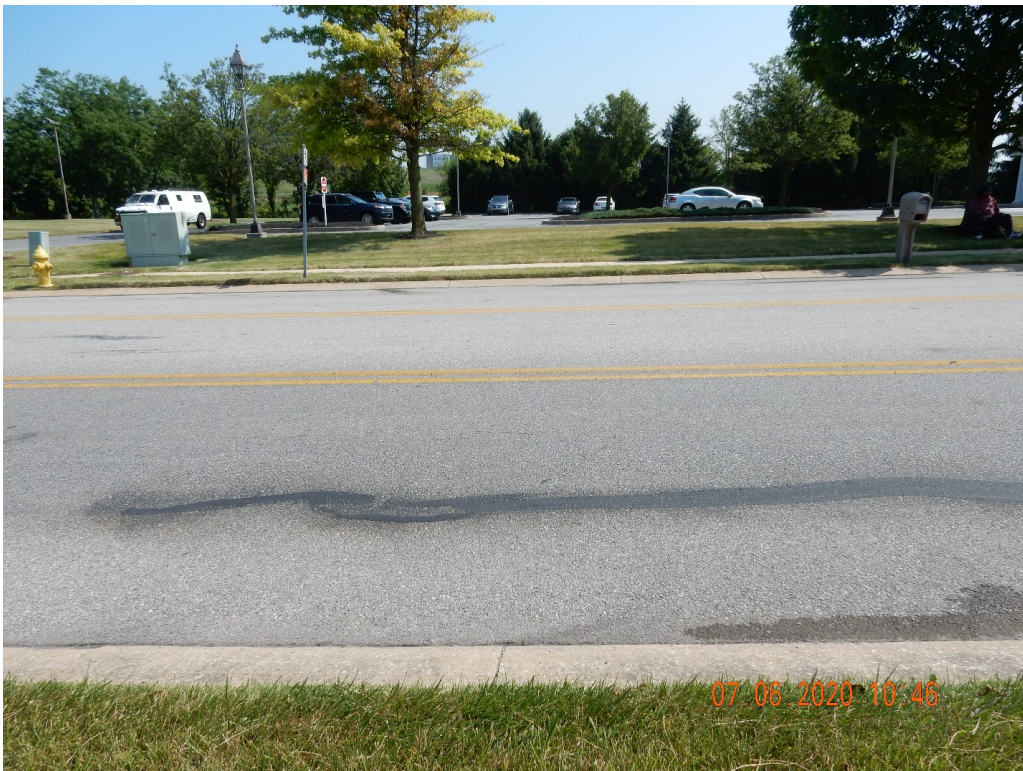
Figure 4. Southbound with sealed longitudinal cracks.

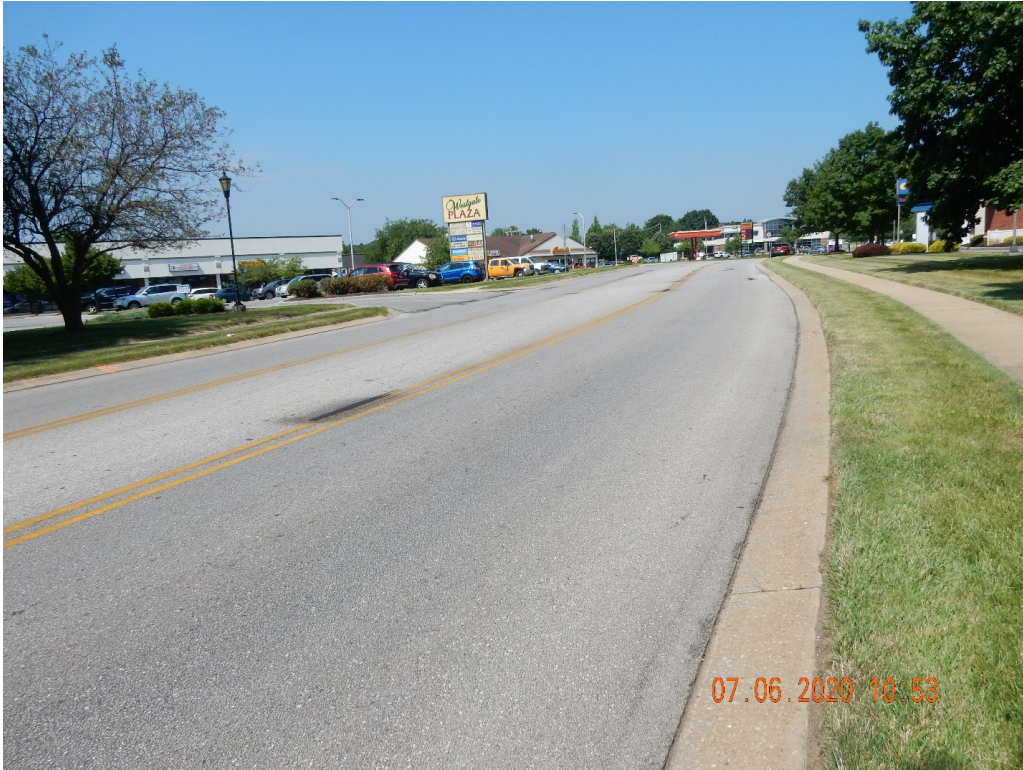
Figure 5. General view of the existing pavement (picture taken at intersection with Loucks Road).

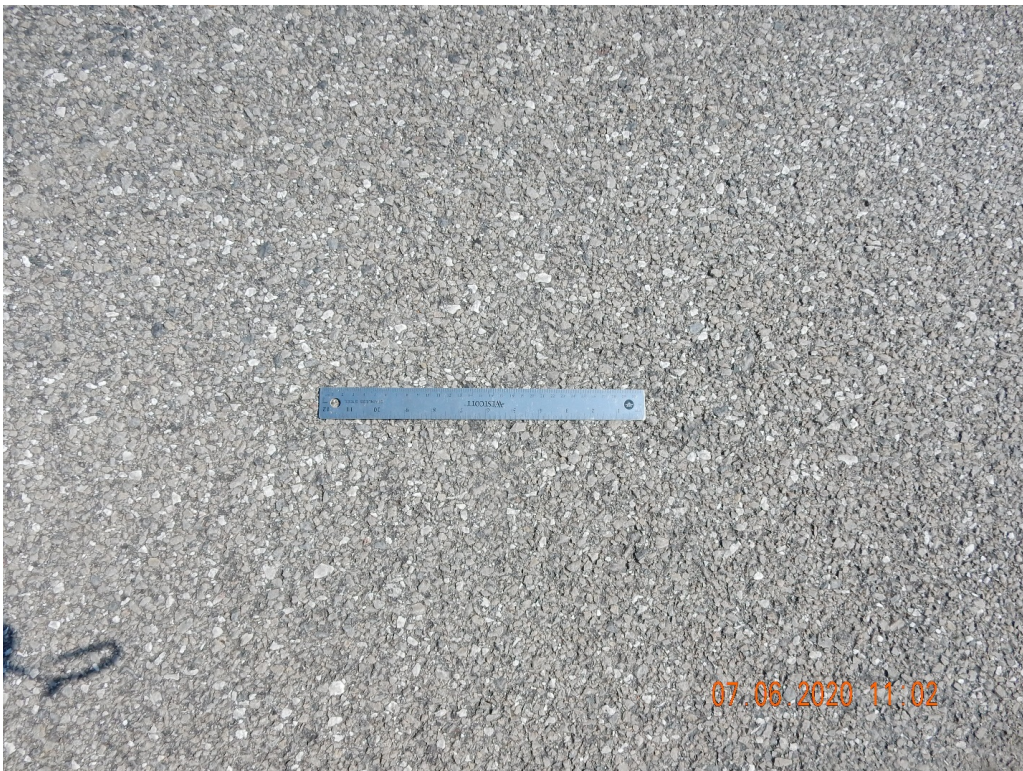
Figure 6. Close-up view of surface texture of existing pavement.

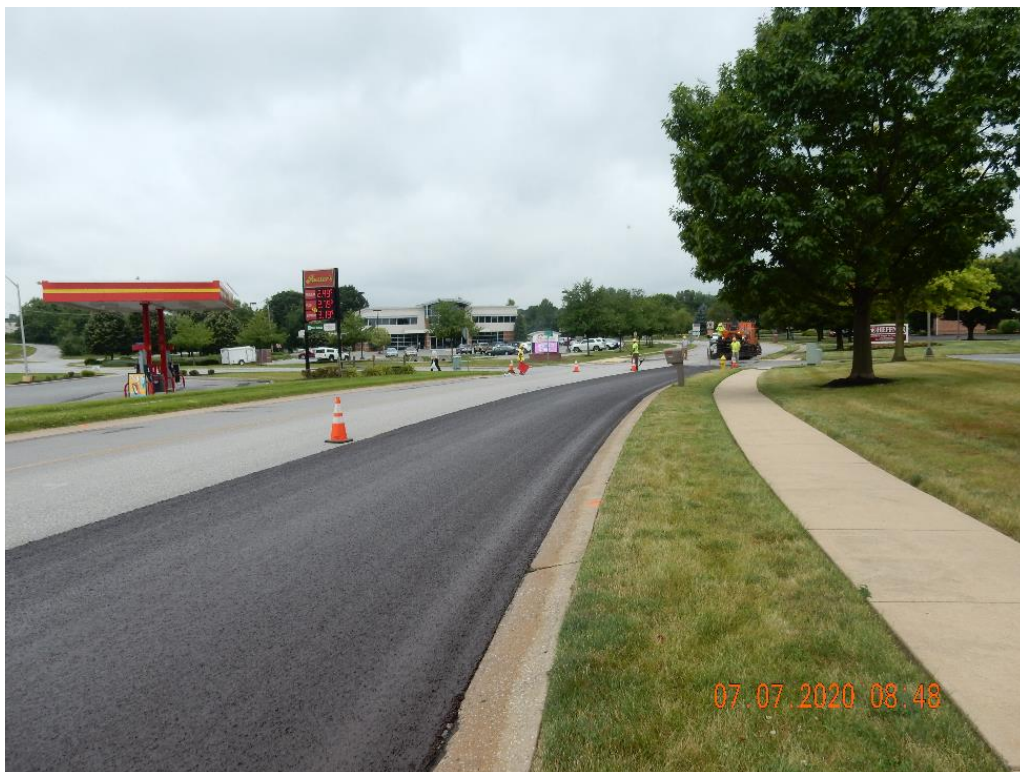
Figure 7. The scratch layer of fiber-reinforced micro surfacing placed on the northbound lane.

Three test sections of micro surfacing were placed on Kenneth Road between Loucks Road and Trolley Road in Manchester County. The test sections received a scratch layer application of Type A micro surfacing followed by main layer application of Type A micro surfacing. The scratch layer was placed at an application rate of approximately 15 lb/yd². The top layer was placed at 32 to 35 lb/yd². The northbound and the center lane were placed with a micro surfacing mix that included glass fibers at a rate of roughly 0.2% by the weight of the mix. The southbound was placed as the control section, with a micro surfacing mix that did not contain fibers. Placement of material in all lanes took place moving in the southbound direction. First, placement of the northbound took place, followed by the center lane and the southbound, respectively. The material was placed on a cloudy day with ambient temperature ranging between 75–80 °F (24–27 °C) during placement. The existing pavement temperature varied in the range of 90–96 °F (32–36 °C) during placement. When placing the center lane mix, the road marking paint was first tacked to ensure adequate bond between the micro surfacing and the underlying pavement. The placed material was rolled using a pneumatic tire roller for compaction. The compaction rolling was not conducted on the scratch layer. Figures 7 through 15 present different stages of material placement.

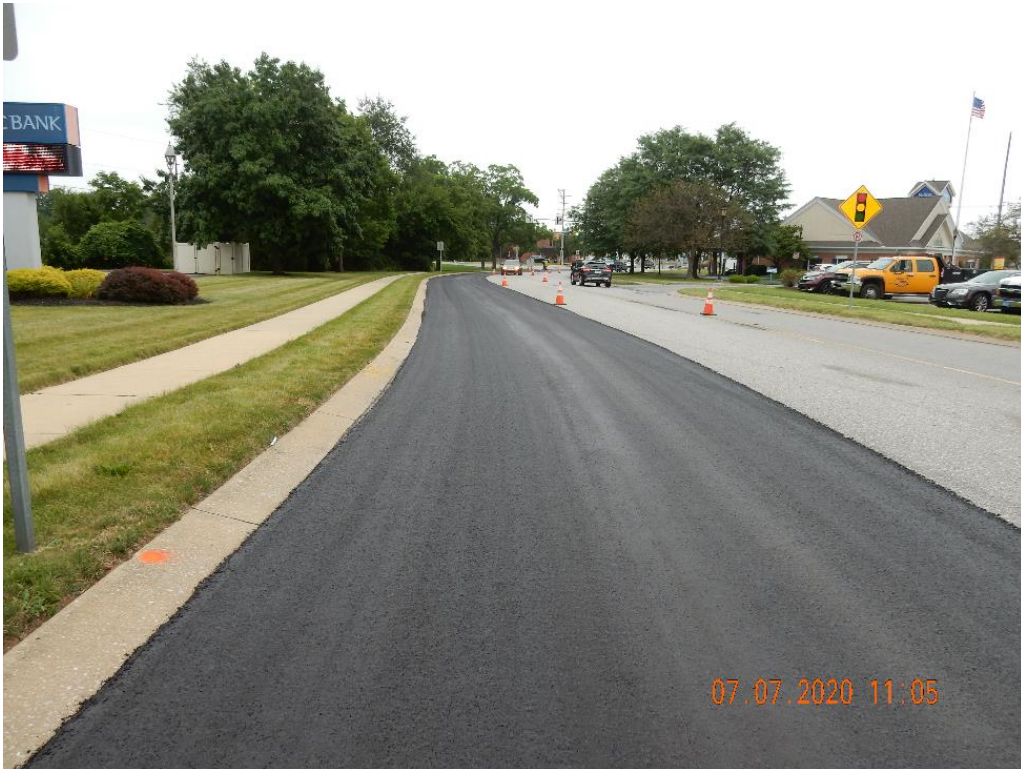
Figure 8. The top layer of fiber-reinforced micro surfacing placed on the northbound lane.

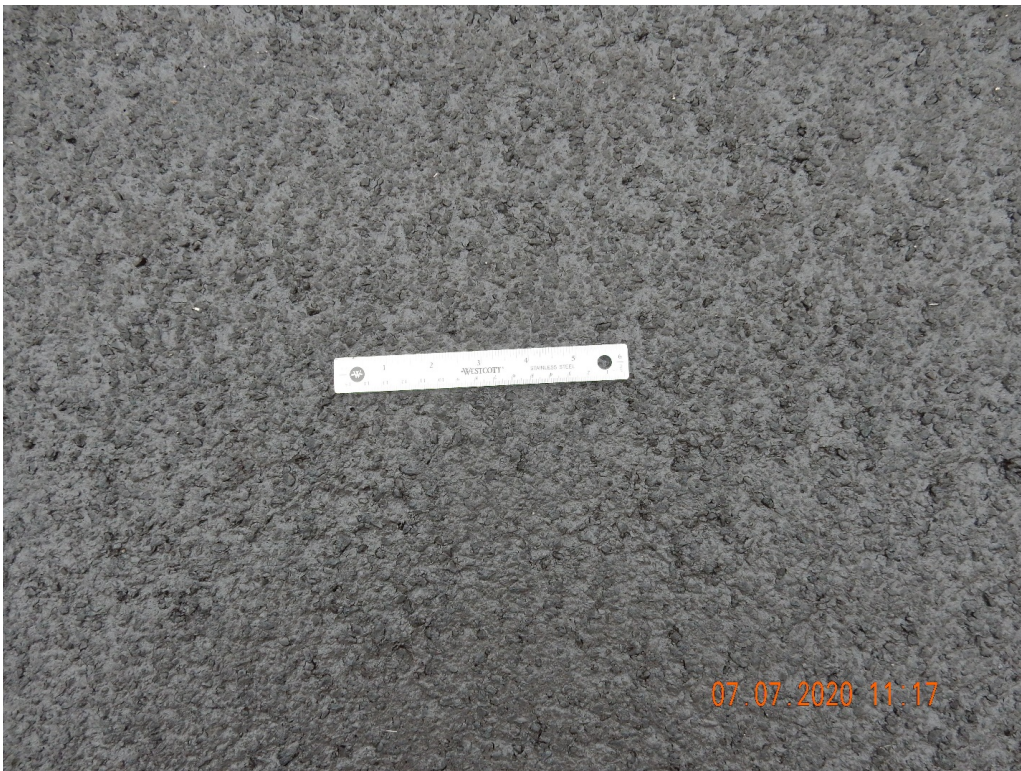
Figure 9. A close-up view of the micro surfacing texture on the northbound lane.

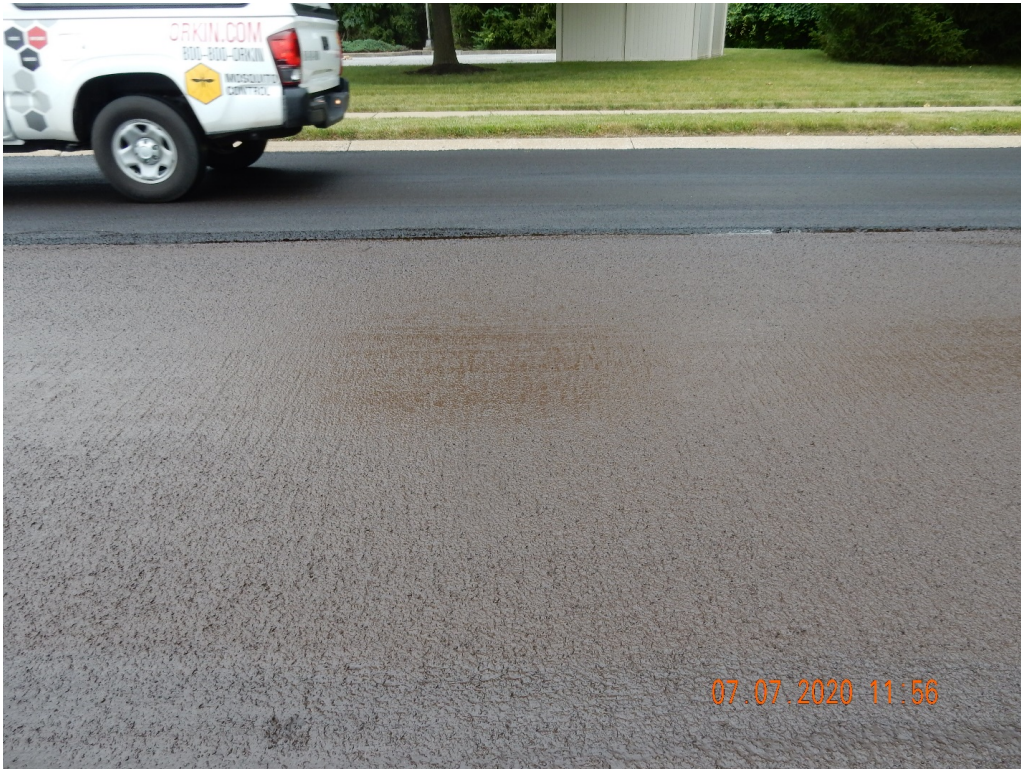
Figure 10. Cured micro on the northbound (far side) and freshly placed micro on the center lane.

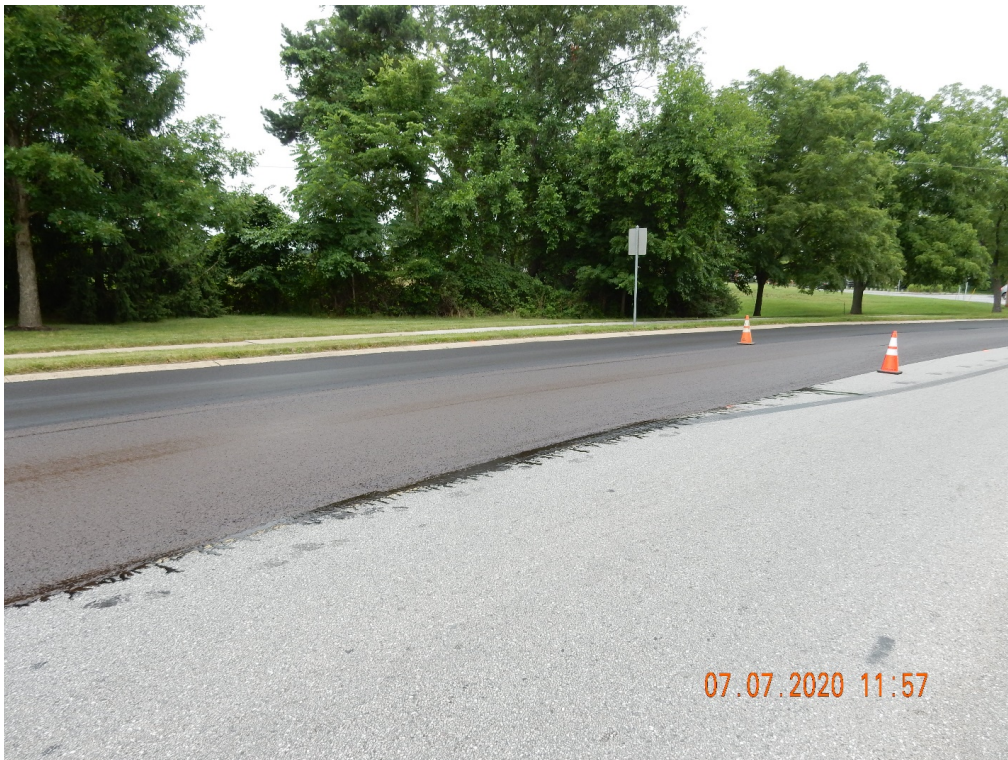
Figure 11. Completed micro (northbound), freshly placed scratch micro (center lane), and existing pavement to be paved (southbound).

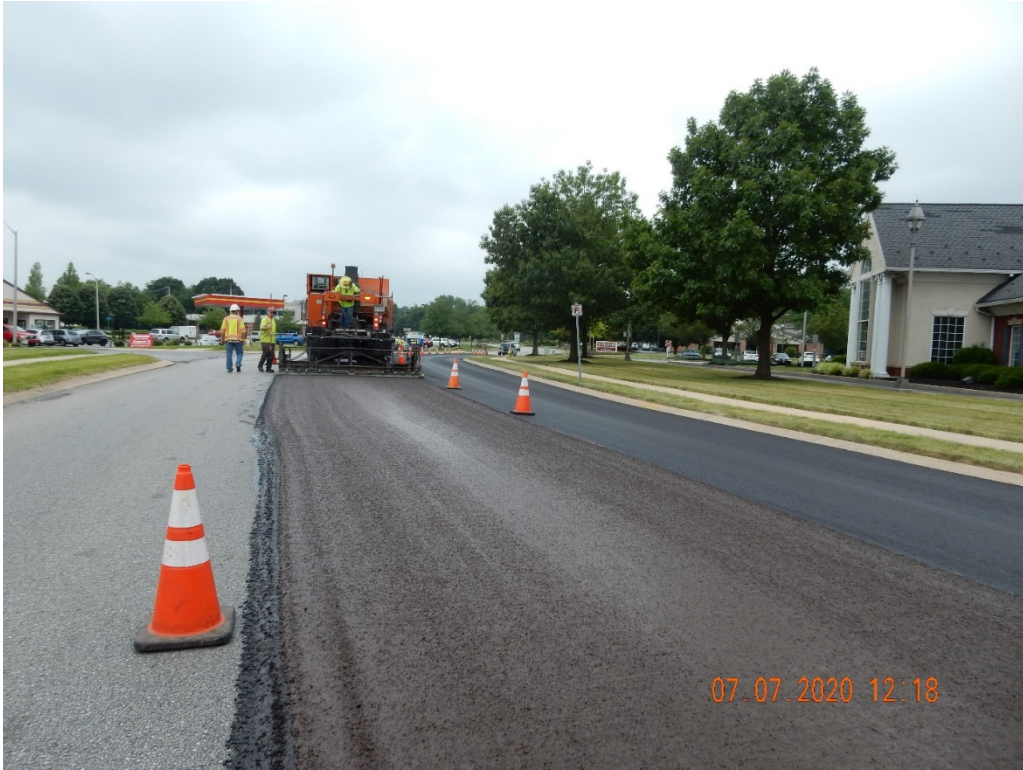
Figure 12. Placement of second layer of micro on the center lane.

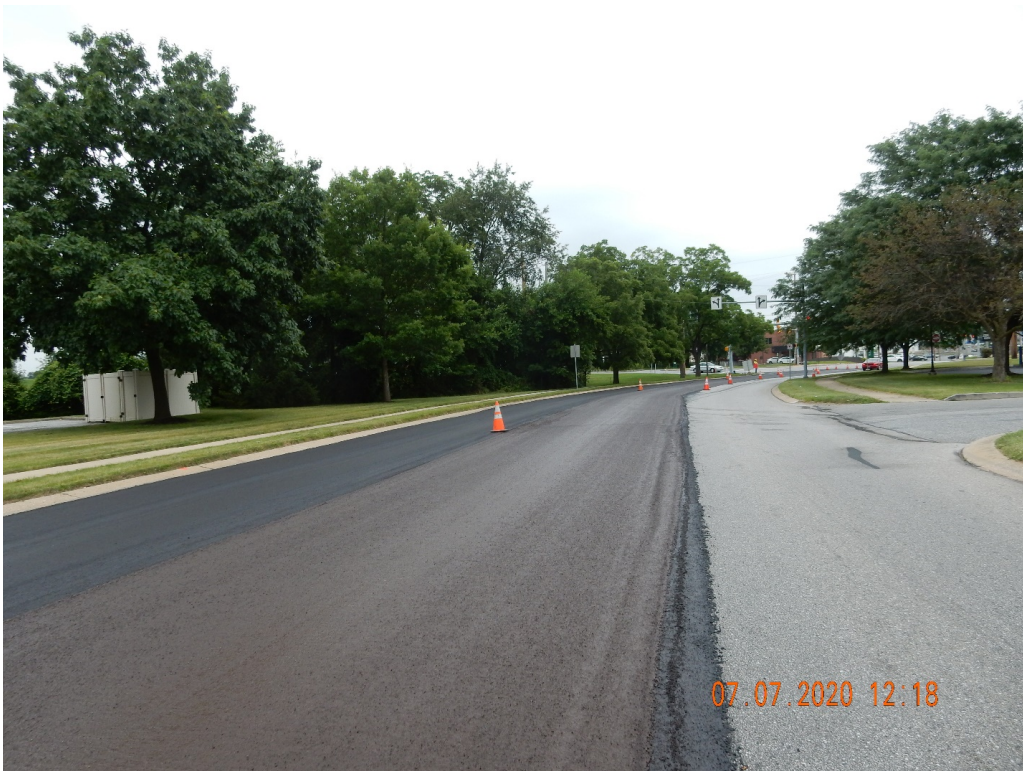
Figure 13. Freshly placed micro on the center lane.

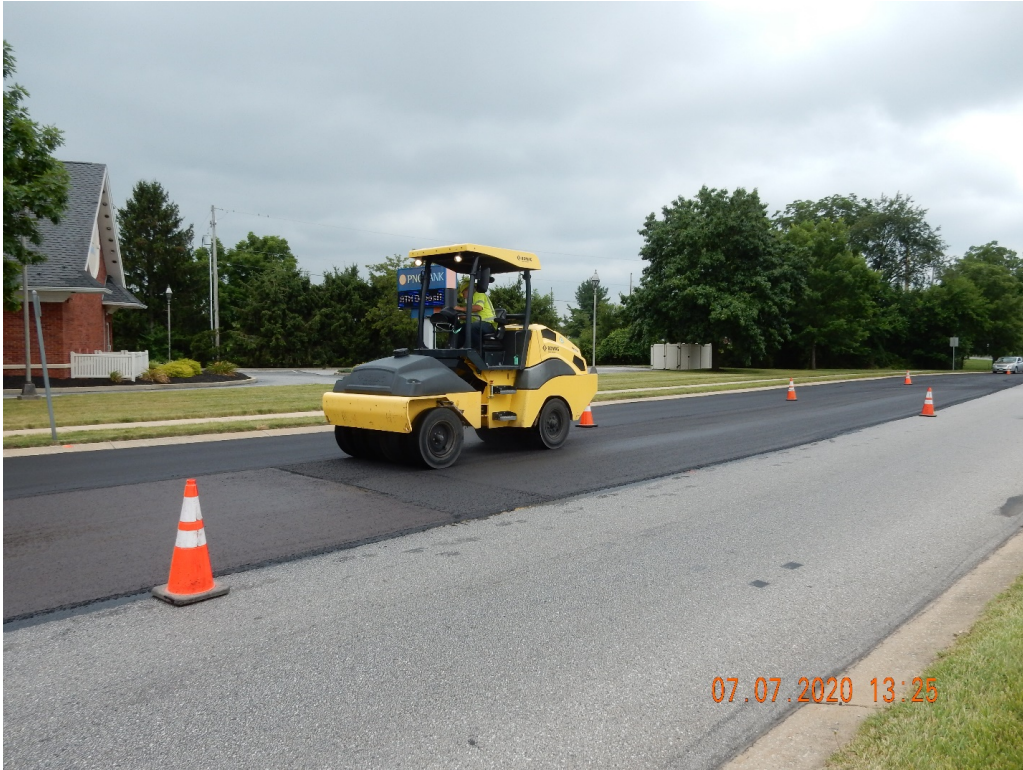
Figure 14. Compacting the center lane micro (second layer).

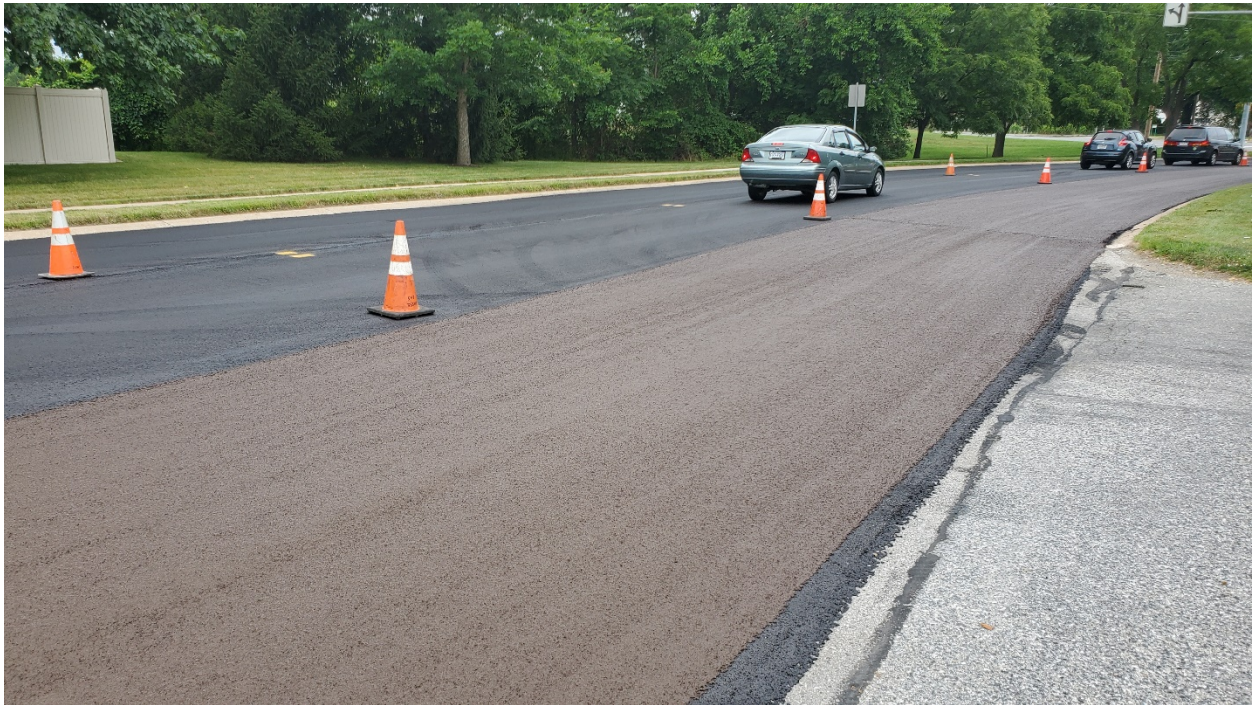
Figure 15. Completed micro on the southbound lane.

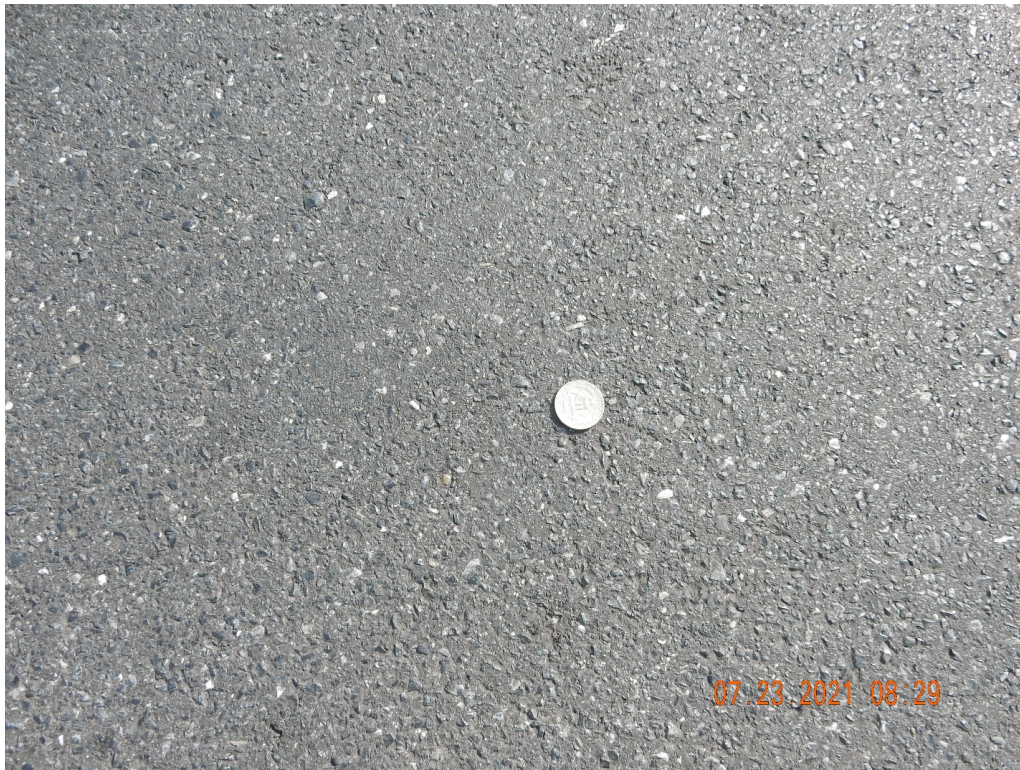
Figure 16. A close-up view of the surface texture on the southbound one year after placement.

This visit took place roughly one year after placement and was conducted by the principal investigator and the project technical liaison. The road appeared to be in great shape on both the control and fiber sections as evidenced in Figures 16 through 22. There were no signs of cracking, rutting, bleeding, raveling, or material loss. This was expected, as the placed mix was only about a year old. At the intersection with Loucks Road, a moderate level of rutting and flashing of the control section was observed due to standing vehicles at the traffic light (Figure 23). At the intersection with Trolley Road on the northbound, loss of material was observed on the right-hand side of the experimental section but limited to a very small area (Figures 24 and 25).

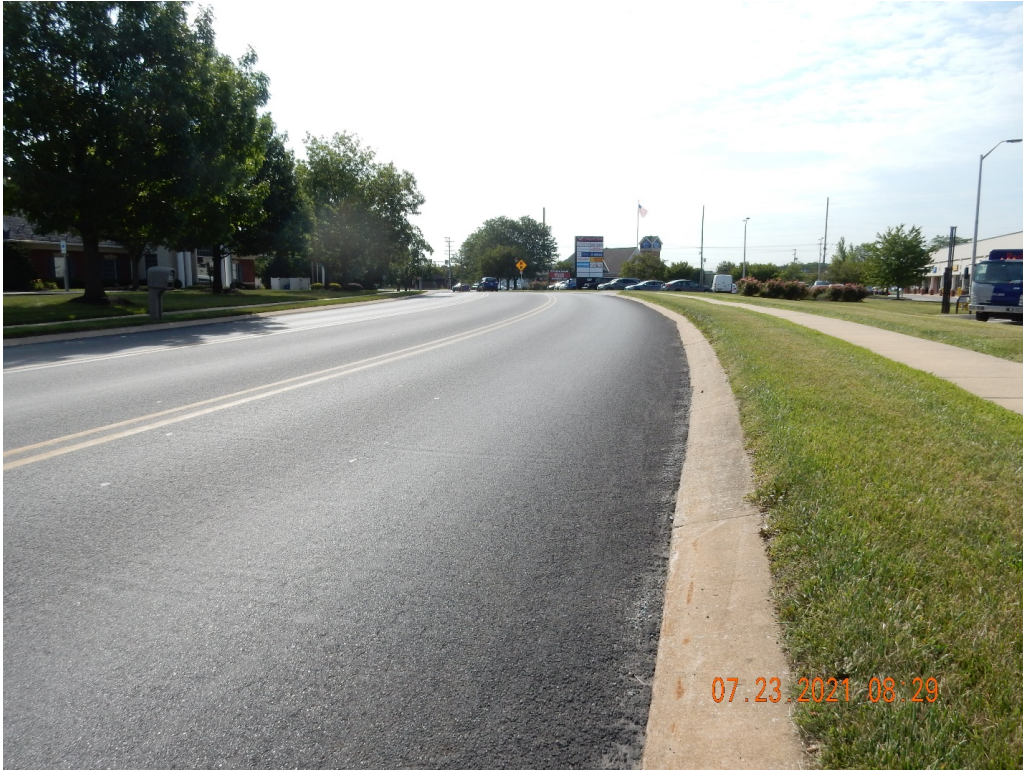
Figure 17. A general view of the micro after one year in service, looking southbound.

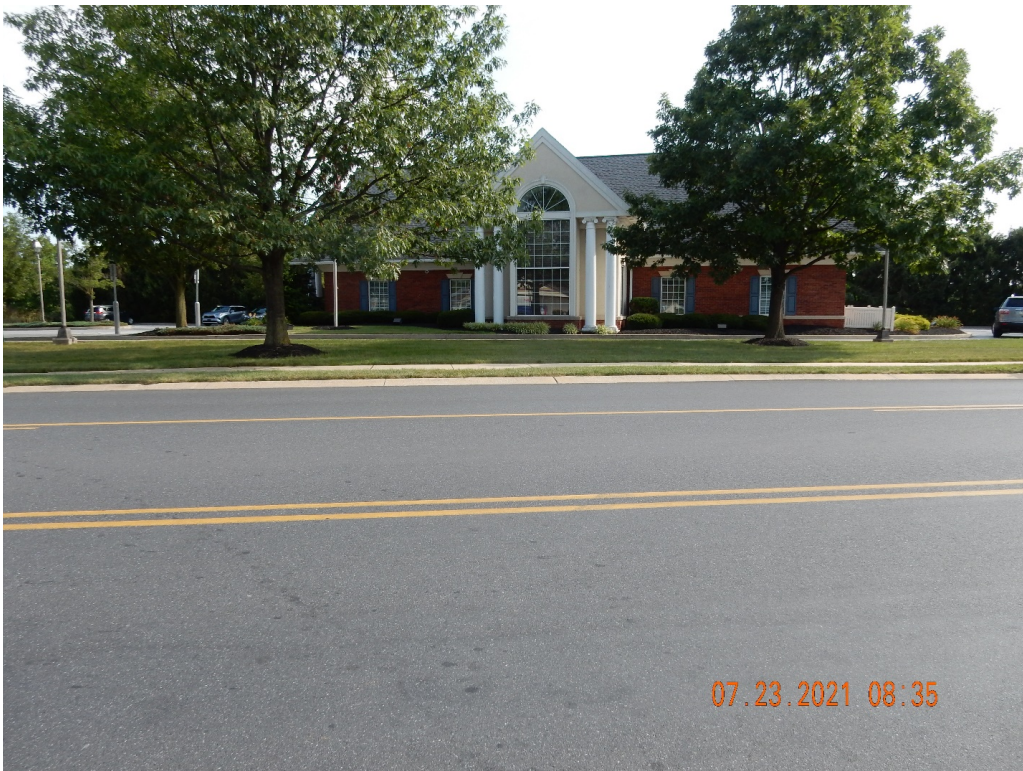
Figure 18. Another view of the micro after one year of service.

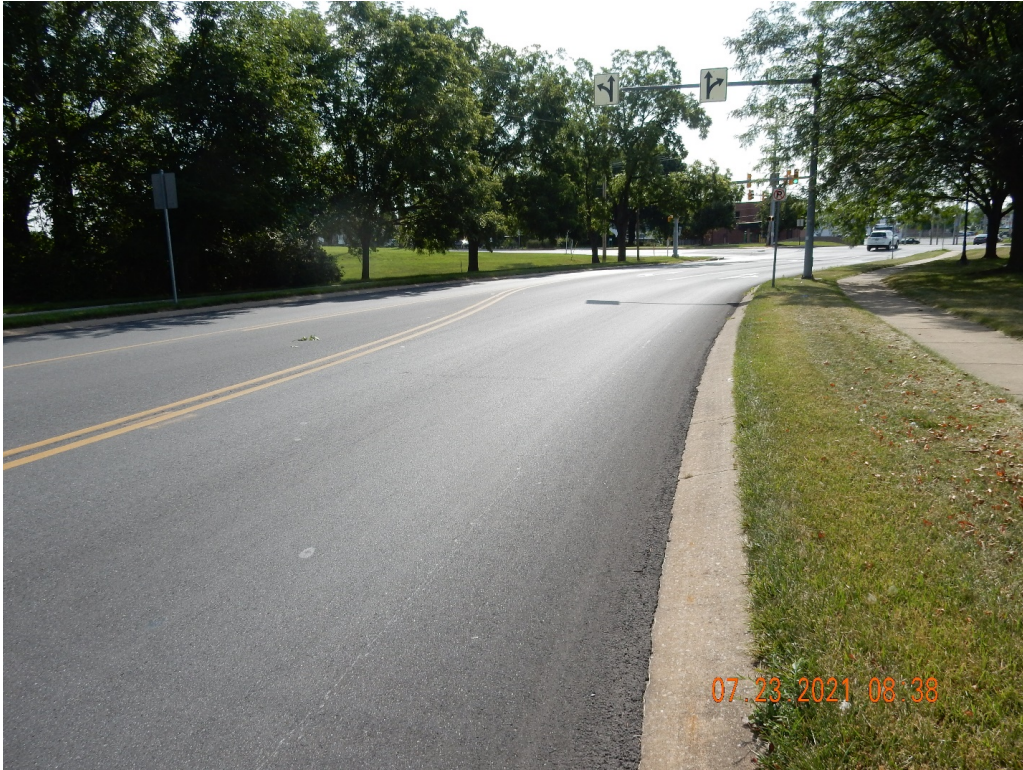
Figure 19. Excellent performance and texture after one year of service (looking southbound).

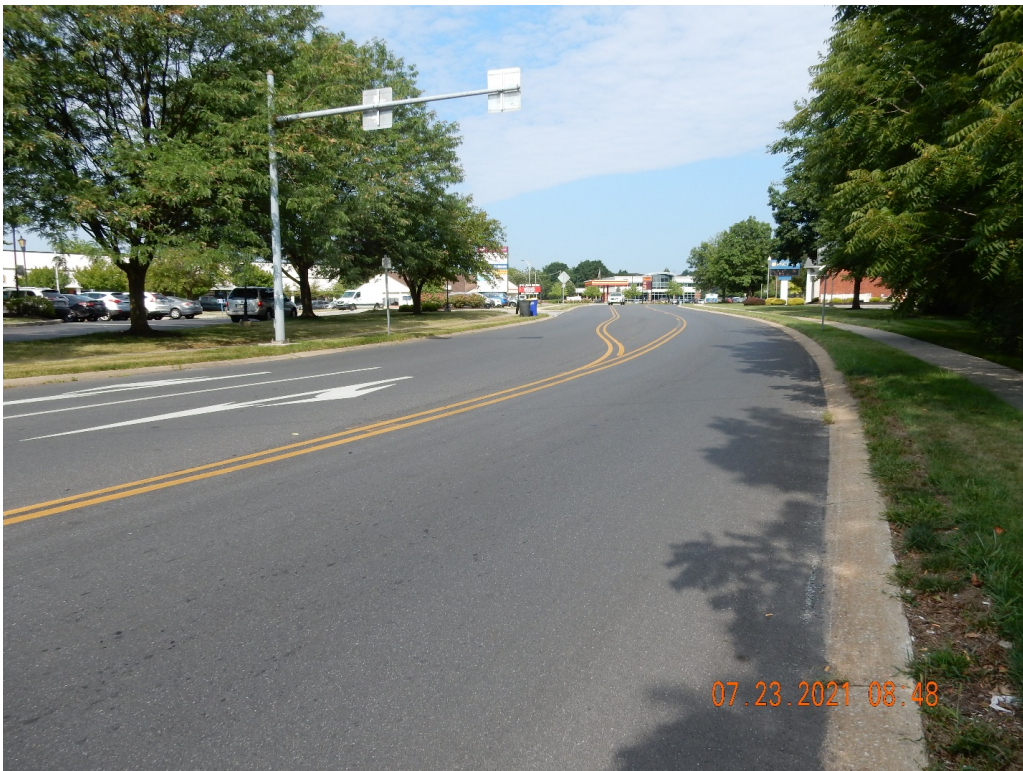
Figure 20. General view of the micro after one year of service (looking northbound).

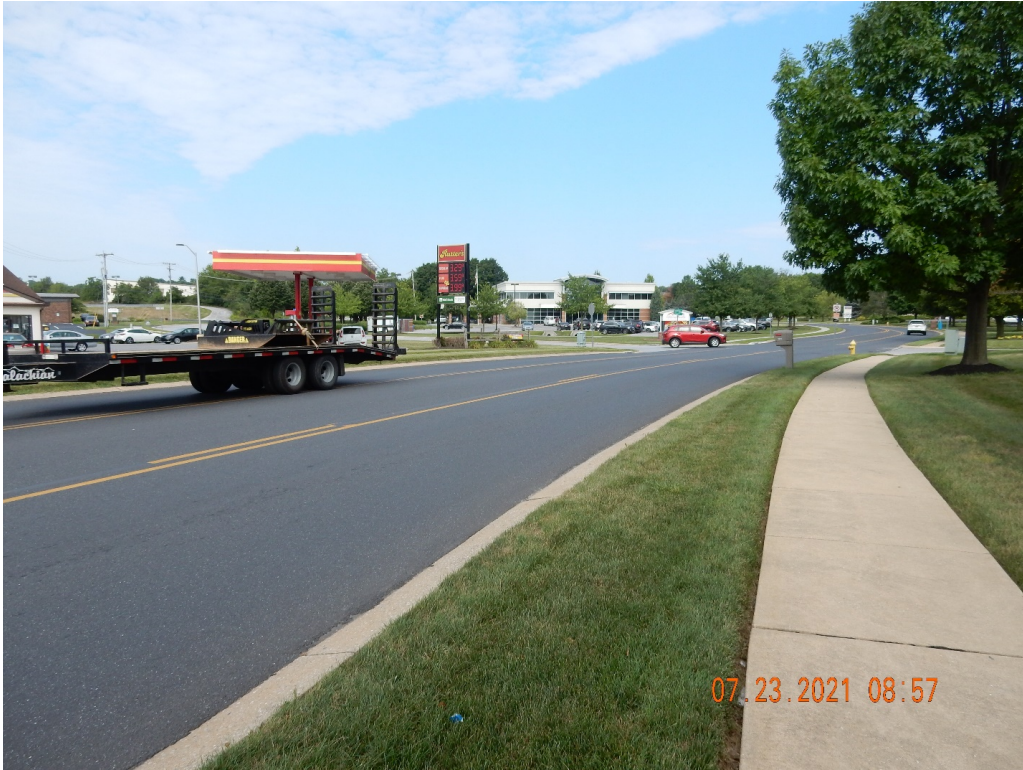
Figure 21. Another view of the micro after one year of service looking northbound.

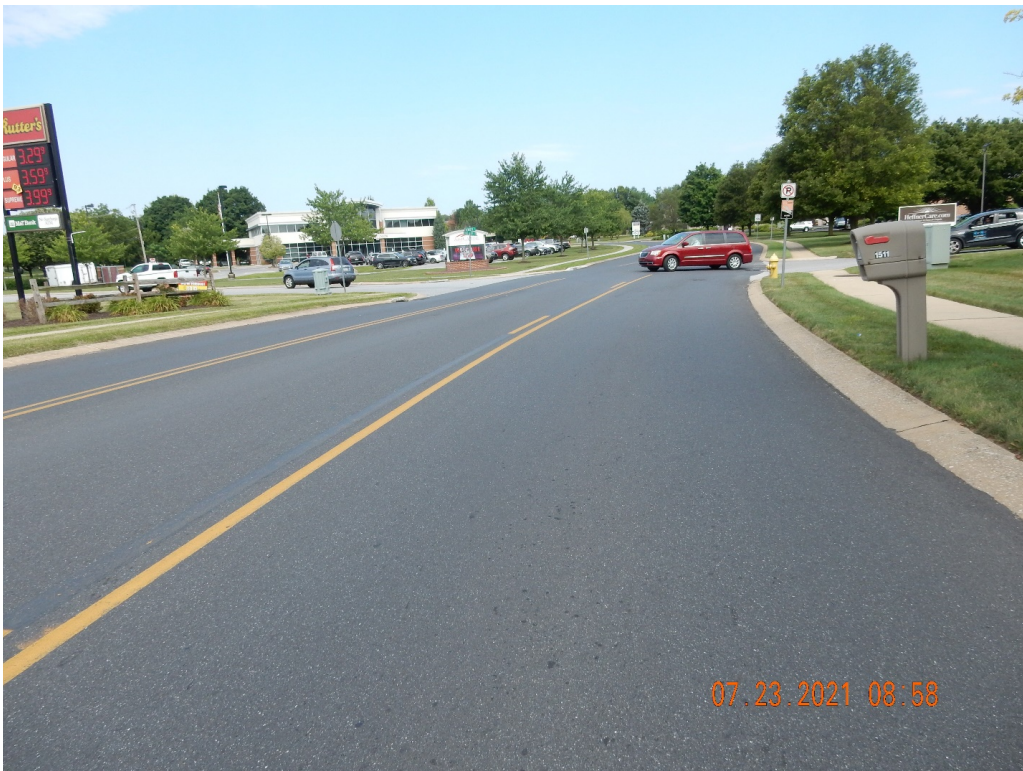
Figure 22. Excellent texture and appearance of the mat on all three lanes.

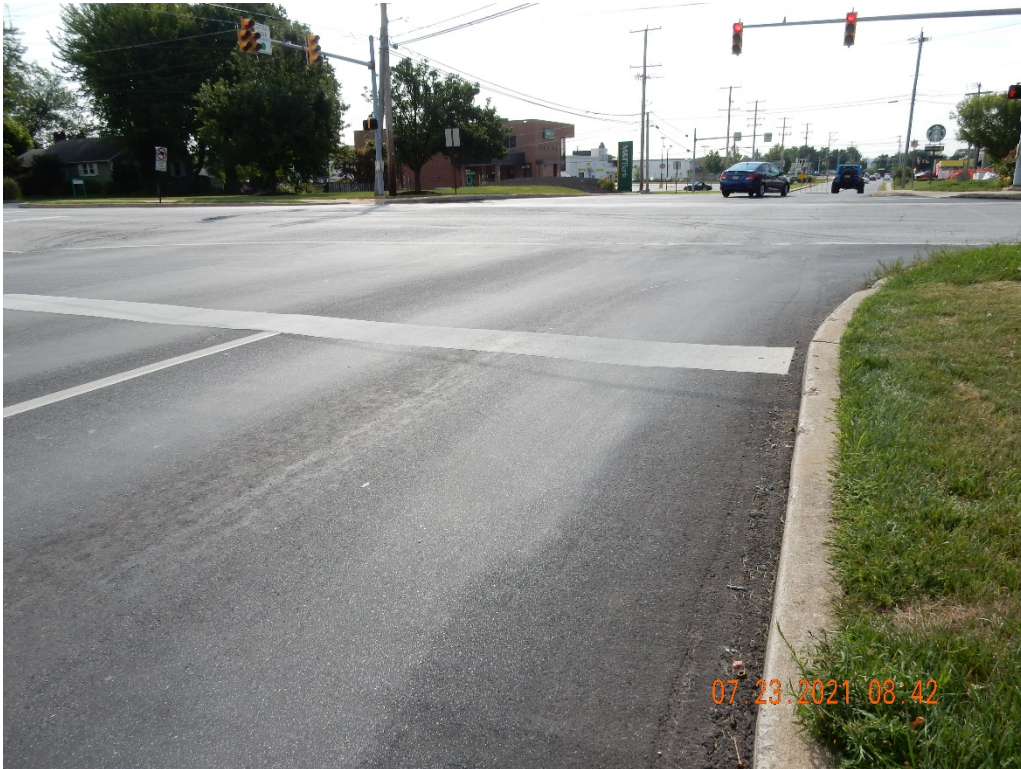
Figure 23. Minor rutting and bleeding on the southbound lane at the intersection.

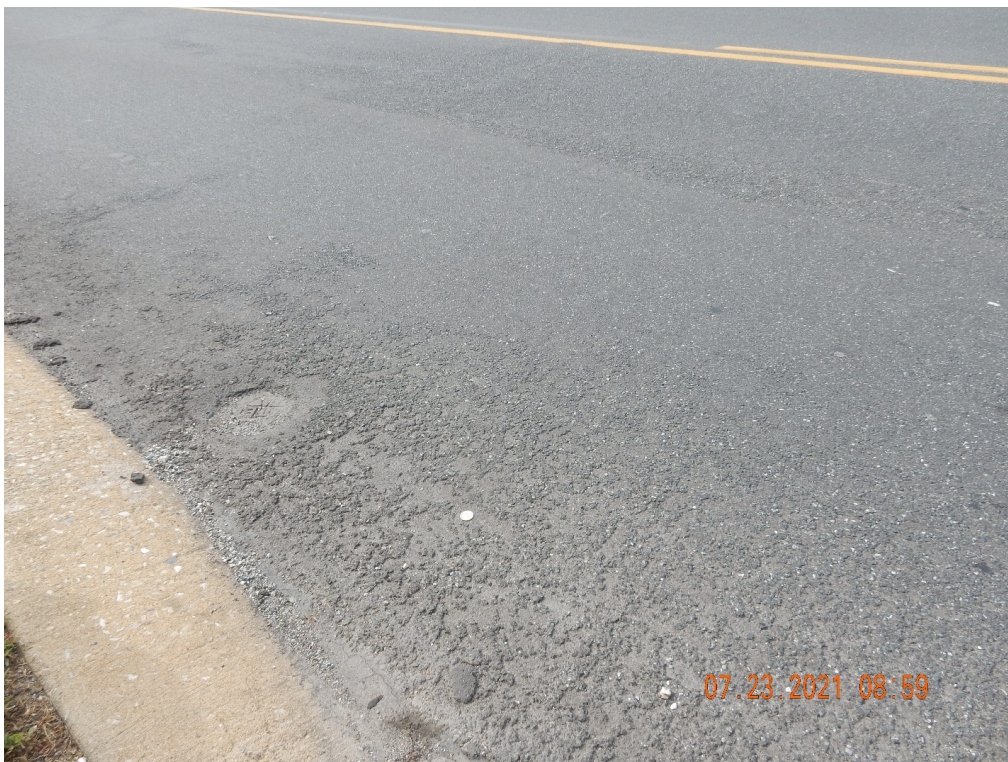
Figure 24. Localized loss of material on the northbound lane at the intersection with Trolley Road, possibly because of inadequate application or compaction.

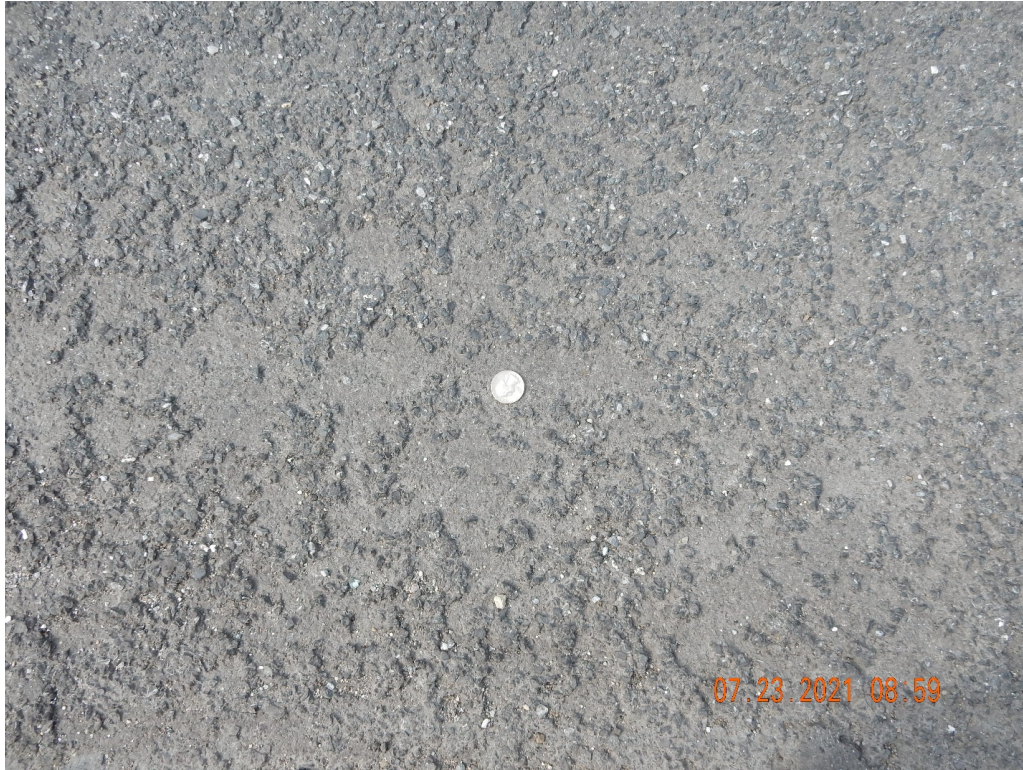
Figure 25. A close-up view of the localized material loss on the northbound lane at intersection with Trolley Road.

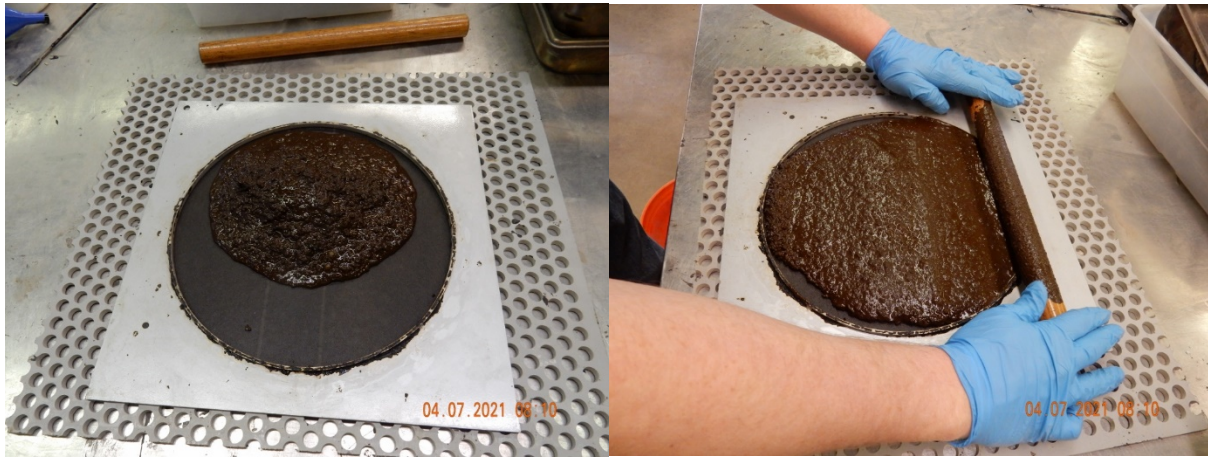
Figure 27. (a) The micro surfacing material poured into the mold, (b) spreading the micro surfacing material using the wooden dowel rod to evenly spread across the mold to uniform thickness.

mix design. The specimens fit a circular mold with an 11-inch diameter. The steps followed to create and test a specimen, as shown in Figures 26 through 28, are as follows:

- Place the felt paper on top of a sheet of perforated plastic.
- Place the circular mold on top of the paper, leaving about ½ inch on all sides.
- Preheat the emulsion at 60 °C for 30 minutes.
- In a mixing bowl, place 877.2 grams of aggregate.
- Add 8.8 grams of cement powder to the aggregate.
- If including fibers, add in 3.5 grams of the fiber.
- Mix in 73.7 grams of water and stir the mixture to ensure the entire mixture is uniformly damped.
- Add in 105.3 grams of heated emulsion.
- Mix the emulsion in for 30 seconds.
- Once mixed, pour the mixture into the mold favoring one side.
- Using a dowel rod or window squeegee, gently spread the mixture evenly across the mold, making sure no divots are pressed into the felt paper.
- Place the mold into a 60 °C oven until it dries to a constant mass, no shorter than 15 hours, no longer than 30 hours.

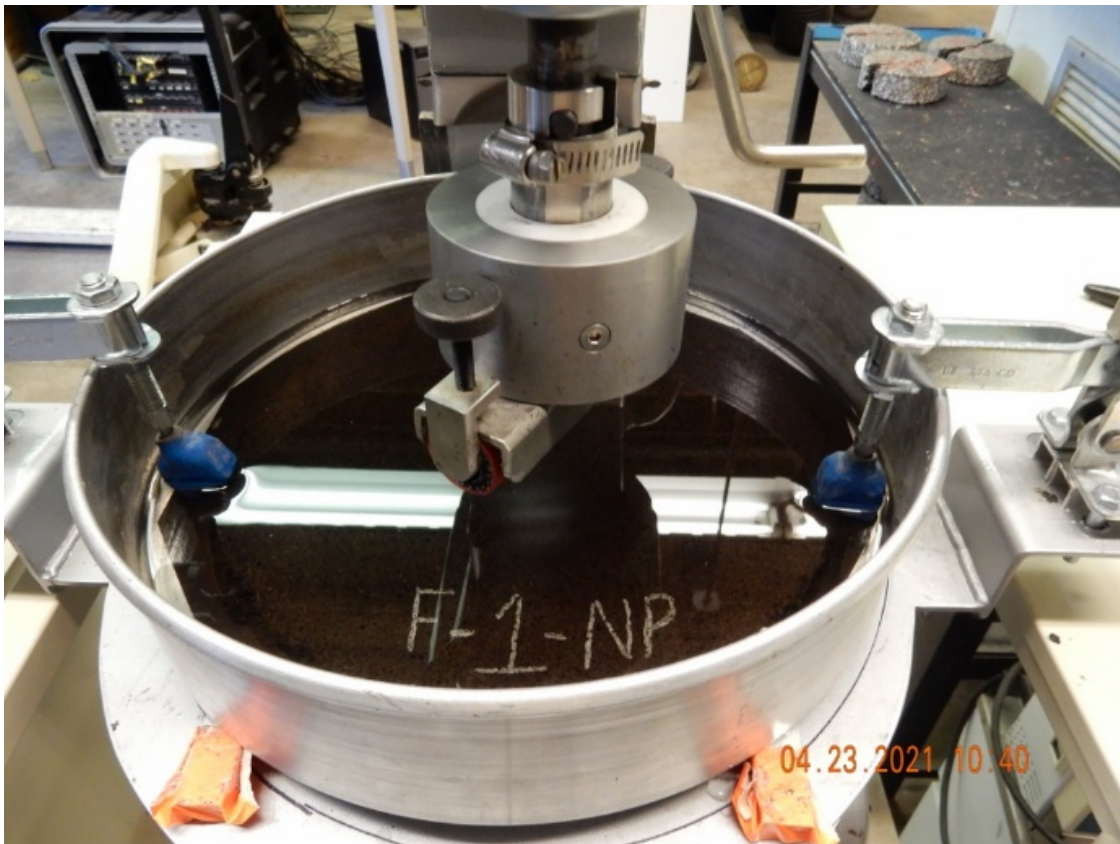
Figure 28. Micro surface specimen clamped in the abrasion pan with the pan filled with water before testing.

- Clamp the specimen down to the abrasion pan and pour in water to submerge the specimen to a depth of 6.35 mm. The water must be at a temperature of 77 °F (25°C).
