Fibers in Micro Surfacing

FINAL REPORT

COMMONWEALTH OF PENNSYLVANIA
DEPARTMENT OF TRANSPORTATION

CONTRACT # E03718
WORK ORDER # 003

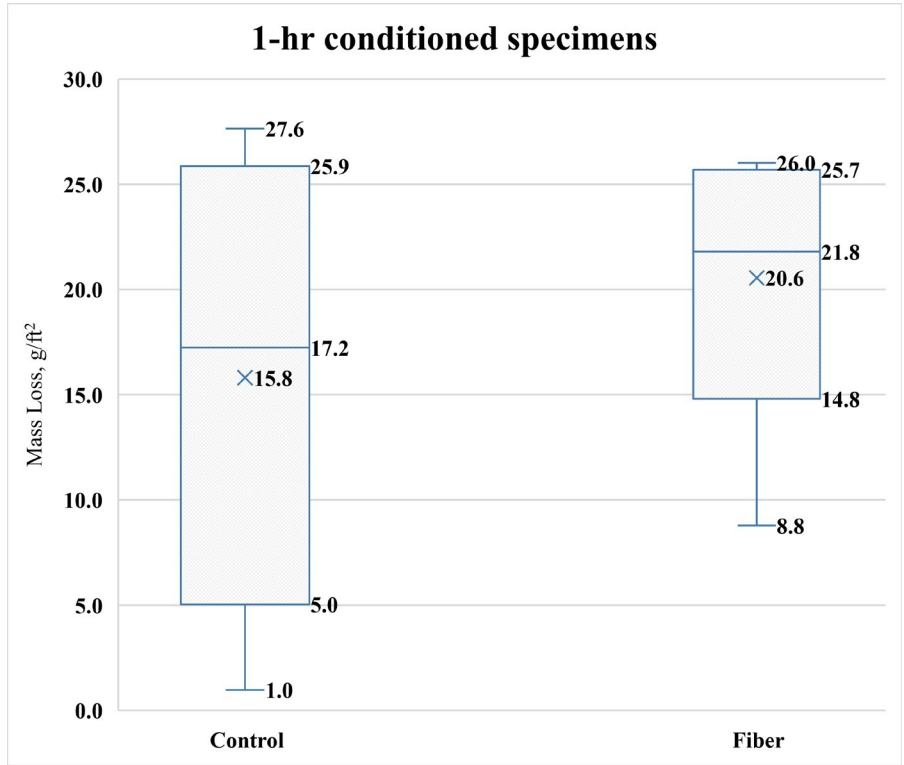
Figure 30. Box and whisker plot for identifying the 1-hr outliers.

The first approach for identification of the outliers was through the use of the box and whisker plot, which presents the distribution of data using quartiles. The summary of data is presented with five numbers: minimum value, first (lower) quartile, median, third (upper) quartile, and maximum value. The first quartile (Q1) presents the value exceeding 25% of the values. The third quartile (Q3) presents the value exceeding 75% of the values. The interquartile range (IQR) is the difference between Q3 and Q1 and shows the middle 50% of data. The upper and lower whiskers show the data that land outside the middle 50% of the data. To determine the outliers based on the box and whisker plot, two values are calculated: LL (lower limit)= $Q1 - 1.5 \times IQR$ and UL (upper limit)= $Q3 + 1.5 \times IQR$. Any value below LL or higher than UL is considered an outlier. Through this approach it was found that none of the values could be removed as an outlier.

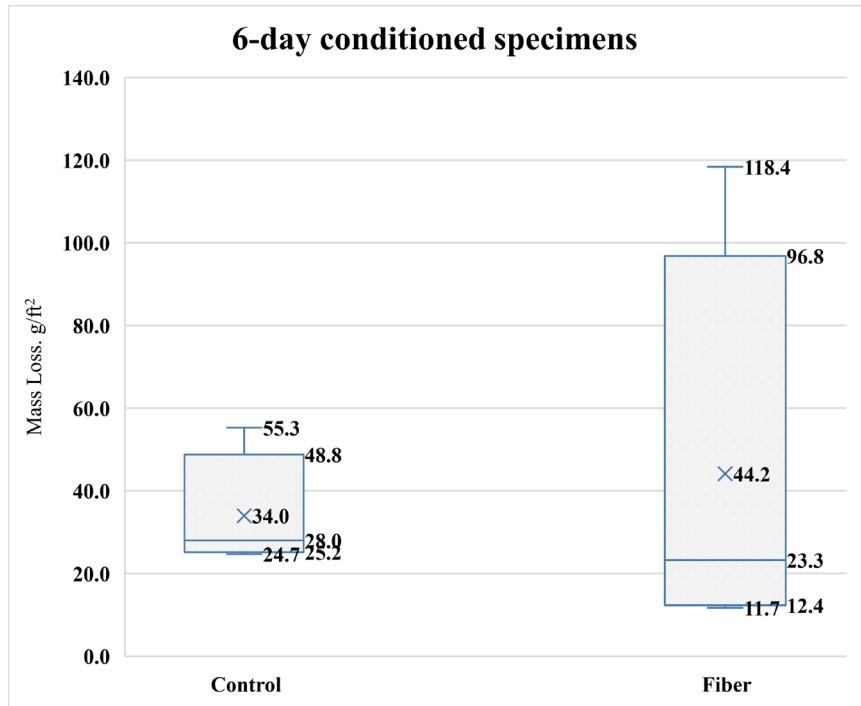
Figure 31. Box and whisker plot for identifying the 6-day outliers.

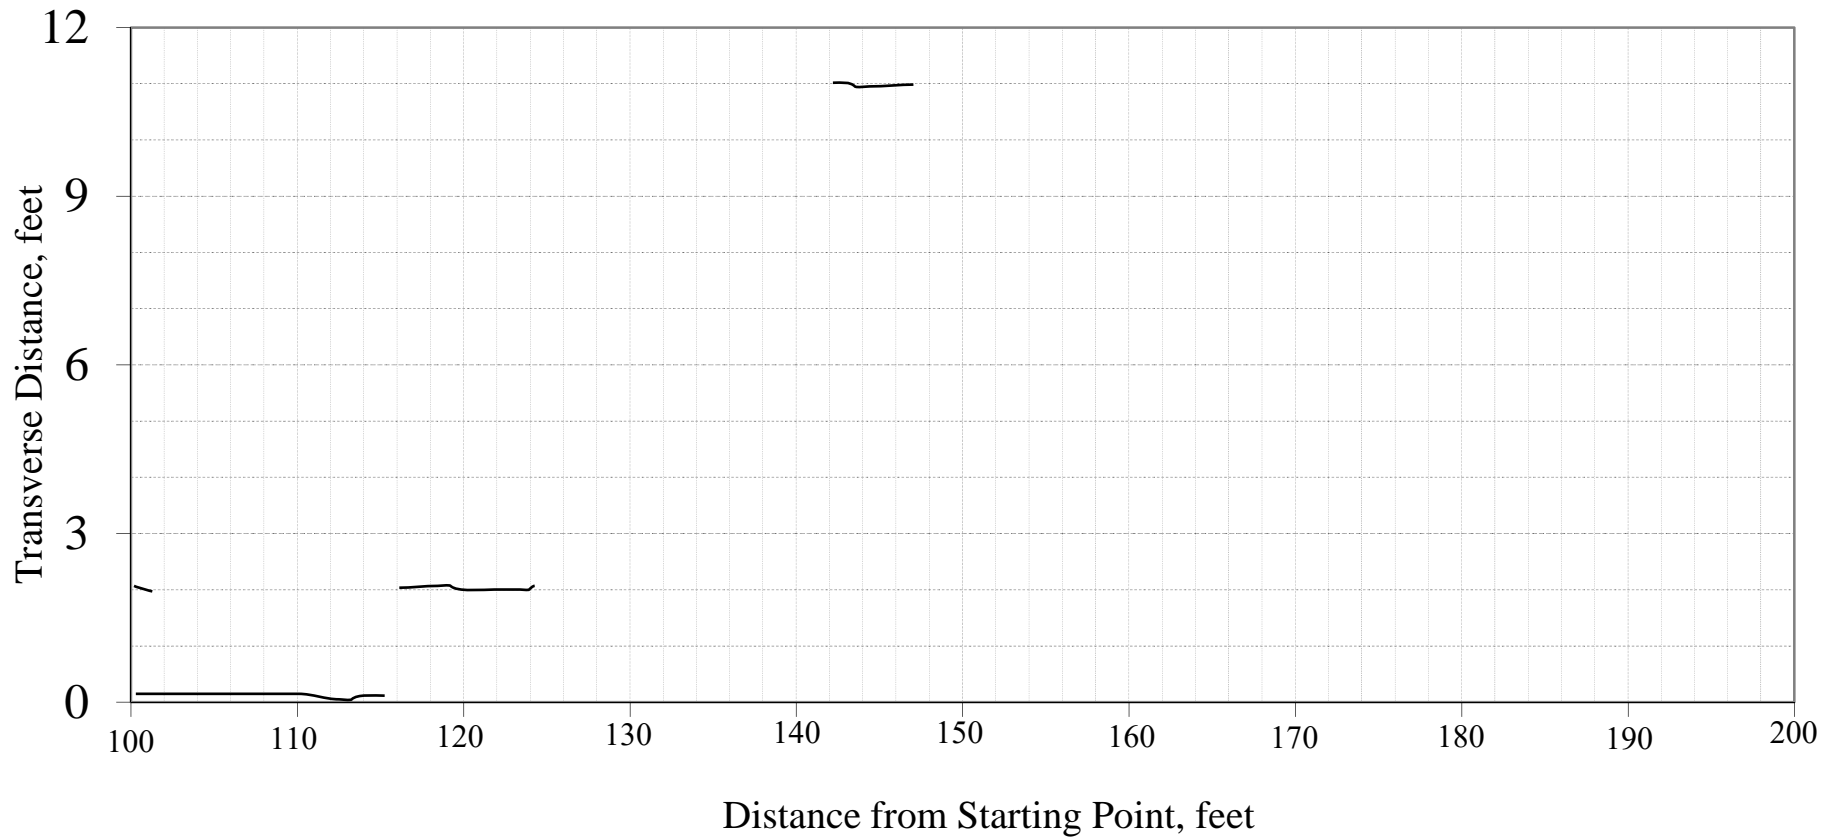
- Zero Mark is at the Torley Rd., right before the catch basin storm drain.
- All shown cracks on this page and subsequent pages have been sealed and are not visible.
- Survey was conducted from the roadside.
- Location and length of all mapped cracks are approximate.
- The road is in good shape. Raveling is minor,. There was no visible rutting.

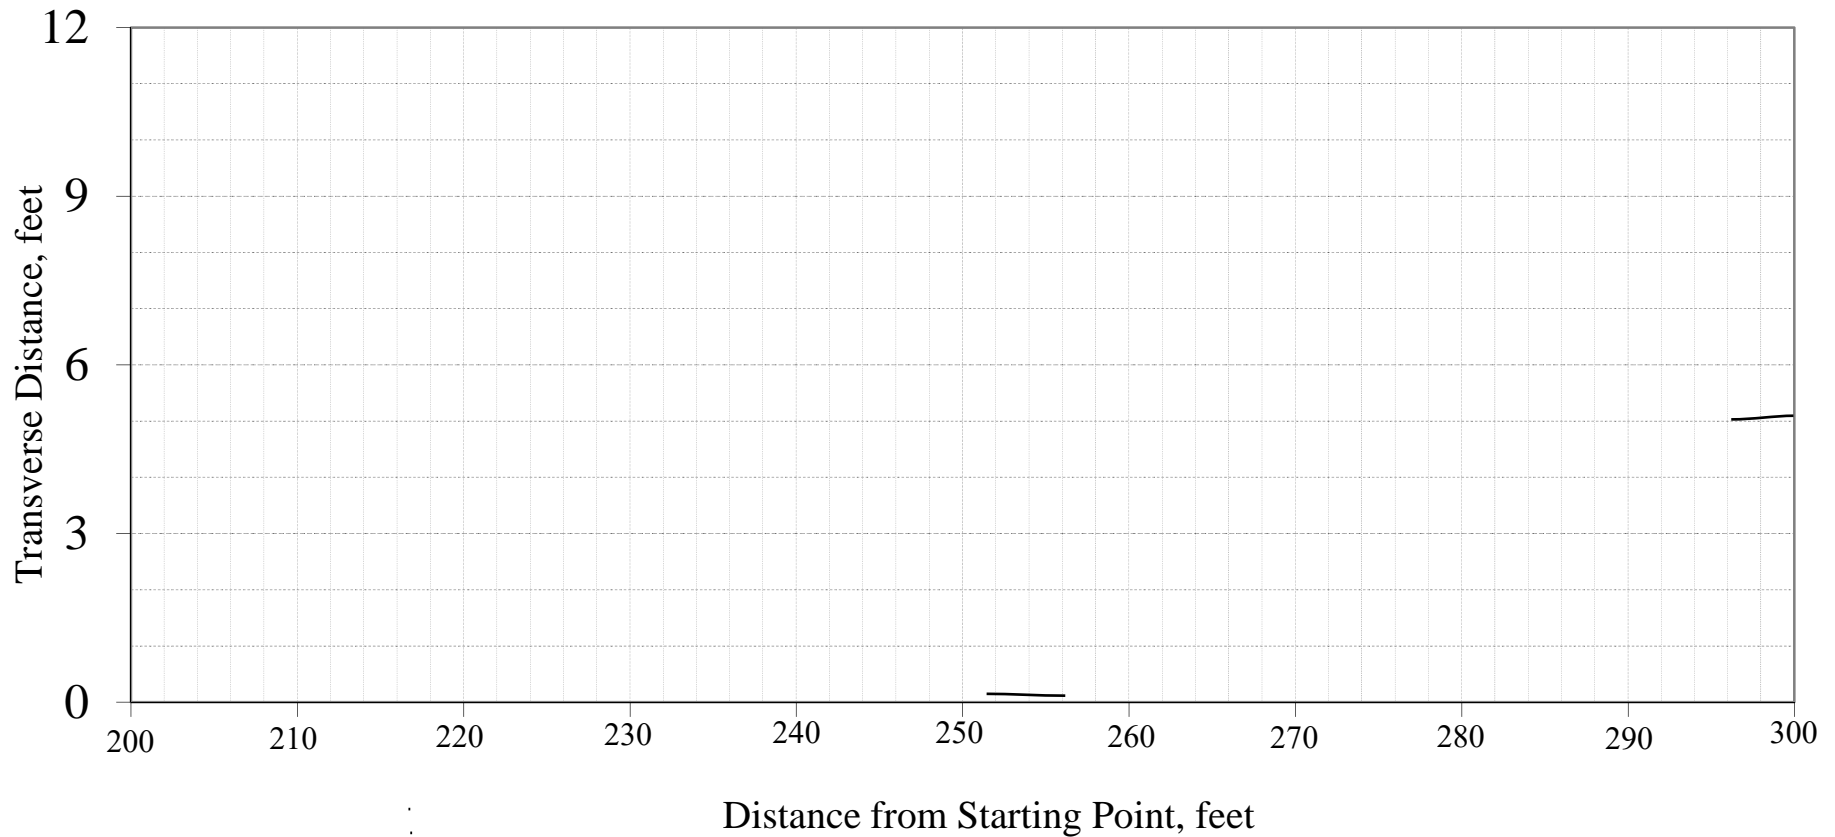
- Zero Mark is at the Torley Rd., right before the catch basin storm drain.
- All shown cracks on this page and subsequent pages have been sealed and are not visible.
- Survey was conducted from the roadside.
- Location and length of all mapped cracks are approximate.
- The road is in good shape. Raveling is minor,. There was no visible rutting.

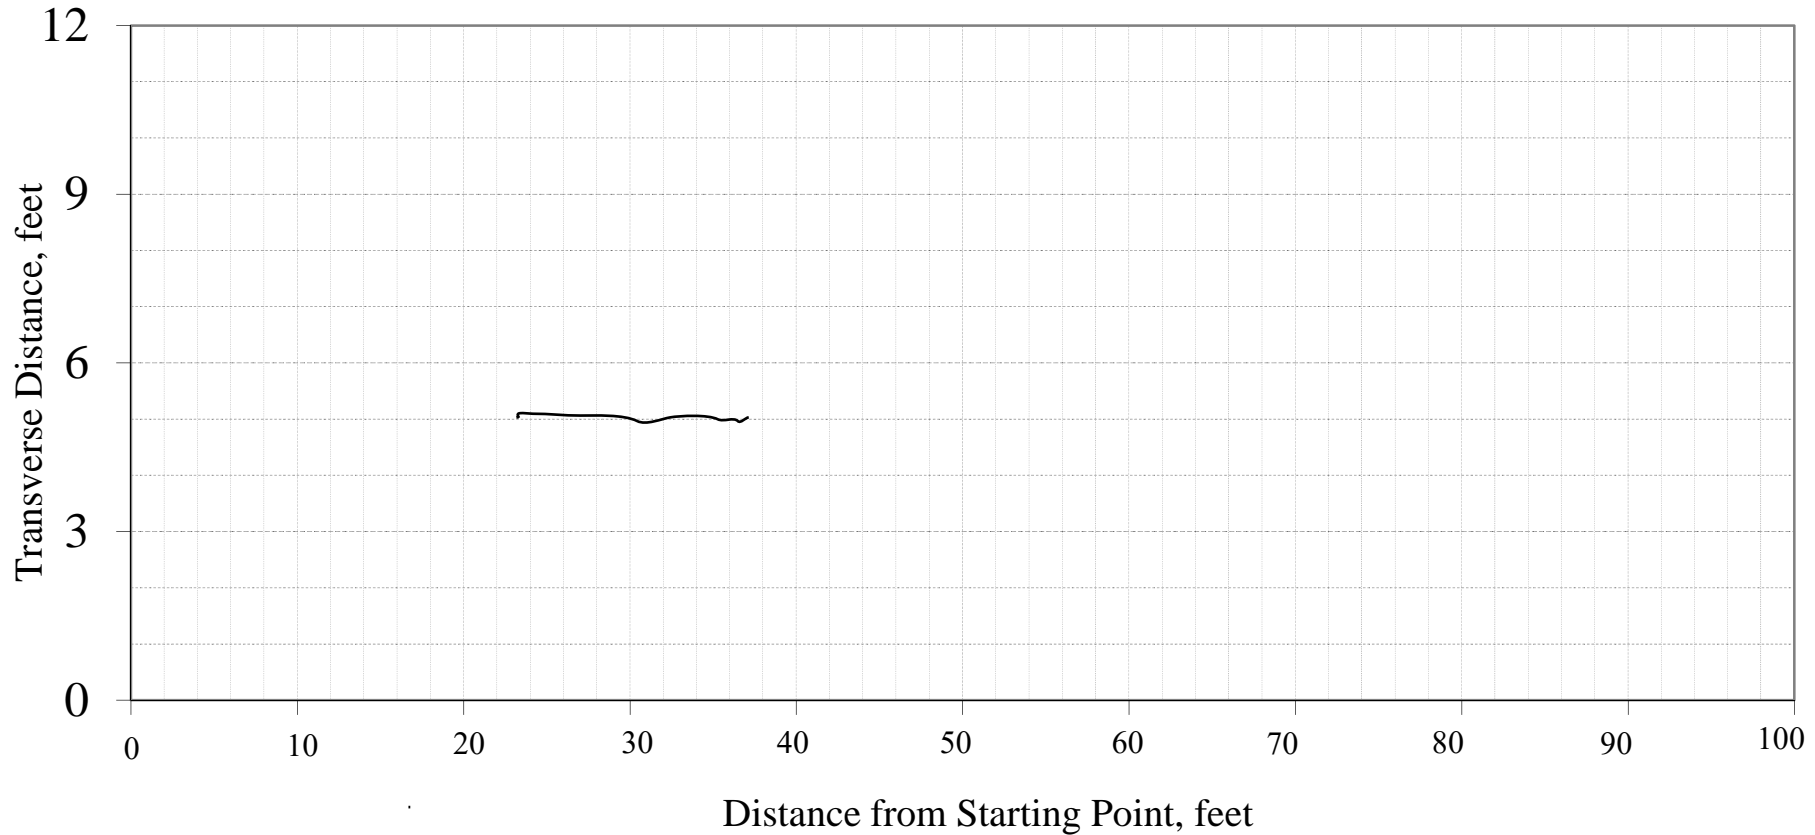
- Zero Mark is aligned with the wide cross walk white stripe at intersection with Loucks Rd.
- All shown cracks on this page and subsequent pages have been sealed and are not visible.
- Survey was conducted from the roadside.
- Location and length of all mapped cracks are approximate.
- The road is in good shape. Raveling is minor,. There was no visible rutting.

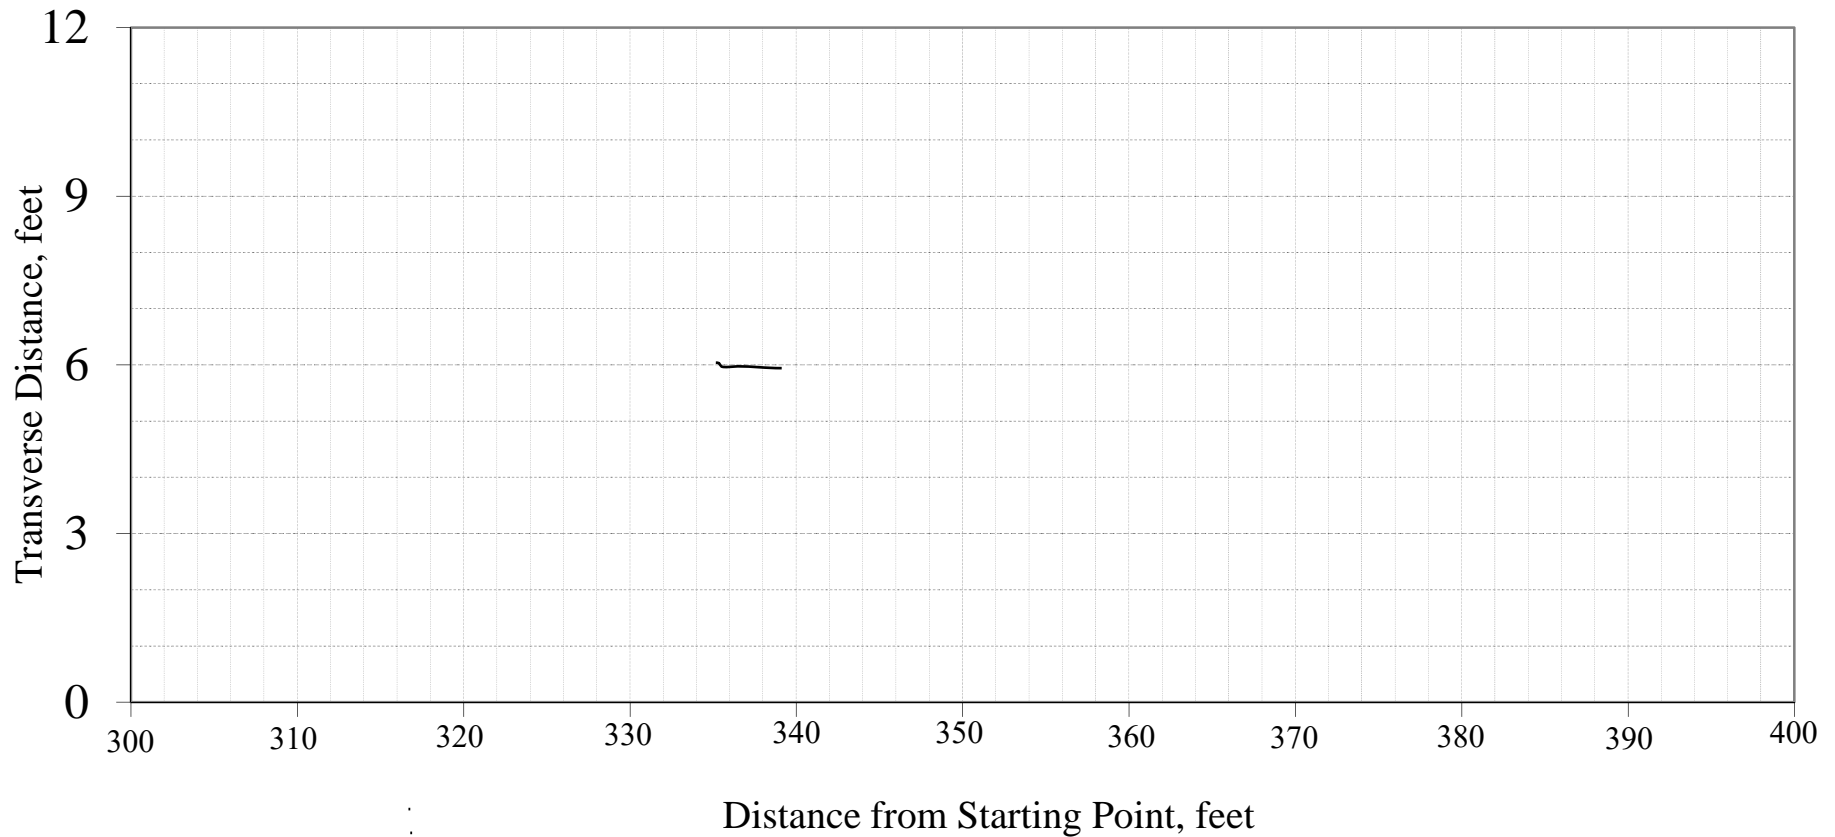
- Zero Mark is aligned with the wide cross walk white stripe at intersection with Loucks Rd.
- All shown cracks on this page and subsequent pages have been sealed and are not visible.
- Survey was conducted from the roadside.
- Location and length of all mapped cracks are approximate.
- The road is in good shape. Raveling is minor,. There was no visible rutting.

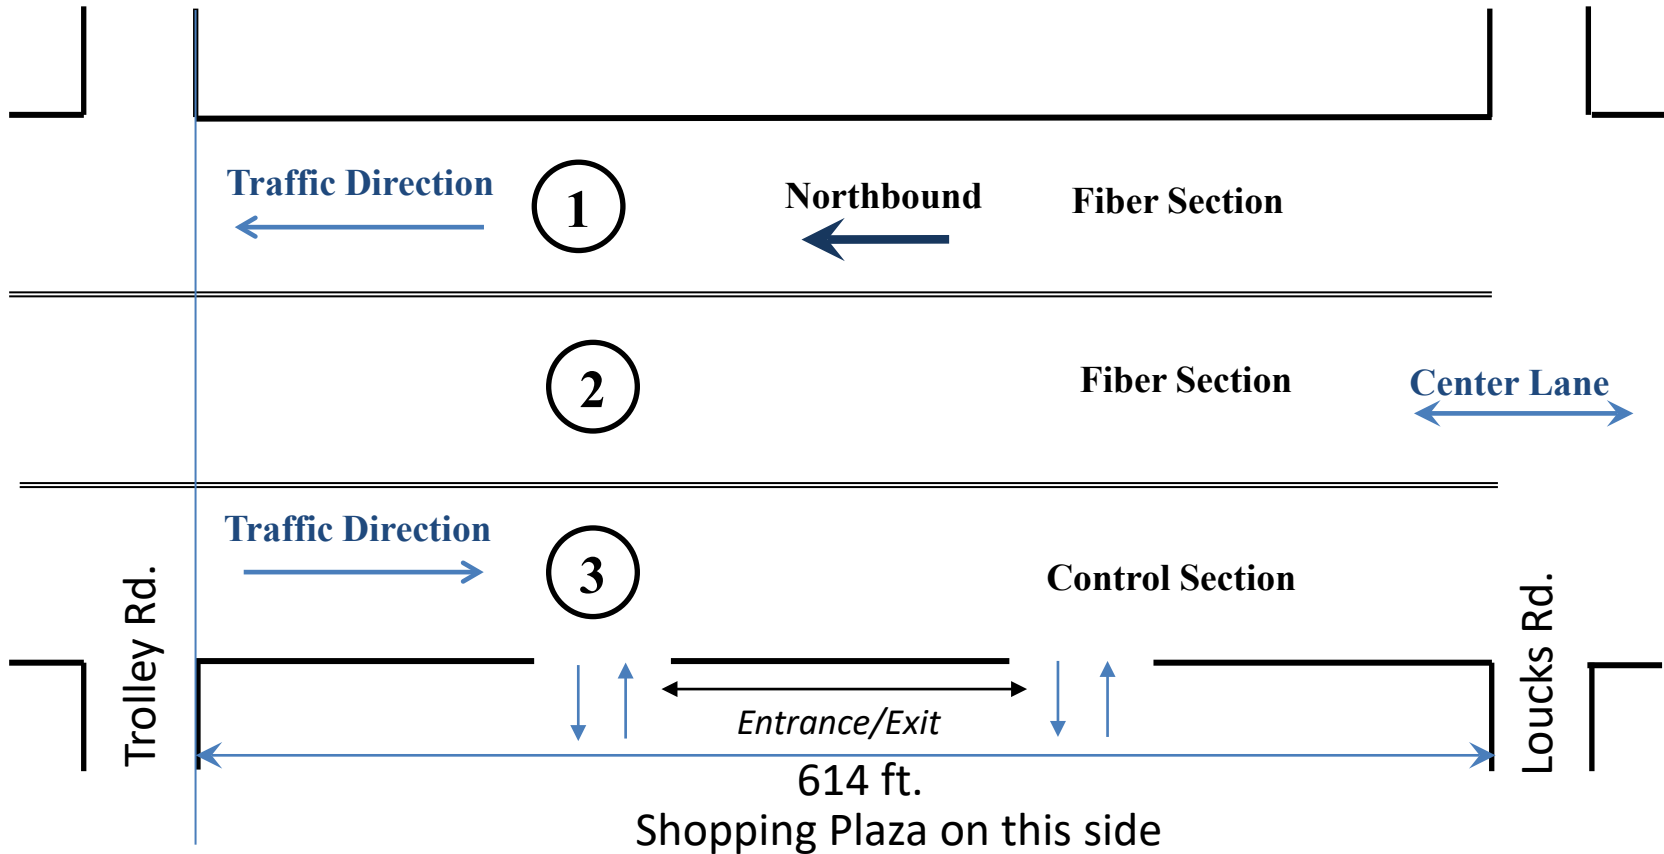
Appendix B: Micro Surfacing Site Layout

Paving Sequence: Numbers 1, 2, and 3 indicate sequence of micro surfacing

Two layers of type A micro surfacing were applied: a scratch layer and a top layer
Placement Date: July 7, 2020
