Resiliency of Prestressed Concrete Beams Exposed to Fire

FINAL REPORT (Revision 1)

June 30, 2023

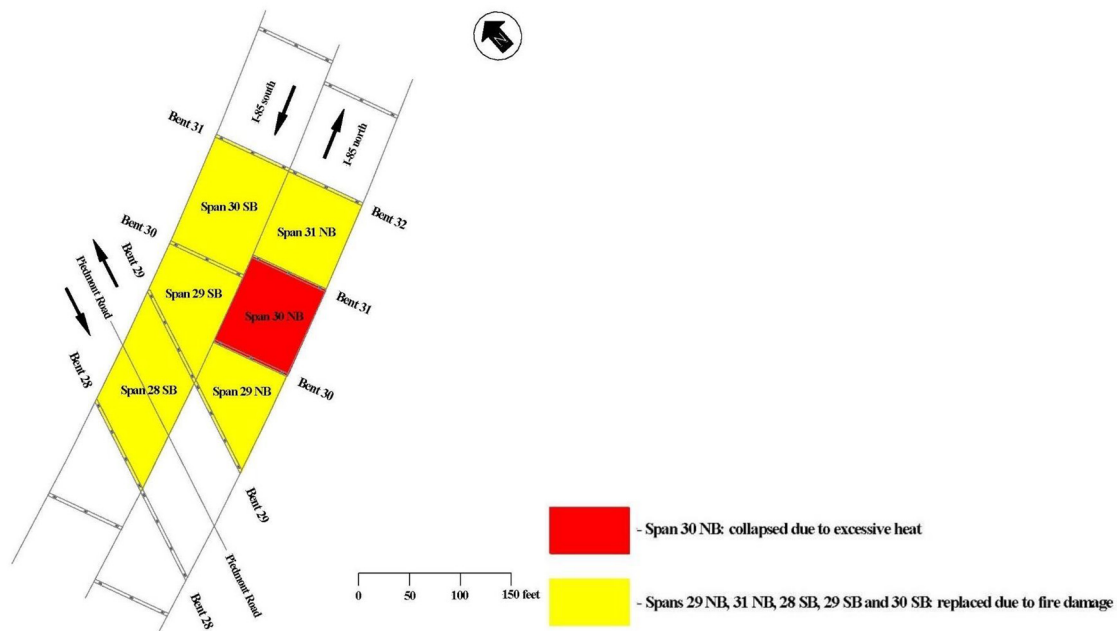
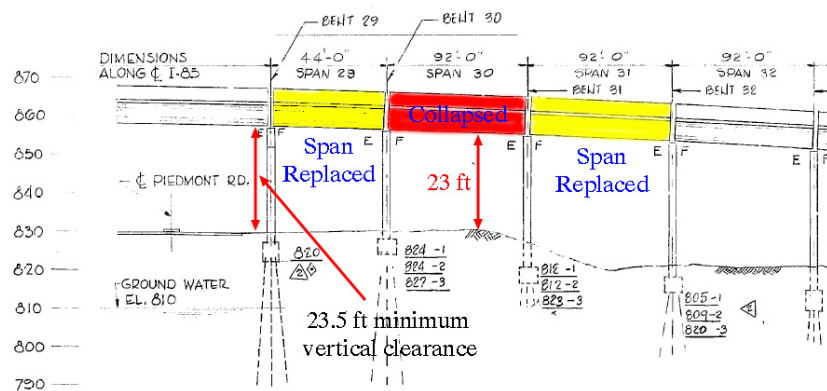
Figure 1: Location of the collapsed span and damaged spans of the I-85 highway interchange

In March 2017, a massive fire broke out beneath the I-85 highway interchange in Atlanta, Georgia, causing span 30NB (a 92 ft long elevated span) to collapse as illustrated in Figure 1. The fire, which burned for over an hour from 6:05 am to 7:14 pm [5], was fueled by construction materials stored under the bridge, including seventy-six high-density polyethylene conduits and nine racks of fiberglass conduit. The spans adjacent to the collapsed span, two in the northbound direction and three in the southbound direction, as shown in Figure 1, were removed following the event by Georgia Department of Transportation (GDOT) due to structural damage from thermal exposure. This incident led to a $15 million replacement project [22], caused widespread traffic disruptions, and raised concerns about the safety of aging infrastructure across the United States. It also highlighted the potential fire hazard associated with storing combustible materials in close proximity to bridges and other critical infrastructure.

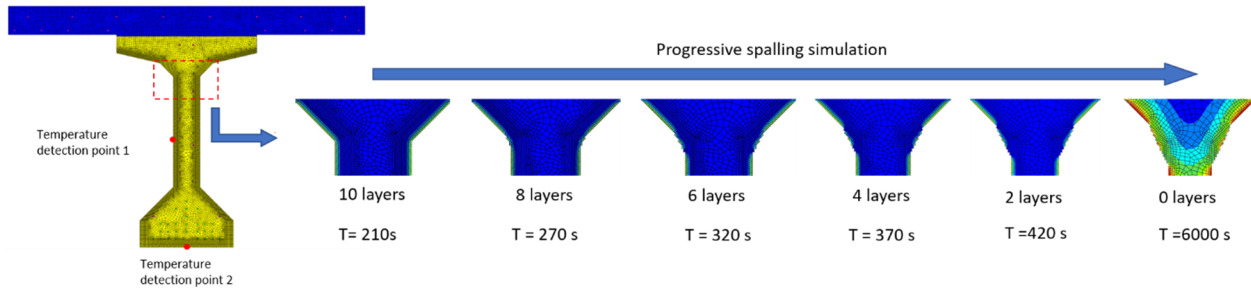
Figure 10: Thermal spalling process of the I-85 girder

The spalling process of the concrete cover for the entire cross-section is illustrated in Figure 10. To save the computation power, one layer or several layers of concrete cover is/are removed from the thermal analysis model consistently along the girder's perimeter if the spalling threshold is reached, as described in the previous section. The temperature at two locations, one on the web and one on the bottom surface of the girder, are recorded for spalling simulation. For example, if the average surface temperature of these two locations exceeds 450°C, then spalling is triggered. The concrete cover is spalled to the layer with an average temperature of 150°C. Figure 10 presents the spalling process as the girder is exposed to the heat flux time history in Figure 6. The region framed in the red dash line box is amplified to present the spalling process more clearly. In the analysis, the concrete cover first spalls at 210

sec (3 mins 30 secs) and requires the removal of the two outmost layers from the thermal analysis model. Subsequently, the spalling happened four additional times at t = 270 sec (4 mins 30 secs), 320 sec (5 mins 20 secs), 370 sec (6 mins 10 secs), and 420 sec (7 mins); the thermal demand required that two layers of the concrete cover were removed at each of these time steps. Once the steel reinforcement layer was reached, no additional removal was conducted at that location. Some strands, such as those located at the bottom of the flange, are directly exposed to the thermal impact, resulting in a significant temperature increase in the following heat/spall process.

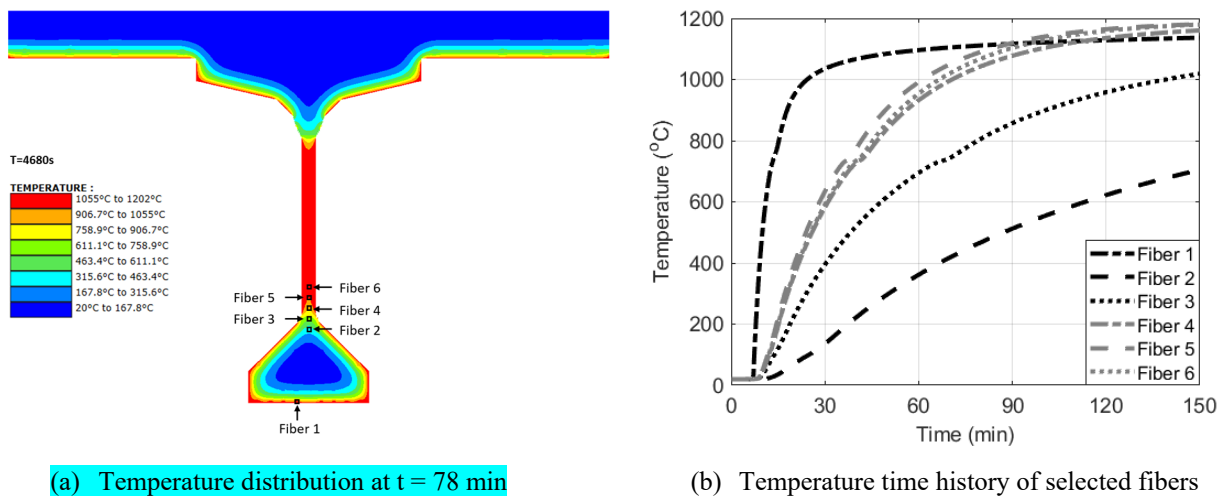
Figure 11: Thermal analysis result of the prestressed girder of element 30

Figure 11a illustrates the temperature distribution of the spalled concrete girder 14 ft from the middle span (element 30) at 78 min after the fire starts, while Figure 11b presents the temperature-time history curve for selected strand fibers. It could be noticed that the temperature elevation of all the strand fibers accelerates around 7 minutes after the fire starts, which is consistent with the time that the whole concrete cover is spalled from the girder, according to Figure 10. The temperature of Fiber 1, which is located at the bottom of the girder cross-section, increases dramatically since it is directly exposed to the fire. Around the time that the bridge collapsed (1 h 9 min), Fiber 1 has reached 1150°C, which could reduce the strength to less than 1% of the strength at normal temperature. For the strand fibers harped into the web (i.e., Fiber 4 to Fiber 6), the temperature increase is not as intense as Fiber 1 but still reaches 1000°C, which also compromises the strands after 1 hr of heating. Fibers 2 and 3, which are located at the junction of the bottom flange and the web, are protected by more concrete. Correspondingly, the temperature of these two elements reaches 400°C and 720°C, respectively, yielding their strength to 13% and 3% of the strength at normal temperature. In general, the harped strands in the region from 0.6L-0.8L located in the web of the concrete girder experience a temperature exceeding 900°C (could be indicated by the orange color in Figure 11a), which does impact their strength and the capacity of the PS concrete girder.

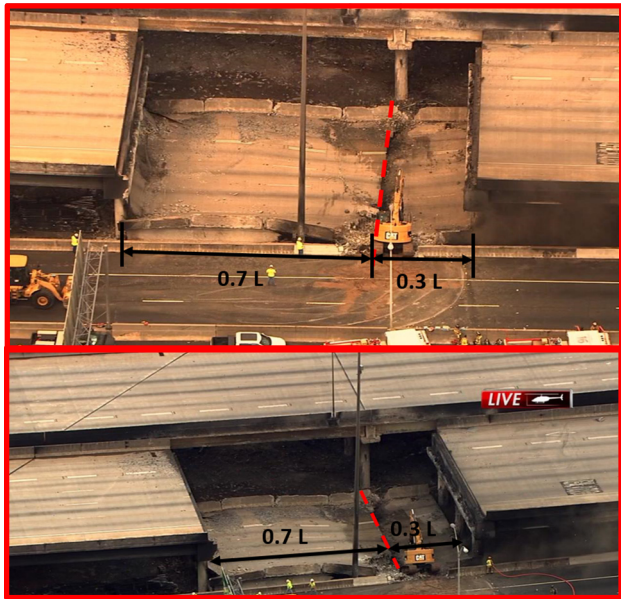
(b) Observations of damage location

The uniformly distributed load calculated per Table 1 is applied onto the target fiber element girder, as shown in Figure 5, for structural analysis. The entire girder is engulfed in the flame. This gravity load is conservatively assumed to be constant throughout the fire event. The boundary condition is idealized as a pin-roller for the simply supported beam, as shown in Figure 15a or Figure 9. The deformation of the girder at 78 min at 10x magnification is presented in Figure 15a. It is the time interval that no convergence is captured in the finite element analysis and can be considered as the failure time of the bridge. It is close to the collapse time of this bridge span in the fire hazard in 2017, which is 1 hour and 9 minutes. The deflection time history at midspan is shown in Figure 16. It can be noticed that at the beginning phase of the fire loading, the displacement equals zero since the prestressed strands provide an equivalent distributed load upward. Before the whole concrete cover is removed from the model, the cross-section of the PS concrete girder retains its stiffness and moment capacity since the temperature of the strand is low. Once the concrete cover is removed (around 7 minutes per Figure 11b), the temperature of the directly exposed strands elevates significantly, which decreases the capacity of the PS concrete girder. It is not very obvious but still remarkable that the discontinuity of curvature at the location of element 30 circled in Figure 15a. This location is close to the presumed failure location of span 30NB (at 30% of the span length from the pier) that collapsed in the fire hazard, as shown in Figure 15b.

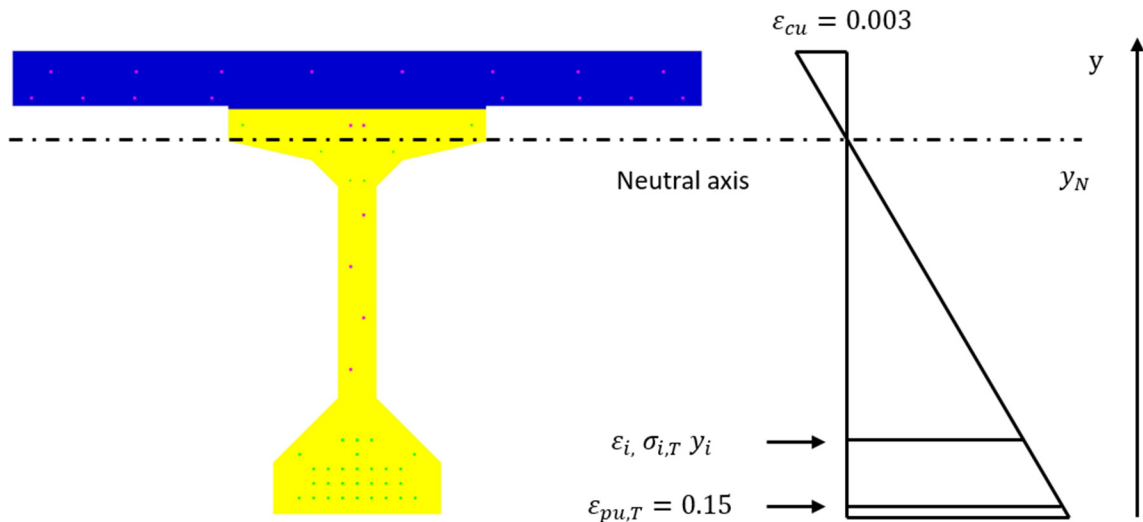
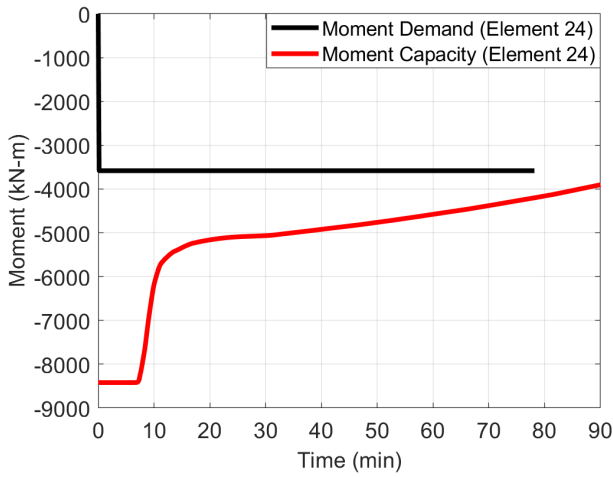
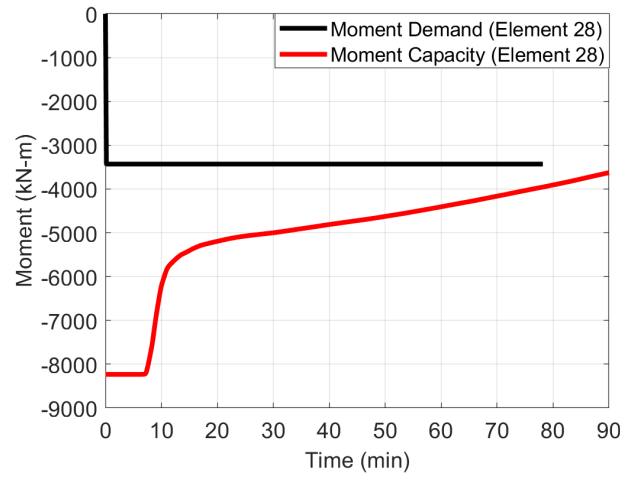
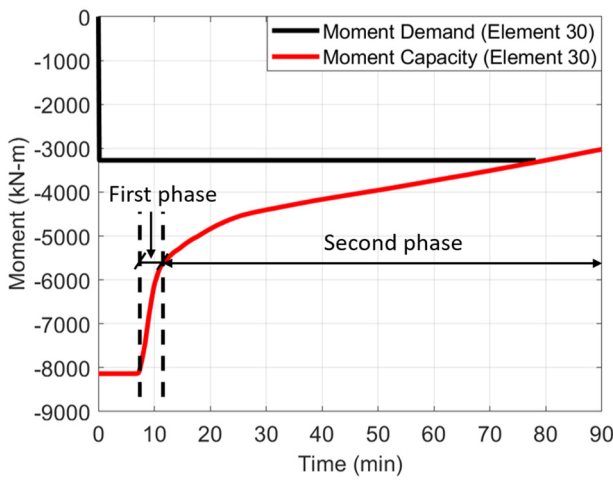
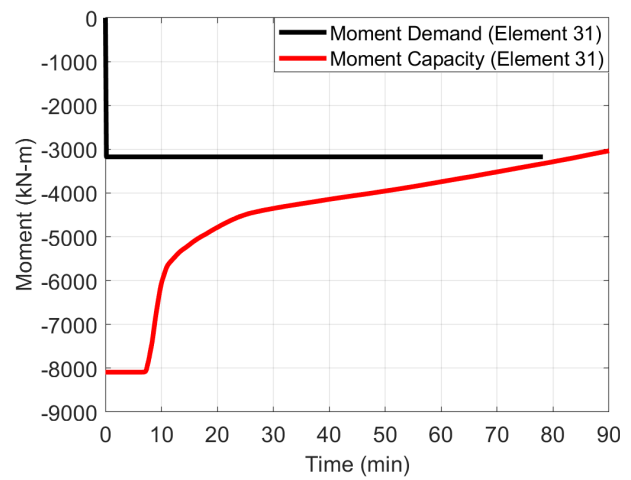
Figure 20: Moment capacity vs. demand time history for selected elements

The moment capacity of the cross-section gradually decreases when exposed to fire hazards, especially after the concrete cover is removed due to thermal spalling. Figure 20 plots the changes in moment demand vs. capacity with time for selected elements. The moment capacity of th

e "kink" element 30 (Figure 20c) drops to the demand value at the time of flexural failure. For all the cross-sections, the first significant drop (per Figure 20c) in moment capacity occurs right after the full removal of the concrete cover at 7 mins due to the direct exposure of the strand at the bottom location (which experiences significant temperature increase per Figure 11). The second and more minor decrease is attributed to the loss of stress of other strands embedded in the concrete. Compared to element 24 at midspan, the rate moment loss at the "kink" element 30 at the second phase is larger (i.e., approximately 34.6 kN-m/min for element 30 vs. 20 kN-m/min for element 24) since the harped strands in the web experience higher temperatures due to increased thermal penetration. Element 28 does not reach the failure threshold since the harped strands are still in the bottom flange and protected by more concrete. Element 31, which is next to element 30, also has a high potential of failure since its capacity almost reaches the demand value at the failure time. Though the harped strands of element 39 also experience high temperatures, the moment demand for this location is not significant, which makes this element not as critical as element 30. Per Figure 21, which shows the moment capacity vs. demand along the girder, the critical region in which the capacity decreases to the demand value is framed with a gray dash box. In summary, this numerical simulation approach can effectively predict the failure time and detect the failure location of span 30NB.

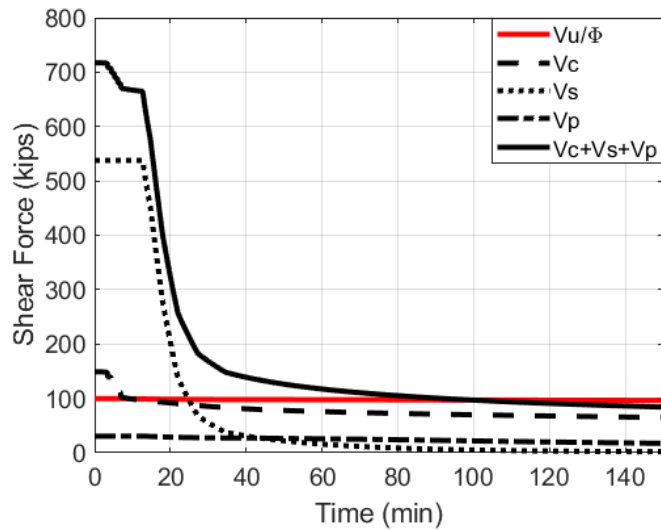
Figure 23: Shear capacity and demand at the cross-section near the support

The shear capacity time history at the critical location near the support is plotted in Figure 23 against the components of shear capacity. The capacity contributed by concrete (V_c) decreases in the first 10 min due to the spalling of the concrete cover at the bottom flange. With thermal penetration, the compression strength gradually decreases, reducing shear capacity. The vertical reinforcement provides the largest portion of the shear capacity (V_s) at ambient temperature. However, once the concrete cover of the flange is spalled, this portion is significantly reduced since the high temperature exposure compromises the vertical reinforcement. Though small, the portion contributed by the harped strands is not significantly influenced since those strands are in the top flange of the girder at this location and are well protected by the thicker concrete around them. Figure 23 shows that the shear capacity of the prestressed girder is significantly impacted in the fire hazard but is not indicate as the governing failure mode of the span 30NB bridge in the 2017 fire hazard since it requires a longer time (1 hr 39 min) to be reached. Moreover, the location of shear failure would be closer to the support rather than the observed failure location at $0.3L$ from the support, as shown in Figure 15b.
