Corrosion Repair Strategies for Steel Girder Ends Using High Performance and Traditional Materials

FINAL REPORT

CONTRACT # 4400018535 / 511801
WORK ORDER # PIT 002

University of Pittsburgh
Civil and Environmental Engineering

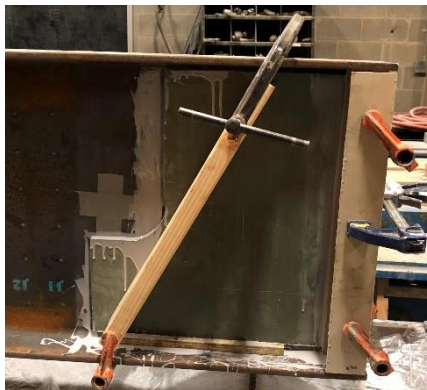
SSPC SP5 surface preparation

installation of FRP

completed FRP repair

Figure 46 GFRP repair detail for Girder 6.

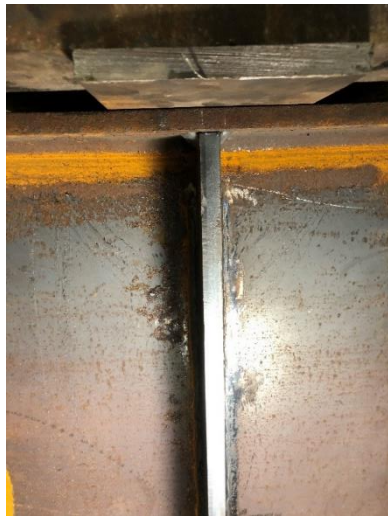
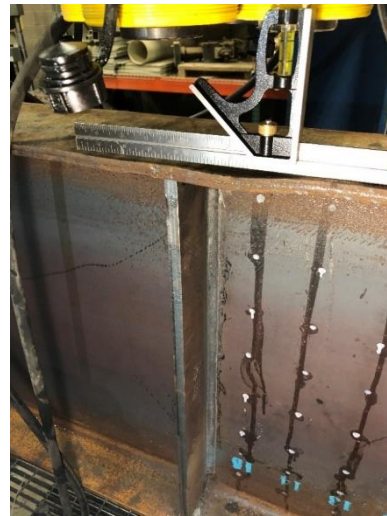
Figure 49 Girder 1A following testing.

Undamaged control Girder 1A behaved essentially as predicted, achieving a maximum shear capacity $V = 213$ kips ($v = 27.7$ ksi). This capacity corresponded to web yield beneath the applied load (260 kips applied over a 5 in. length of flange); this is shown in Figure 49. The predicted capacity based on this limit state was an applied load of 256 kips or shear of 210 kips. Nonetheless, strain data (Figure 48) indicated that web buckling had also just initiated at this capacity.

a) yield lines expressed in mill scale under point of application of load

b) distortion of top flange associated with web yield under point of application of load

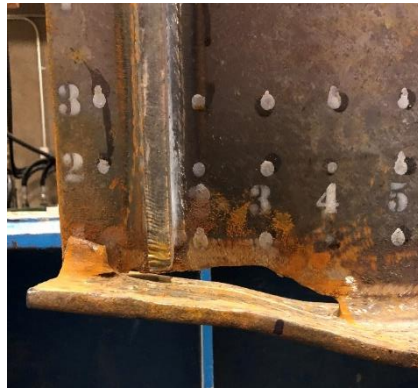
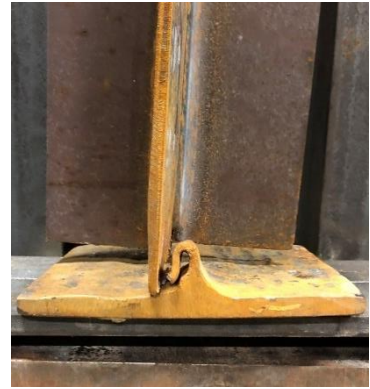
Figure 50 Girder 2A during and after testing.

Unrepaired corroded Girder 2A exhibited little capacity, achieving a shear resistance of barely 7% of 1A: $V = 15.1$ kips ($v = 2.0$ ksi). In this girder, shown in Figure 50, the bearing capacity was provided almost entirely by the bottom flange bending about its weak axis. The web collapsed and some residual capacity was observed at displacements exceeding 0.75 in. (Figure 47) as the hole in the web physically closed and began to bear again on the flange.

b) residual distortion of bearing region after testing

c) complete collapse of the web

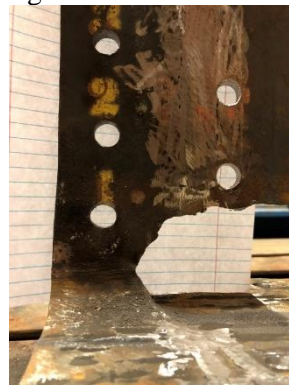
Figure 51 Girder 3A following testing.

Girder 3A demonstrated a conventional bolted steel repair. The girder capacity was effectively restored to approximately that of 1A: $V = 197$ kips ($v = 27.3$ ksi). 3A exhibited very clear web buckling in the unstrengthened region of shear span as shown in Figure 51. Following testing, the bolted stiffeners were removed (Figure 51d); no web distortion or collapse was observed although a few of the bolt holes appear to show evidence of bolt-bearing distortion ('ploughing').

a) bearing region following testing

b) web distortion following testing and removal of stiffeners

c) web buckling

d) bearing region following testing and removal of stiffeners

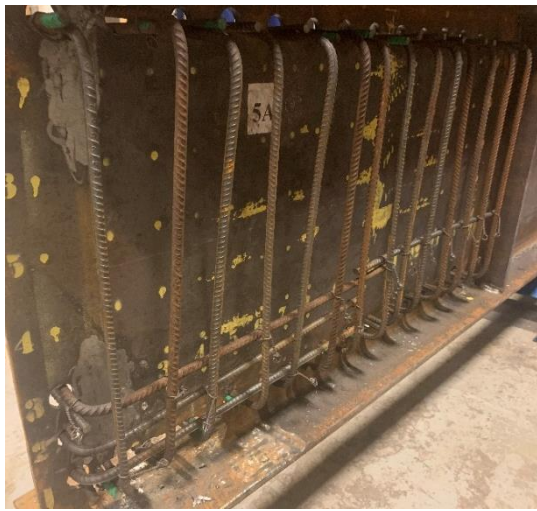
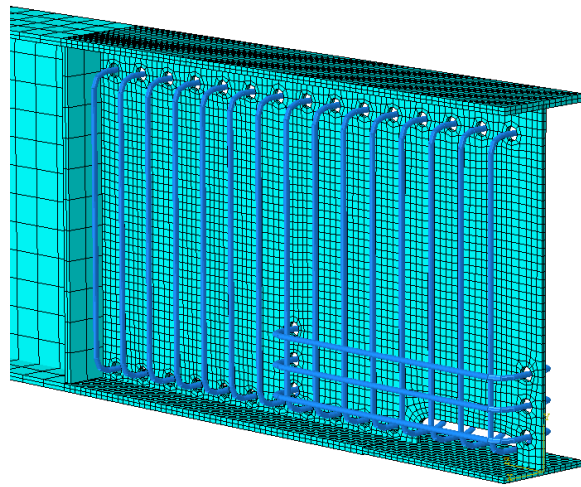
Figure 66 Modeling internal reinforcing steel of Girder 5A.

a) Girder 5A

b) ABAQUS model with concrete hidden

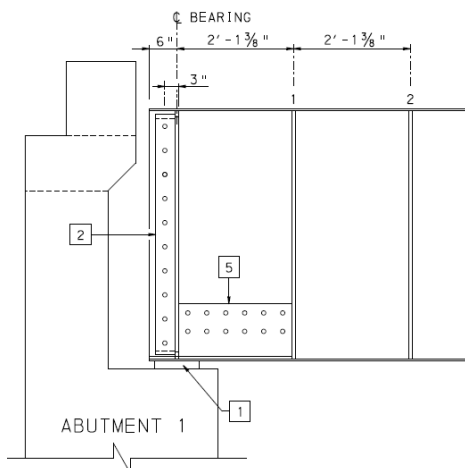
Figure 76 Bolted steel repair.

Not surprisingly, considering the significant stiffening effect of the repair, the FE-predicted capacity increased to 297 kips. At 297 kips, a tension field has clearly developed in the shear panel as can be seen in Figure 76b. The conservatively designed repair plates have mitigated web yield and crippling.

a) Bridge D repair (intermediate stiffeners are not modeled)

Bolted steel repairs are modeled in the same manner as described in Section 4.3.3. The repair details, shown in Figure 76a are those used to repair Bridge D in the field³³. The 7 x 5/8 in. bearing stiffeners are replaced with considerably stiffer L9.5x5x3/4 SLBB angles. Section loss to the lower region of the 3/8 in. web is repaired with 0.5 in. bent plates, extending 12 in. up the web and across the full width of the flange, on both sides of the web.

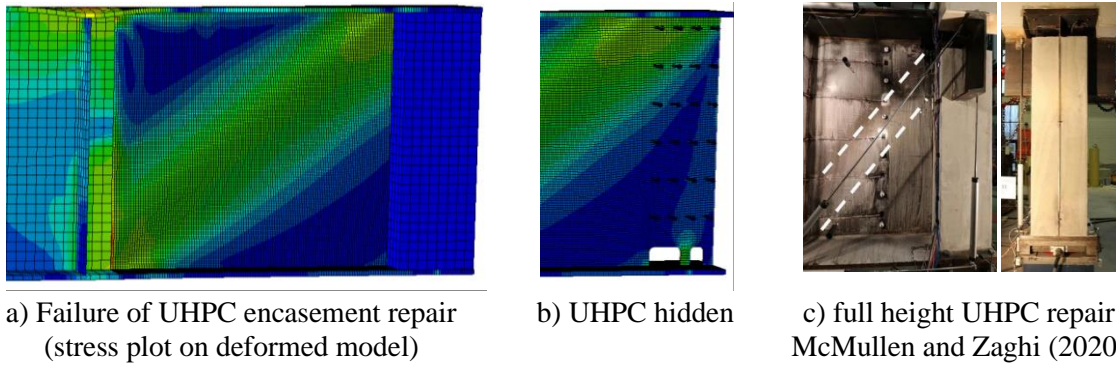
Figure 77 UHPC encasement repair.

The UHPC encasement modeled is similar to the full height repairs proposed and tested by McMullen and Zaghi (2020) and shown in Figure 77c. In this model, 19 ksi UHPC was modeled. The UHPC columns extend the full height of the web, the full breadth of the flanges, and 16 in. along the length of the beam. Four vertical rows of bolted studs are used in the undamaged region of the web (Figure 77b). The stud spacing is 8 inches vertically and 4 inches horizontally.

The FE-predicted capacity was 244 kips, exceeding the 183 kip capacity of the undamaged girder. As reported in McMullen and Zaghi, the model shows evidence that tension field action was being developed over the shorter shear panel bounded by the UHPC and bearing stiffener at the load point (Figure 77a).

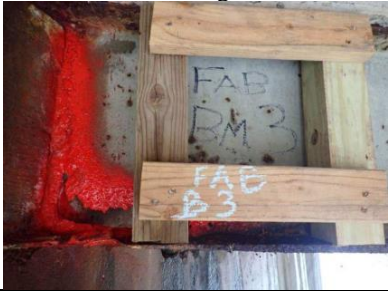
Near end	Beam	Far end
no report damage	1	no reported damage
no report damage	2	E-W1: C _L = 4; C _H = 1.75; t _{w min} = 0.375 (85%)
E-M3: b = 5; E-M4: b = 10; and associated web thinning adjacent holes 50% loss of flange over 5 in.	3	E-M4: b = 12; a = 3.5 E-W3: C _{L3} = 17; C _{L1} = 2; C _{H1} = 3.5; C _{H2} = H ₀ ; t _{w min} = 0.125 (28%) >50% loss of flange over 17 in.

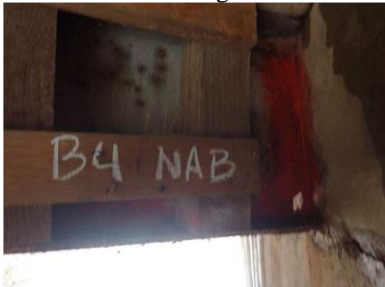
E-M4: b = 1; a = 1 E-W3: C _{L3} = 24; C _{L1} = 5; C _{H1} = 2; C _{H2} = H ₀ ; t _{w min} = 0.125 (28%) >50% loss of flange over 17 in.

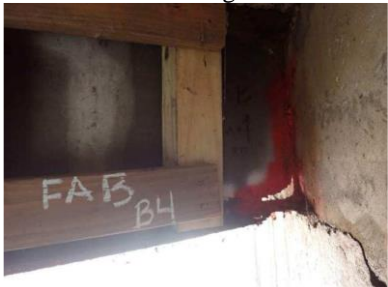
4	E-M4: b = 3; a = 1.5 E-W3: C _{L3} = 17; C _{L1} = 2; C _{H1} = 3.5; C _{H2} = H ₀ ; t _{w min} = 0.125 (28%) (away from M4) 100% loss of flange over 4 in.

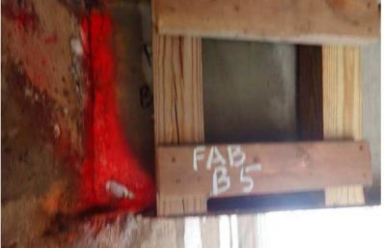
Near end	Beam	Far end
<p>E-W1: $C_{L1} = 12$; $C_H = 1$; $t_w = 0.125$ (28%)</p>	5	<p><i>E-M4: $b = 2$; $a = 2$</i> E-W3: $C_{L3} = 12$; $C_{L1} = 2$; $C_{H1} = 2$; $C_{H2} = H_o$; $t_{w \min} = 0.19$ (43%) (away from M4) 100% loss of flange over 4 in.</p>

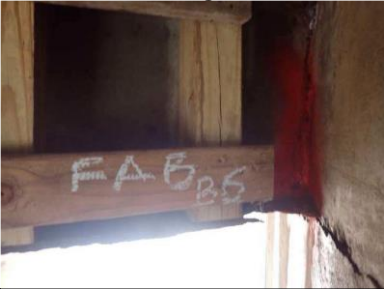
<p>E-W3: $C_{L3} = 5$; $C_{L1} = 2$; $C_{H1} = 3$; $C_{H2} = H_o$ $t_{w \min} = 0.06$ (14%) 12% loss of flange over 6 in.</p>	6	<p>E-W3: $C_{L3} = 12$; $C_{L1} = 1$; $C_{H1} = 2$; $C_{H2} = H_o$; $t_{w \min} = 0.125$ (28%) 85% loss of flange over 4.5 in.</p>

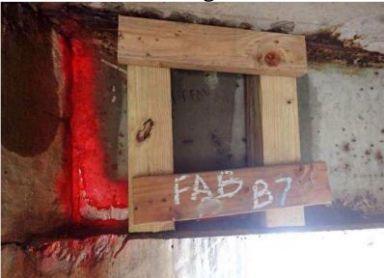
<p>E-W3: $C_{L3} = 8$; $C_{L1} = 3$; $C_{H1} = 3$; $C_{H2} = H_o$ $t_{w \min} = 0.25$ (57%) 100% loss of flange over 6 in.</p>	7	<p><i>E-M4: $b = 12$; $a = 2$</i> E-W3: $C_{L3} = 20$; $C_{L1} = 1.5$; $C_{H1} = 3$; $C_{H2} = H_o$; $t_{w \min} = 0.125$ (28%) (away from M4) 85% loss of flange over 4.5 in.</p>

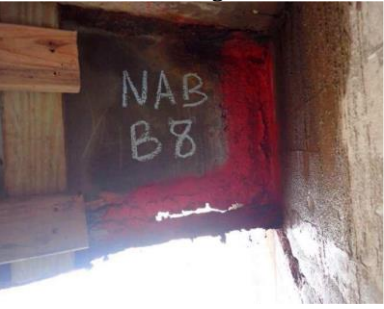
<p><i>E-M4: $b = 12$; $a = 1$</i> E-W1: $C_{L1} = 23$; $C_H = 3$; $t_w = 0.25$ (57%) 85% loss of flange over 7 in.</p>

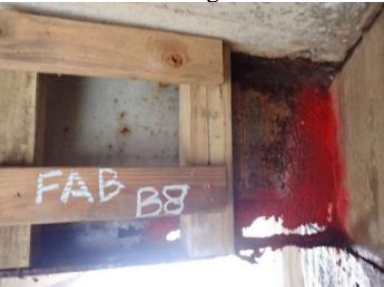
8	<p><i>E-M4: $19 = 12$; $a = 3$</i> E-W3: $C_{L3} = 26$; $C_{L1} = 6$; $C_{H1} = 3$; $C_{H2} = H_o$; $t_{w \min} = 0.125$ (28%) (away from M4) 75% loss of flange over 10 in.</p>

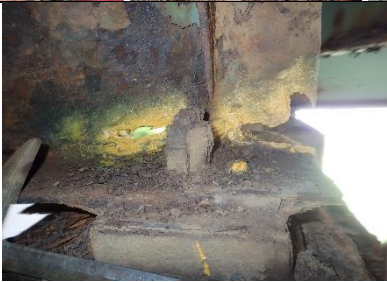
<p>Pier 3 Span 4 Beam 2</p>	<p>M1: $b = 4$; $a = 0.5$; inboard of bearing CL M1: $b = 3$; $a = 3$; end of beam</p>

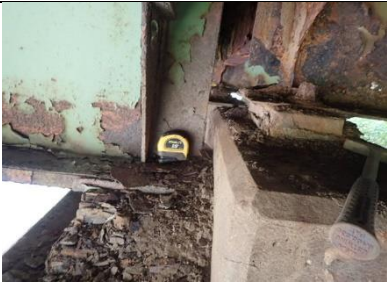
<p>Pier 3 Span 4 Beam 3</p>	<p>M1: $b = 3.5$; $a = 2.5$ span 3 girder end seen on left</p>

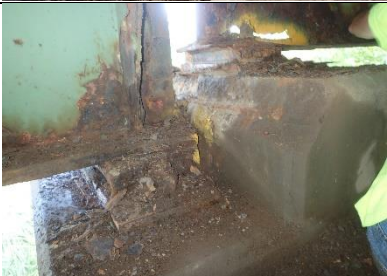
<p>Pier 3 Span 3 Beam 1</p>	<p>W1: $C_L \approx B_L$; $C_H \approx B_L/2$</p>

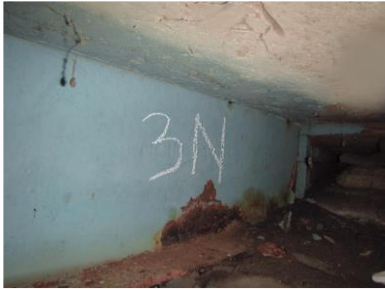
no measurable section loss

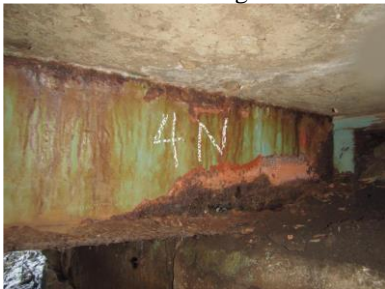
W2: $C_{L1} \approx C_{L2} \approx B_L$; $C_H \approx 3.5$; $t_w = 0.32$ (83%) 100% loss of bottom flange at end of beam

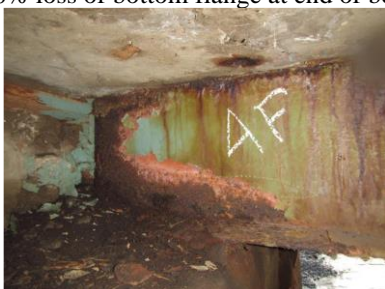
4	W3: $C_{L1} \approx B_L$; $C_{L2} \approx B_L/2$; $C_{H1} \approx 3.5$; $C_{H2} = 9$; $t_w = 0.32$ (83%) >50% loss of bottom flange at end of beam

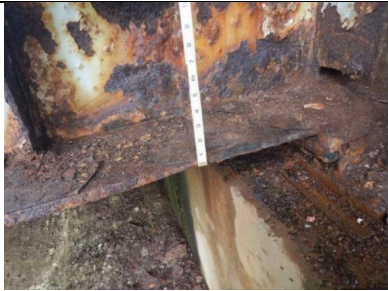
<p>Span 1 Girder 1 Near Abutment</p>	<p>M1: b = 5; a = 2; bearing stiffener W1: C_L ≈ 24; C_H ≈ 6</p>

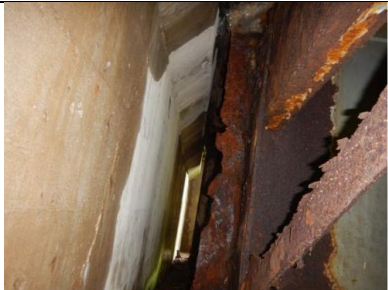
<p>Span 1 Girder 2 Near Abutment</p>	<p>M3: b ≈ 2; a ≈ 12; behind CL bearing W1: C_L ≈ 12; C_H ≈ 56</p>

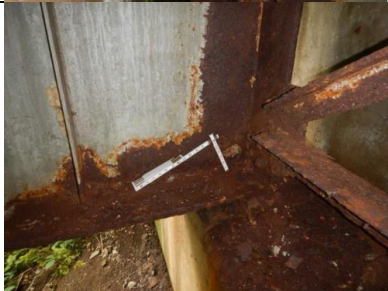
<p>Span 1 Girder 6 Near Abutment</p>	<p>M1: b = 3; a = 3 W4: C_{L1} ≈ 20; C_{L2} ≈ 40; C_{L3} ≈ 12; C_{H1} ≈ 6; C_{H2} ≈ 56;</p>

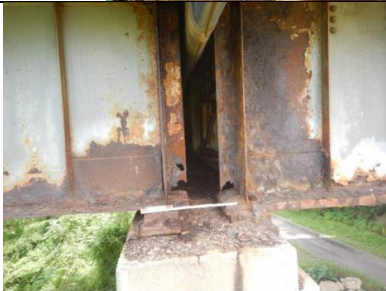
<p>Pier 3 Span 3/4 Girder 6</p>	<p>Span 3 M1: b = 6; a = 4 (web) M1: b = 6; a = 6; (bearing stiffener) W4: C_{L1} ≈ 24; C_{L2} ≈ 36; C_{L3} ≈ 6; C_{H1} ≈ 12; C_{H2} ≈ 56</p>

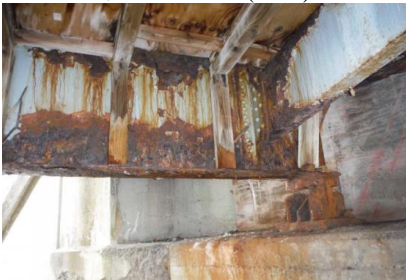
4	no reported damage
<p>W1: $C_L \approx 144$; $C_H \approx 24$ $t_{w \min} = 0.505$ (81%) $t_{bf \min} = 0.279$ (31%)</p>

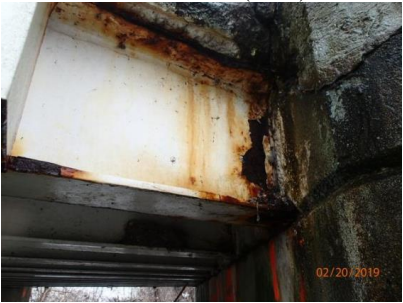
Near end	Beam	Far end
<p>E-W1: $C_L = 6; C_H = 12$ $t_{w \min} = 0.195$ (63%)</p>

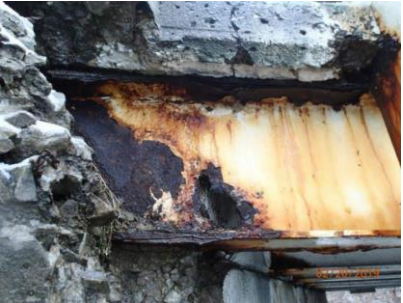
<p>1</p>	<p>M1: $b = 4; a = 6$ E-W5: $C_L = 20; C_H = 14$</p>

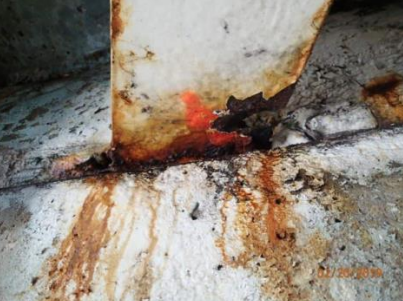
<p>no report damage</p>	<p>6</p>	<p>2" of 100% loss along the right bottom flange</p>

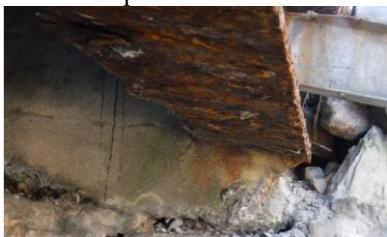
Near end	Beam	Far end
<p>E-W1: $C_L = 4.5$; $C_H = 14$ beam reported to be 'twisted'</p>

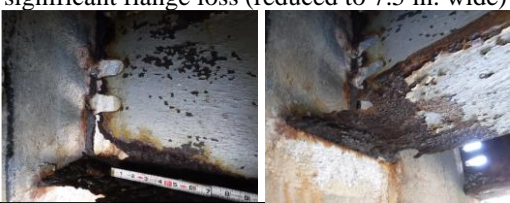
1	<p>E-W1: $C_L = 3$; $C_H = 14$</p>
<p>E-W1: $C_L = 5$; $C_H = 14$</p>	2	<p>E-W1: $C_L = 1$; $C_H = 9$ significant flange loss (reduced to 7.5 in. wide)</p>

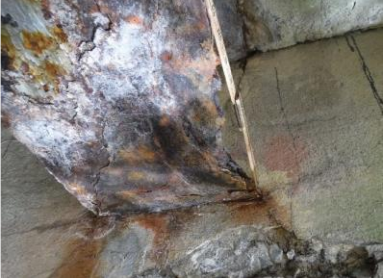
7	E-W1: $C_L = 3.5; C_H = 14$ section loss of bottom flange (reduced to 9 in.)

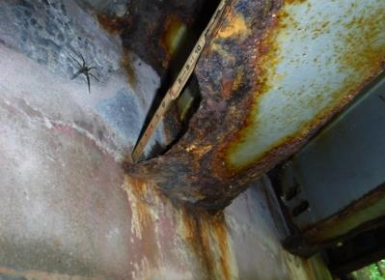
<p>9" of 100% section loss to bottom flange</p>

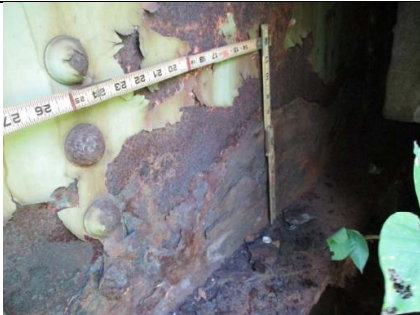
Near Abutment Span 1 Girder 1	<p>W2: $C_{L1} = 132$; $C_{L2} = 12$; $C_H = 9$ $t_{w \text{ min}} = 0.493''$ (72%) $t_{bf \text{ min}} = 0.975''$ (89%)</p>

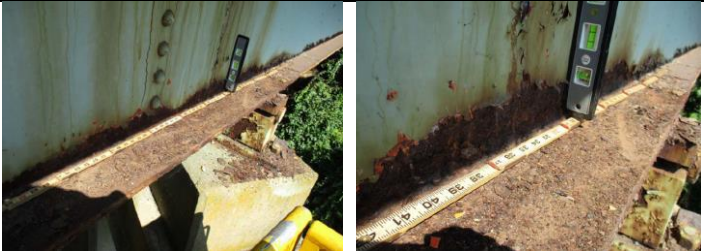
Near Abutment Span 1 Girder 8	<p>W1: $C_L = 84$; $C_H = 6$ $t_{w \text{ min}} = 0.375''$ (55%) $t_{bf \text{ min}} = 0.538''$ (49%)</p>	
Pier 1 Span 2 Girder 1	<p>W1: $C_L = 96$; $C_H = 5$ $t_{w \text{ min}} = 0.493''$ (72%)</p>	
Pier 2 Span 2 Girder 14	<p>W1: $C_L = 120$; $C_H = 3$ $t_{w \text{ min}} = 0.493''$ (72%) $t_{bf \text{ min}} = 0.913''$ (83%)</p>

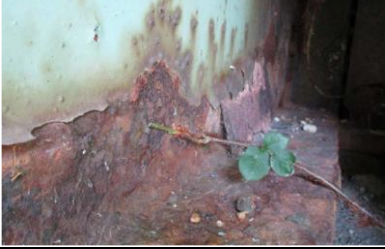
Far Abutment Span 3 Girder 1	<p>W1: $C_L = 36$; $C_H = 3$</p>	
Far Abutment Span 3 Girder 7	<p>W1: $C_L = 132$; $C_H = 3$</p>	
Far Abutment Span 3 Girder 14	<p>W3: $C_{L1} = 12$; $C_{L2} = 120$; $C_{L3} = 132$; $C_{H1} = 9$; $C_{H2} = 34$; $C_{H3} = 9$ $t_{w \text{ min}} = 0.493''$ (72%)</p>

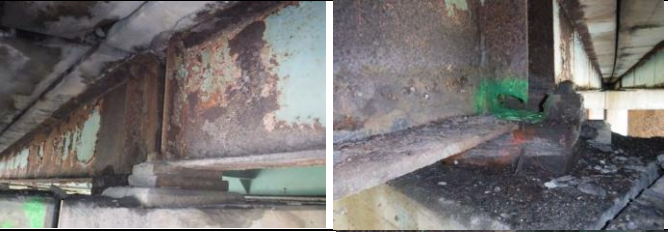
<p>Near Abutment Span 1 Girder 7</p>	<p>beam end corrosion noted, no other details provided</p>	
<p>Pier 1 Span 1 Girders 6/7</p>	<p>beam end corrosion noted, no other details provided</p>	
<p>Pier 2 Span 2/3 Girder 6</p>	<p>M1: b = 4; a = 2 (bearing stiffener) M1: b = 2; a = 1.5 (web) W1: C_L = 48; C_H = 30</p>

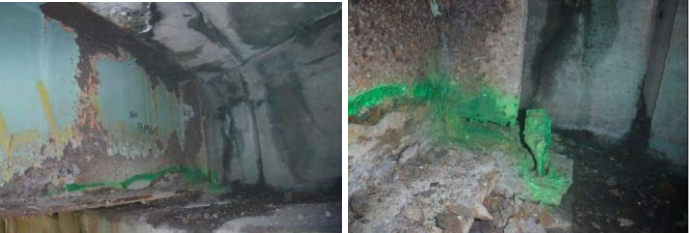
<p>Far Abutment Span 4 Girder 6</p>	<p>M1: b = 5; a = 2 (bearing stiffener) W5: C_L = 60; C_H = 24</p>
