# Development of a Strategic Plan to Upgrade Stations on the Keystone Corridor

Final Report

JULY 7, 2009

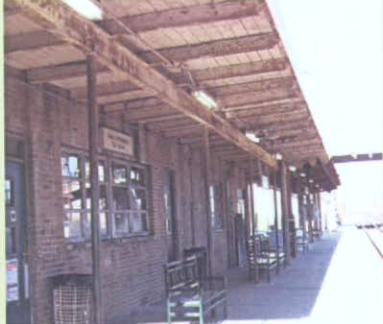
The eastbound platform at Paoli Station has a station building constructed of brick. The building appears to be in good/fair condition. Six metal benches are provided outside under the cover of the station canopy. Additional benches are provided inside the station building provided an estimated seating capacity of at least 50 passengers.

Seating and Shelter – Eastbound Platform		
	Outside Seating	Station Building Shelter
Type	Metal benches	Wooden benches
Condition	Good	Good
Quantity	Six	Eight
Covered	Yes	Yes
Photograph

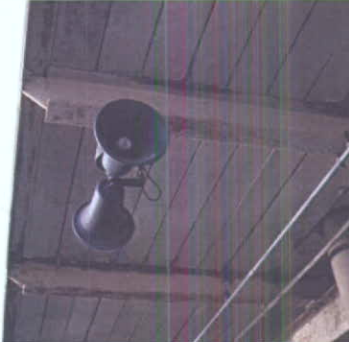
A public address system is located under the platform canopy roof. Six speakers were observed. The system appears to be operational; however, no announcements were heard during the site visit.

Schedule and Public Address Speaker – Eastbound Platform		
	Schedule	Public Announcement
Type	Paper attached to bulletin board	Six speakers
Condition	Good	Not observed
Clarity	Good	Not observed
Secured	No	Yes
Photograph

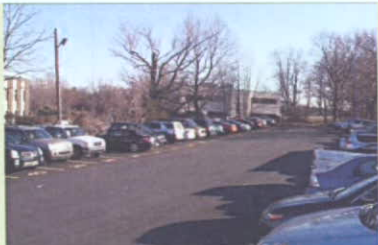
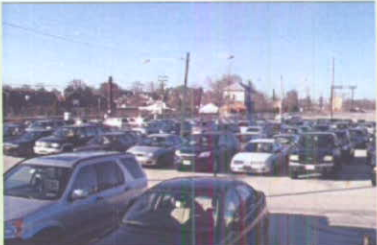
The travel lanes in this parking lot are approximately 24 feet wide. Parking spaces are approximately nine feet by 20 feet and they are clearly delineated. The surface of the parking lot is in good condition. Access to this lot is from North Valley Road. No curbing is located within this parking lot.

Parking/Loading – Westbound Platform		
	Parking Adjacent to Westbound Platform	“Permit” Parking Lot
Total Spaces	46	291
Handicap Spaces	0	0
Surface Type	Asphalt	Asphalt
Curbing	No	No
Condition	Good	Good
Dimensions- Parking stall	Nine feet by 18 feet	Nine feet by 20 feet
Interior Travel Lanes	20 feet	24 feet
Lot Access	24 feet	22 feet
Fair Box	Yes	No
Daily Fee	\$1.00	N/A \$20 per month
Parking Overflow	No	No
Passenger Loading	No	No
Photograph

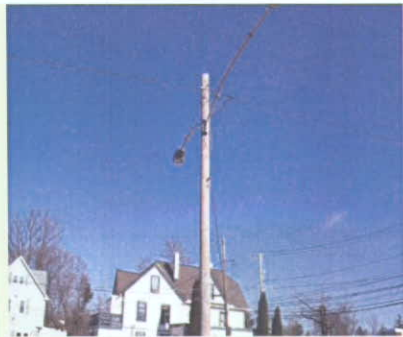
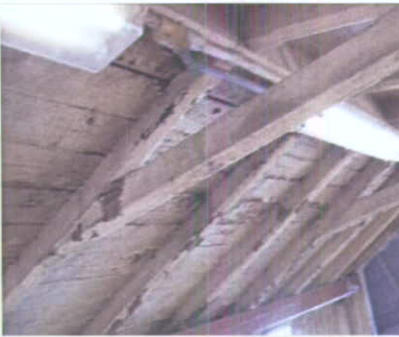
Beyond the lighting for the platform areas, site lighting includes fixtures for the parking lots and pedestrian circulation areas. The parking lots adjacent to the eastbound and westbound platforms have three metal poles centrally located to their respective lots. Overall, these parking lots are lit well. In addition to parking lot lighting, fixtures are situated at the stairs to the westbound platform. In addition, there is roof-mounted lighting at the eastbound station building.

Site Lighting		
	"Permit" Parking Lot	Stairway to Westbound Platform
Type of Light Fixtures	Incandescent	Florescent
Number	Six	Three
Condition	Good	Good
Photograph

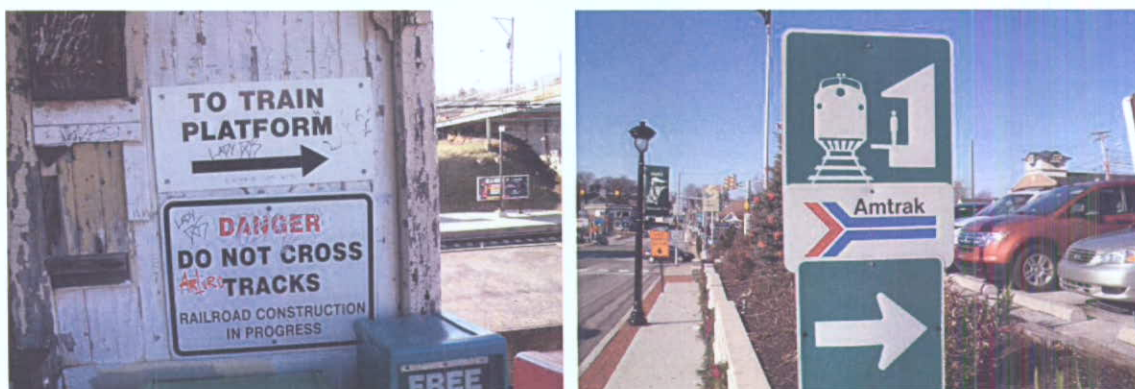
In addition to the signage located on the platforms, there is also signage along Lancaster Avenue and North Valley Road. There is a large freestanding sign at the Lancaster Avenue entrance to the parking lots identifying the SEPTA Station. Some of the informational signs for the parking lots are weathered and in need of restoration.

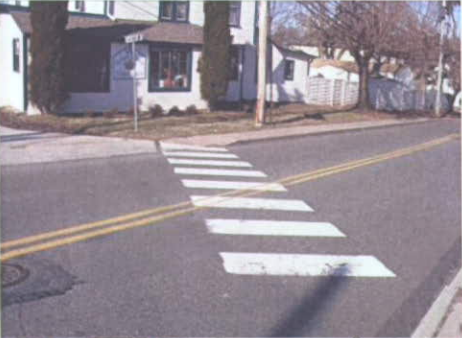
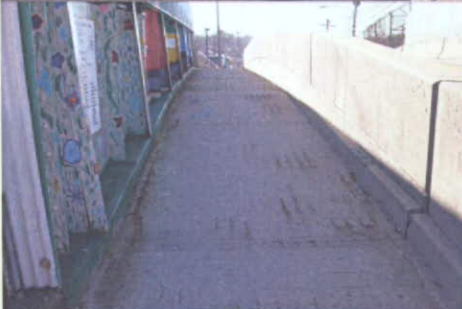
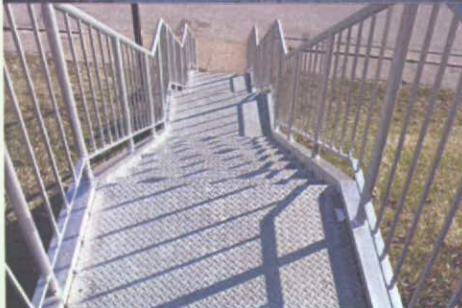
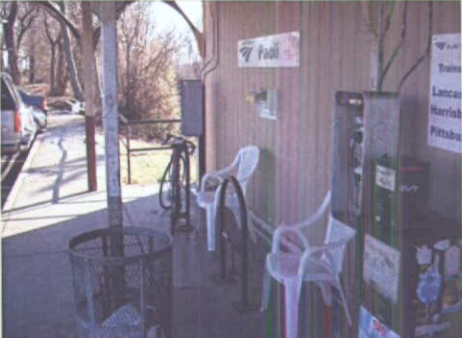
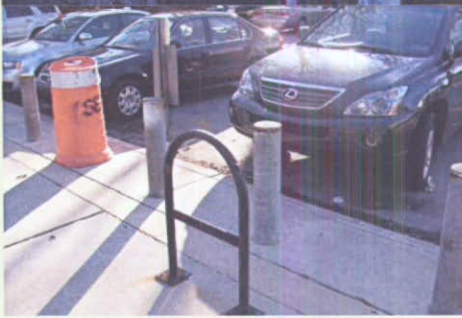
Connecting the parking lots to the platform areas are crosswalks and stairs. On the eastbound side, there is a sidewalk along the parking lot providing direct access to the stairway from the North Valley Road Bridge and Lancaster Avenue.

Two bicycle racks are provided near the westbound platform and one near the eastbound platform area.

Sidewalks/Pedestrian Amenities		
	Circulation	Other
Type	Sidewalks, crosswalks Stairways North Valley Road bridge	Bicycle racks
Condition	Sidewalks – Good Stairways - Good North Valley bridge - Fair	Good
Dimensions	Sidewalks – four to six feet wide North Valley bridge – four feet wide	N/A
Photograph

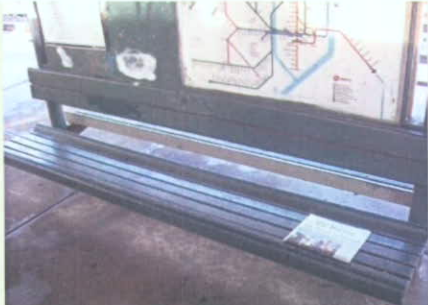
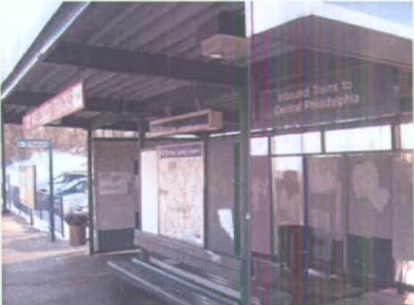
off. Both benches are 9.5 feet in length by 1.5 feet deep. The bench and shelter conditions are summarized as follows.

Platform Seating – Eastbound Platform		
	Seating	Shelter
Type	Wooden benches	Three-Sided, Metal and Plexi-glass
Dimensions	9.5 feet by 1.5 feet	26 feet by 8.5 feet (shelter) 26 feet by seven feet (overhang)
Condition	Fair	Good
Quantity	Two	One
Covered	Yes	Yes
Photograph

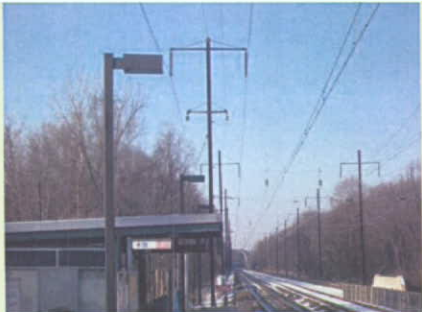
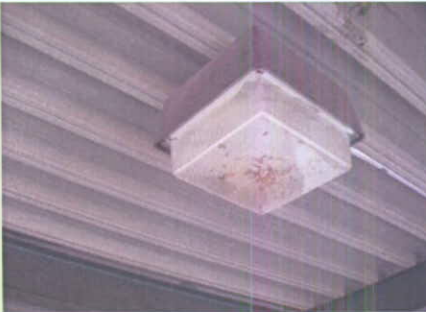
The lighting located along the platform is primarily free-standing box lights. Two are located over the mini high-level platform and four additional box lights are located along the primary platform, two on either side of the shelter.

In addition to the platform lighting, there are four, ceiling mounted lights within the shelter to provide additional illumination for the covered waiting area. All lights on the eastbound platform were operational at the time of this report.

Lighting – Eastbound Platform		
	Freestanding	Ceiling of Shelter
Type	Box lights	Box style
Dimensions	N/A	N/A
Quantity	Four over primary platform Two over mini high-level platform	Four mounted to ceiling of shelter
Condition	Good	Good
Photograph

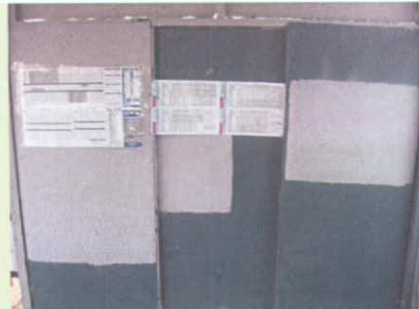
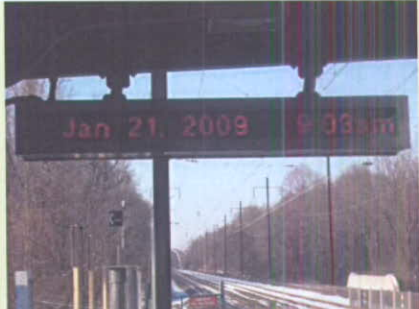
During the site visit, a paper copy of the schedule was located within the shelter. It was taped to a bulletin board inside the shelter on the eastern wall. In addition to the paper schedule, there was an electronic reader board attached to the ceiling of the overhang, which identified the next SEPTA train scheduled to arrive together with the arrival time. When the train was delayed, the electronic reader board identified the delay.

There was one public announcement speaker located on the west side of the shelter. During the site visit, multiple eastbound trains stopped at the station but no announcements were made.

Schedule and Public Address Speaker – Eastbound Platform		
	Schedule	Public Announcement
Type	Paper/Electronic Reader Board	Speaker
Condition	Good	Undetermined
Clarity	Good	Undetermined
Secured	No	N/A
Photograph

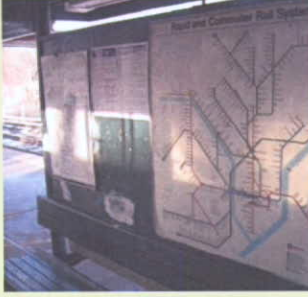
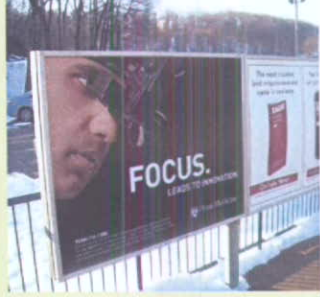
Signage – Eastbound Platform			
	Location	Information	Advertising
Type	Freestanding, wall mounted	Freestanding, wall mounted	Freestanding
Condition	Good/Fair	Excellent (New Amtrak) Fair (SEPTA)	Excellent
Clarity	Good	Good	Good

Signage – Eastbound Platform			
Secured	Yes	Yes	Yes
Photograph

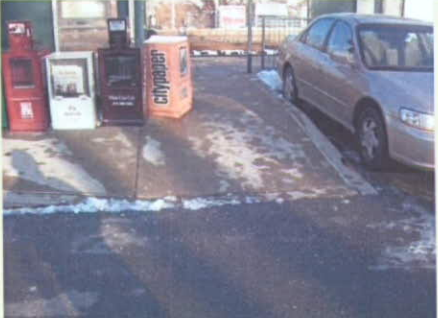
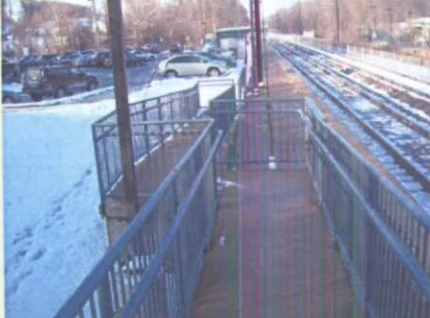
As noted previously, the site contains tactile warning strips along the edge of both platforms to alert visually impaired passengers of their proximity to the edge of the platform. These warning strips are in excellent condition.

ADA Accessibility – Eastbound Platform		
	Primary Platform	Mini-High Level Platform
Type	Curb-cuts Tactile warning strips	Wheelchair ramps Railings Tactile warning strips
Surface	Concrete	Concrete - wheelchair ramps Railings - painted metal Plastic - tactile warning strips
Number	Two curb-cuts Warning strips - entire length	Two ramps Railings - entire length of wheelchair ramps
Dimensions	Vary	Wheelchair ramps - five feet width by 28 feet and 36 feet length
Condition	Excellent	Ramps - excellent Railings - good (some rust)
Photograph

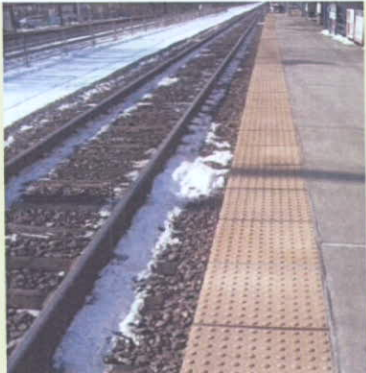
In addition to the detectable/tactile warning system on the primary platform, there is also a yellow surface applied detectable/tactile warning system located on the mini-high level platform at the western end of the primary platform. This warning surface is two feet in width and 18.5 feet in length. The surface applied warning strips are generally in good condition. However, there is some minor buckling that is beginning to occur. The warning strip conditions are summarized as follows.

Warning Strips – Westbound Platform		
	Primary Platform	Mini-High Level Platform
Type	Cast in place detectable/tactile warning system	Surface applied detectable/tactile warning system
Surface	Concrete	Plastic
Dimensions	Two feet width by 199 feet length	Two feet width by 18.5 feet length
Condition	Excellent	Good - some slight buckling is beginning.
Photograph

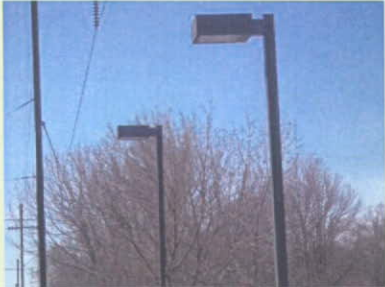
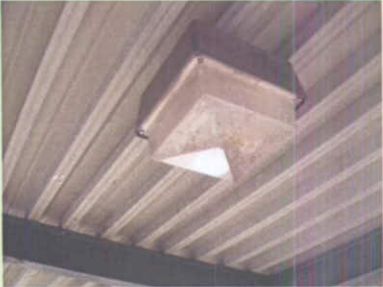
In addition to the platform lighting, there are four ceiling mounted lights within the shelter to provide additional illumination for the covered waiting area. Lamps located on the westbound platform were all operational at the time of this report.

Lighting – Westbound Platform		
	<i>Freestanding</i>	<i>Ceiling of Shelter</i>
<i>Type</i>	Box lights (one older style)	Box style
<i>Dimensions</i>	N/A	N/A
<i>Quantity</i>	Three over primary platform Two over mini high-level platform	Four mounted to ceiling of shelter
<i>Condition</i>	Good	Good
<i>Photograph</i>

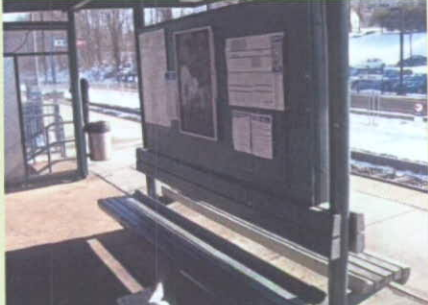
A paper copy of the schedule was stapled to the bulletin board between the benches. The schedule was legible, but not highly secure. The westbound platform did not have an electronic schedule board.

Schedule and Public Address Speaker – Westbound Platform		
	<i>Schedule</i>	<i>Public Announcement Speaker</i>
<i>Type</i>	Paper	N/A
<i>Condition</i>	Good	
<i>Clarity</i>	Good	
<i>Secured</i>	No	
<i>Photograph</i>

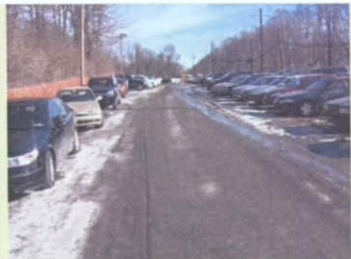
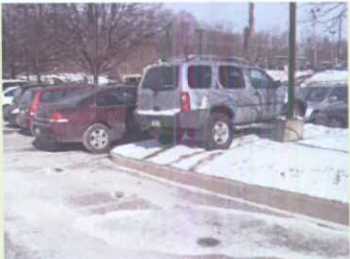
The parking lot immediately adjacent to the westbound platform is in fair to poor condition. Curbing is lacking throughout this area and the edges of the asphalt surface are deteriorating. Potholes and cracks are located throughout the parking lot. It is a daily fee lot and the daily fee is \$1.00. The fee box is located at the perimeter of the parking lot adjacent to the westbound platform. Similar to the eastbound parking lot, there is not designated loading area, but the area of the parking lot immediately adjacent to the platform is utilized for loading and unloading.

Parking/Loading – Westbound Station Site Conditions		
	Parking Lot Adjacent to Westbound Platform	Parking Lot North of Railroad ROW, along Route 30 Bypass
Total Space	107	116
Handicap Spaces	One	0
Surface Type	Asphalt	Asphalt
Curbing	Some.	Yes
Condition	Fair/poor	Good
Dimensions - Parking Stall	8.5 feet by 17.5 feet	8.5 feet by 18 feet
Interior Travel Lanes	21 feet	24 feet
Lot Access	19 feet	24 feet
Fair Box	Yes	No
Daily Fee	\$1.00	No
Parking Overflow	No (seven illegally parked cars)	This appears to serve as the overflow for the station.
Passenger Loading	No, not officially	No
Photograph

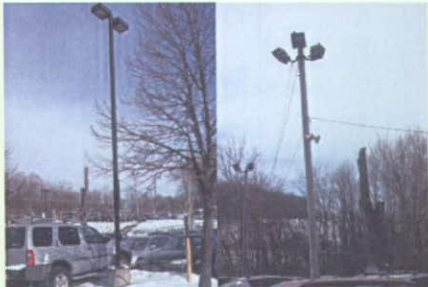
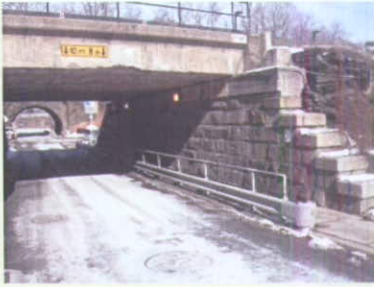
Site Lighting		
	Freestanding	Wall-Mounted
Type	Box lights attached to poles, some wood and some metal	Box
Condition	Generally good. All are functioning.	Good. Functioning
Quantity	Eastbound lot - eight with two at stairs Westbound – three with two at stairs and ramps. North lot - 18	Two in underpass
Photograph

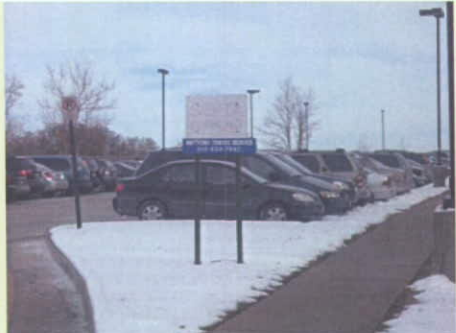
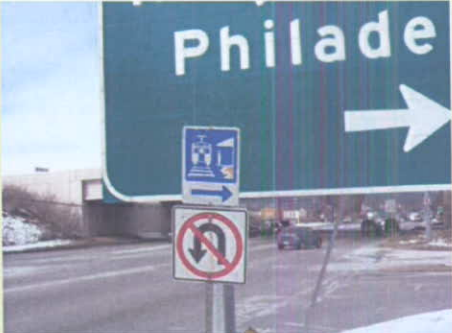
In addition to the signage located on the platforms, there is signage along Walkertown Road identifying the stations as the Exton Station. In addition, directional signage is provided at all points of access to the station identifying the direction of the station. At the points of entry to each of the parking lots, there is also signage outlining the rules of parking in the parking lots. Some of the signs for the parking lots are faded and are in need of restoration. Examples of site signage include the following.

Signage		
	Information	Direction
Type	Freestanding	Freestanding
Condition	Fair	Good
Photograph

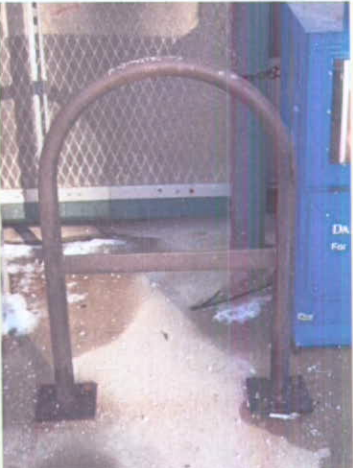
Other pedestrian amenities at the station include one bicycle U-rack located near the shelter of the eastbound platform. There are no dining or retail services on site.

Sidewalks/Pedestrian Amenities		
	Pedestrian	Bicycling
Type	Sidewalk	Bike rack
Condition	Good	Good
Dimensions	Five feet wide	Two bike capacity
Photograph

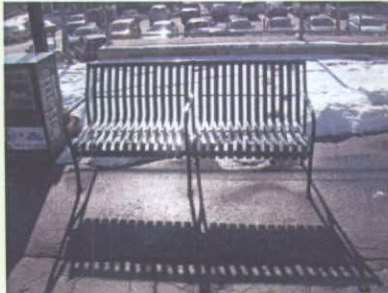
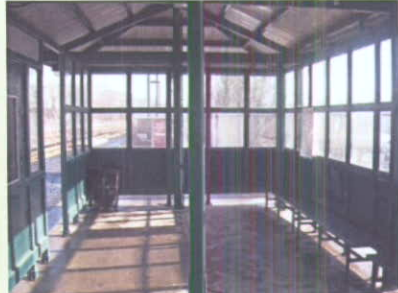
The eastbound platform at Downingtown Station has an enclosed shelter constructed of metal and plexi-glass. The shelter is approximately 17 feet wide by 50 feet long and is in good condition. Two benches are provided within the shelter that are composed of metal and coated plastic. Two additional benches are provided outside the shelter along the platform area that are not covered.

Seating and Shelter – Eastbound Platform		
	Seating	Shelter
Type	Benches- metal/plastic coated	Metal/Plexi-glass
Dimensions	Five feet - ten inches (two benches on platform) 14 feet (two benches within shelter)	17 feet by 50 feet
Condition	Good	Good
Quantity	Four	One
Covered	Two benches within shelter are covered	Yes
Photograph

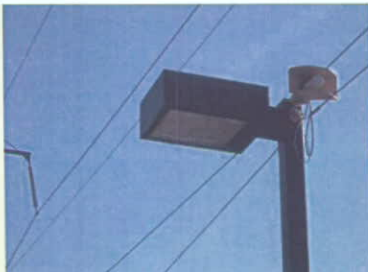
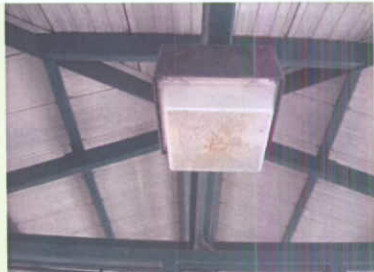
The lighting provided along the eastbound platform consists of seven box lights on metal poles. The lighting is spaced along the platform with three located east of the shelter and four located west of the shelter. Lighting fixtures and poles are in good condition with the exception of two light fixtures. One light east of the shelter, was not operational during an evening site visit and the pole mounted light furthest to the west was not operational.

Lighting – Eastbound Platform		
	Freestanding	Ceiling of Shelter
Type	Box lights	Square, ceiling mounted
Quantity	Seven – three east of shelter, four west of shelter	Seven – two within enclosed area; five under canopy
Condition	Good (one light not operational east of shelter)	Good
Photograph

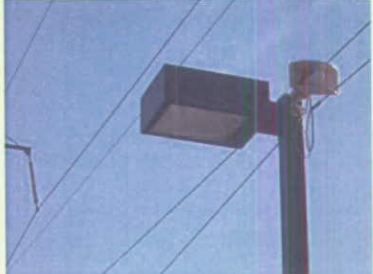
No written schedules are displayed at the eastbound platform for either SEPTA or Amtrak service. A public announcement speaker system has been installed on top of one of the light fixtures. The system appears to be operational; however, no announcements were heard during the site visit.

Schedule and Public Address Speaker – Eastbound Platform		
	Schedule	Public Announcement
Type	None posted.	Speaker
Condition		Appear operational
Clarity		No announcements made during site visit.
Secured		Yes. Secured to top of light fixture.
Photograph

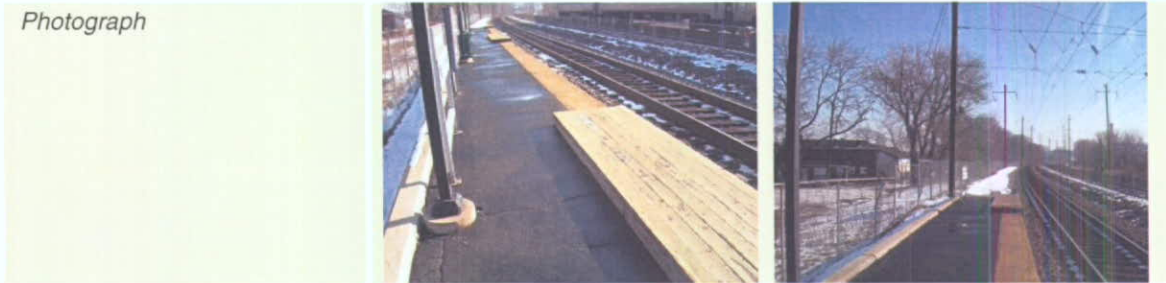
Photograph

Surface Condition – Westbound Platform	
Primary Platform	
Surface	Asphalt
Dimensions	Nine feet - four inches by 350 feet (eastern portion) Ten feet by 308 feet (continuing east) Wooden steps (four) - 3.5 feet by 16 feet by eight inches
Condition	Good/Fair some cracks and slight deterioration along edge of platform

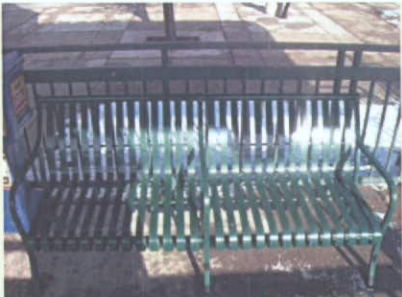
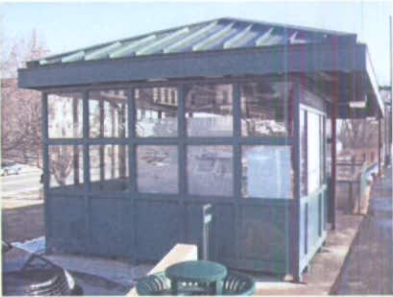
A total of four benches are provided on the platform. Two benches are five feet 10 inches long, one of which is located in the covered canopy area and the other is located on the open platform area. Two additional benches are located within the enclosed shelter and are 12 feet long each. The benches and the sheltered structures are all in good condition.

Seating and Shelter – Westbound Platform		
	Seating	Shelter
Type	Benches - metal/plastic coated	Metal/Plexi-glass (a portion is enclosed)
Dimensions	Five feet – 10 inches (one bench on platform) Five feet - 10 inches (one bench under canopy) 12 feet (two benches within shelter)	17 feet by 20 feet (Canopy without walls) 14 feet by 14 feet (enclosed area)
Condition	Good	Good
Quantity	Four	One
Covered	Two benches within shelter are covered	Yes.
Photograph

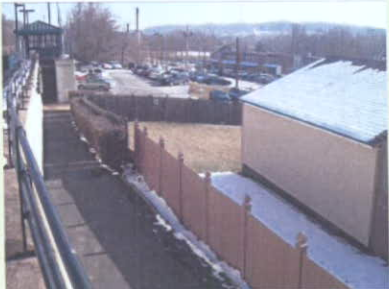
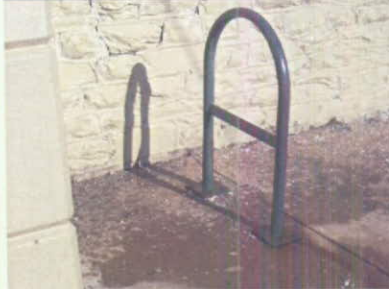
Sidewalks/Pedestrian Amenities		
	Circulation	Other
Type	Tunnel Stairs - connecting tunnel and platforms; connecting southeast parking lot Asphalt walkway from parking lot	Plaza north of westbound platform Bike rack available on south side. No bike rack on north side.
Condition	Fair - tunnel Good - stairs Good - walkway	Good
Dimensions	Tunnel – five feet wide (four foot walkway due to six inch gutter on either side) Stairs - vary from four feet in width to six feet in width	
Photograph

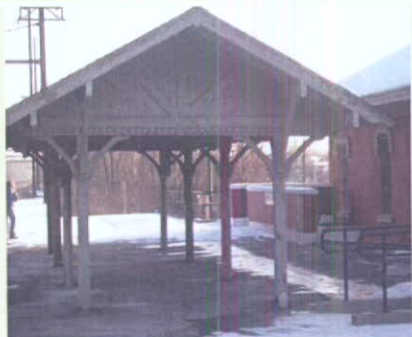
The eastbound platform does have a covered area for passengers waiting, but no seating is available. The covered area is 832 square feet and has no side walls.

Platform Seating and Shelter – Eastbound Platform		
	Seating	Shelter
Type	None	Covered shelter
Dimensions	N/A	16 feet by 52 feet
Condition	N/A	Good- no side walls
Quantity	N/A	One
Covered	N/A	Yes
Photograph	N/A

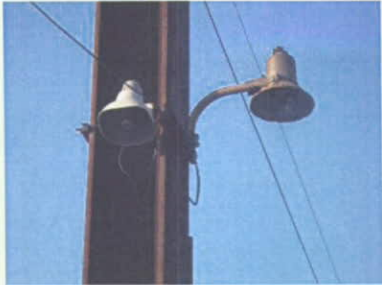
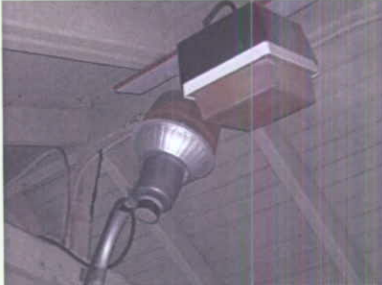
Several light fixtures are also installed within the canopy, on the ceiling of the structure. None of the fixtures were operational. It was noted by an Amtrak official that Amtrak has a difficult time keeping the station adequately lit due to vandalism.

Lighting – Eastbound Platform		
	Freestanding	Shelter/Building
Type	Pole mounted/freestanding box	Variety
Quantity	Two (box lights at eastern end of platform Two older fixtures mounted on an existing pole.	Two mounted to building Five within canopy (not operational)
Condition	Poor (only one box light operational) Poor (older lights not operational)	Good - building lights operational Poor - canopy lights (not operational)
Photograph

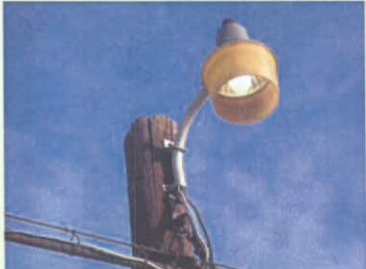
Lighting – Westbound Platform	
Photograph

Lighting – Westbound Platform	
	Freestanding
Type	Fixtures attached to wood poles
Quantity	Four
Condition	Fair/operational

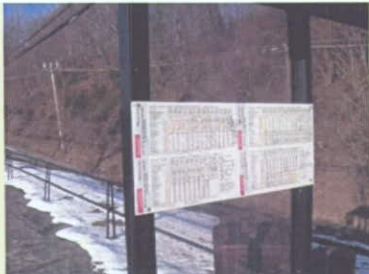
On the westbound platform, the only scheduling information is a paper schedule taped to the inside of the shelter. The schedule information is current and legible, but has graffiti on it. No public service announcement system was observed on the westbound platform.

Schedule and Public Address Speaker – Westbound Platform		
	Schedule	Public Announcement Speaker
Type	Paper	None
Condition	Poor/Fair- graffiti, but still legible	
Clarity	Good	
Secured	Taped to inside of shelter	
Photograph

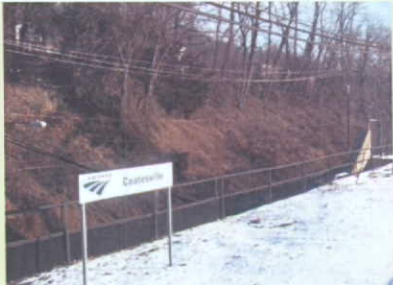
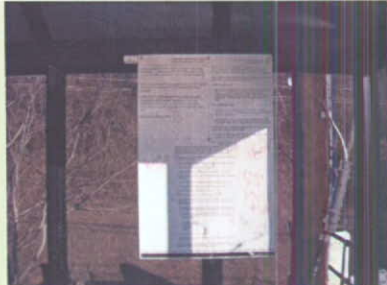
Similar to the eastbound side, there are two types of signage located on the westbound platform area. Signage includes locational signage, which includes the name of the station, Coatesville, on a freestanding sign as well as general riding information mounted to the rear wall of the shelter.

Signage – Westbound Platform		
	Location	Information
Type	Freestanding	Mounted to shelter.
Condition	Good	Fair/Poor-
Clarity	Good	Fair/poor- legible, but has graffiti
Secured	Yes	Taped to shelter wall
Photograph

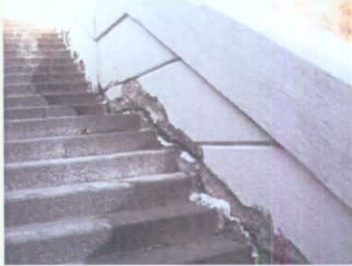
Sidewalks/Pedestrian Amenities		
	Sidewalks	Other Amenities
Type	Concrete sidewalks	Stairs to platform Bicycle racks
Condition	Good	Fair - stairs (deteriorating) Good - bicycle racks
Dimensions	Eight feet near station (six feet in underpass) Four to eight feet in remainder of neighborhood south of station None - north of station	Stairs- six feet wide (railing 2.5 feet high)
Photograph

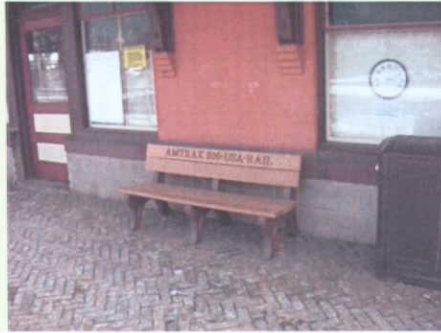
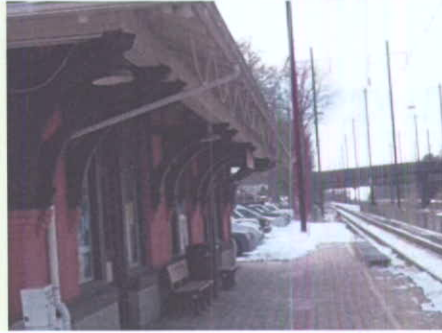
Underneath the overhang of the station building, there are two benches made of a durable plastic material that are both five feet long. The benches are in good condition and appear to be relatively new. Etched into the back of each bench is “AMTRAK 800-USA-RAIL”.

Platform Seating and Shelter – Eastbound Platform		
	Seating	Shelter
Type	Bench	No. Building not available to the public
Dimensions	Five feet	Four feet
Condition	Good - appear to be relatively new	Good. Exterior of building is in good condition.
Quantity	Two	Perimeter of entire building
Covered	Yes/Somewhat - under eaves of building

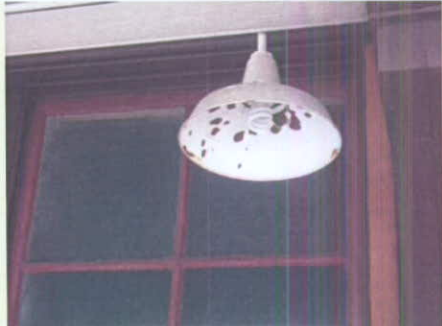
The lighting provided on the eastbound platform is minimal. East of the building there is a wooden pole with three mounted light fixtures. The fixtures include two cobra-head light fixtures, one extending over the platform and the other extending over the parking lot. Neither cobra-head fixture is operational. The third fixture is located below the cobra-head fixtures facing the platform. This fixture is operational and provides some illumination of the platform east of the building.

Freestanding	Under Building Eaves
Type	Cobra	Hanging individual lights
Quantity	One	Five (four on platform-side of building)
Condition	Poor, Only one fixture operational	Fair - One not operational. Some in need of repainting.
Photograph

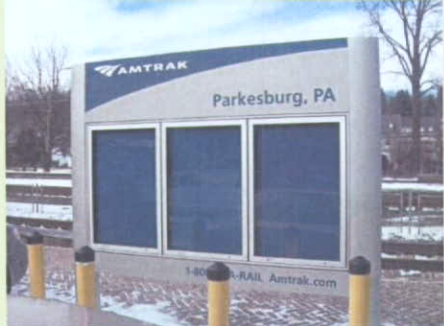
On the eastbound platform, there are no schedules posted on bulletin boards or other signs indicating the frequency of service. There is an Amtrak display board that appears to be new; however, no information is displayed on the sign.

There is a speaker system attached to the light pole on the eastbound platform; however, no announcements were made during the site visit so it is uncertain whether the speaker system is currently in use to announce arriving and departing trains.

Schedule and Public Address Speaker – Eastbound Platform		
	Schedule	Public Announcement
Type	Not available	Speaker
Condition		No announcement made during site visit
Clarity		N/A
Secured		Yes, Attached to light pole
Photograph

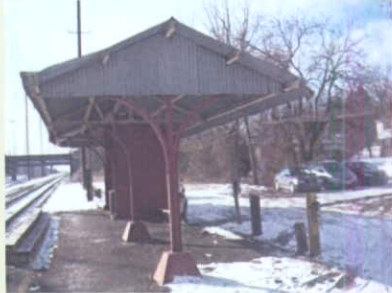
Platform Seating – Westbound Platform		
	Seating	Shelter
Type	Benches- wood, plastic	Three-sided, wood shelter
Dimensions	15 feet by two feet (built into shelter) Five feet (outside benches)	15 feet by 7.5 feet – overhang continues seven feet over platform Covered area - 15 feet by 32 feet
Condition	Good	Good
Quantity	One in shelter Two outside shelter, but under cover	One
Covered	Two covered	Yes
Photograph

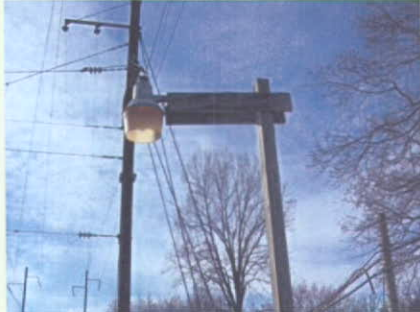
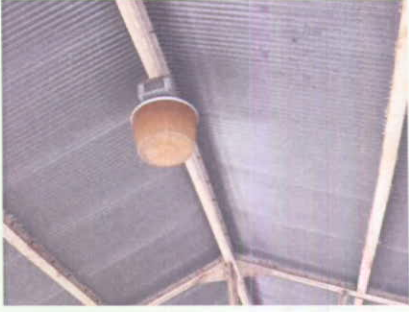
The lighting currently provided on the westbound platform consists of seven cobra-style lights attached to wooden poles. These poles are generally spaced evenly along the platform. Three of the fixtures are located west of the shelter and these were all operational during the site visit. Four of the freestanding lights are located east of the structure. Of these fixtures, two were operational. These included the fixture closest to the building and the fixture farthest to the east. In addition to the pole mounted fixtures, one light is attached to the ceiling of the shelter to provide additional illumination within the structure. This fixture was operational during the site visit.

Lighting Westbound Platform		
	<i>Freestanding</i>	<i>Ceiling of shelter</i>
<i>Type</i>	Older cobra style	Yes
<i>Quantity</i>	Seven	One
<i>Condition</i>	Fair - two lights not operational	Good
<i>Photograph</i>

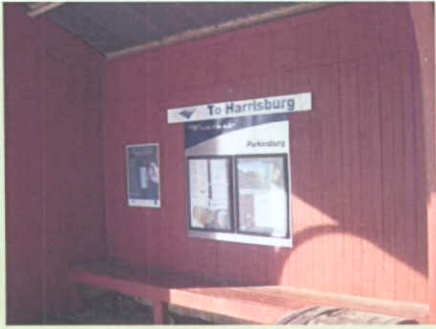
On the westbound platform, the only scheduling information is a paper schedule with plastic/laminated covering providing information on service to Harrisburg. The schedule information is current and legible as well as being secured to the wall and protected from the elements.

Schedule and Public Address Speaker Westbound Platform		
	<i>Schedule</i>	<i>Public Announcement Speaker</i>
<i>Type</i>	Paper with plastic covering	None observed
<i>Condition</i>	Good	N/A
<i>Clarity</i>	Good	N/A
<i>Secured</i>	Yes, by plastic covering	N/A
<i>Photograph</i>

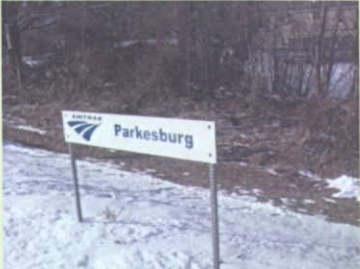
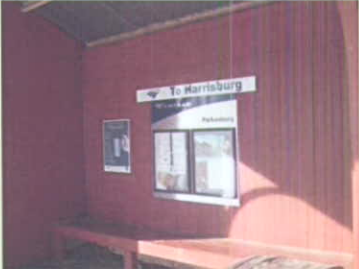
Similar to the eastbound side, there are two types of signage located on the westbound platform area. Signage includes locational signage, which includes the name of the station, Parkesburg, on a freestanding sign as well as a wall mounted sign within the shelter. Also mounted to the wall within the shelter is informational signage providing basic information about using Amtrak.

Signage Westbound Platform		
	Location	Information
Type	Freestanding and wall mounted	Wall mounted
Condition	Good	Good
Clarity	Good	Good
Secured	Yes	Yes
Photograph

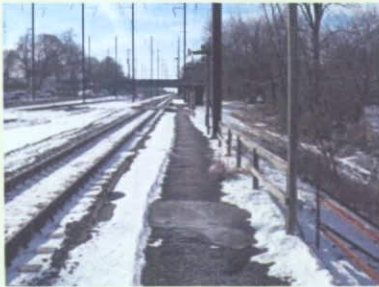
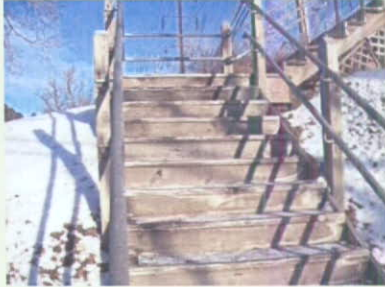
The westbound platform has no dedicated facilities available to provide handicapped access compliant with ADA. The area in the immediate vicinity of the platform is level and could accommodate facilities, but there is significant grade change to Culvert Street and designing facilities in this area will be challenging.

ADA Accessibility Westbound Platform	
	Primary Platform
Type	No dedicated facilities
Surface	N/A
Number	N/A
Dimensions	N/A
Condition	N/A
Photograph

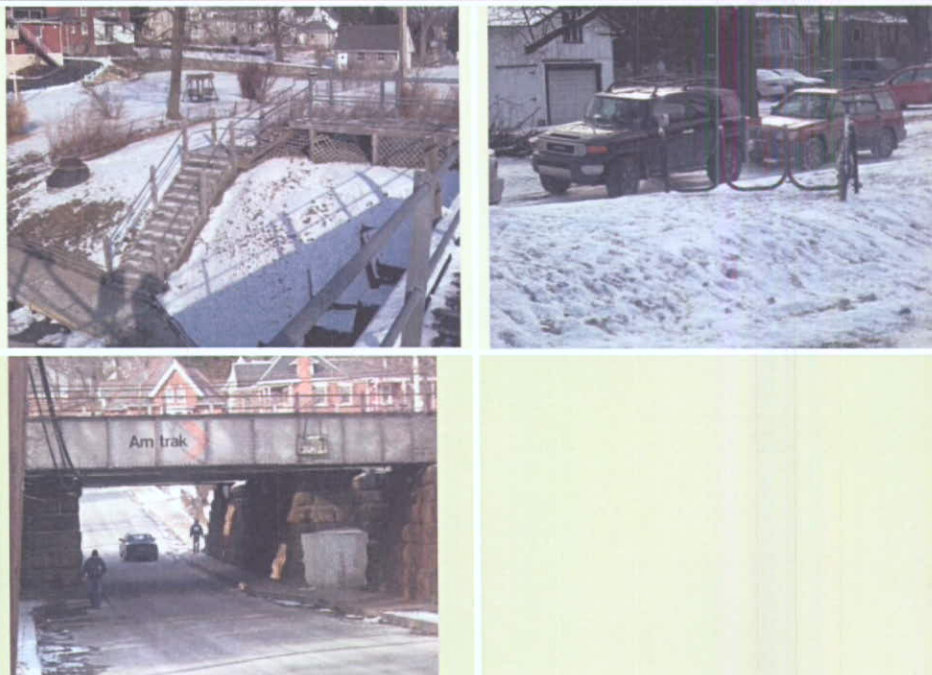
There is a bicycle rack in the eastbound parking lot that holds approximately eight bicycles. During the site visit one bicycle was observed. No bicycle racks are available on the westbound platform.

Sidewalks/Pedestrian Amenities		
	Pedestrian Circulation	Amenities
Type	Sidewalk on east side of Culvert Street Wood steps from westbound platform to sidewalk on east side of Culvert Street.	Bicycle rack in parking lot of eastbound parking lot.
Condition	Good	Good
Dimensions	Five feet typically, 3.5 feet directly under tracks	Eight bicycle capacity

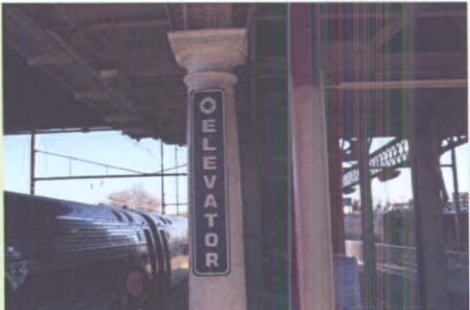
- **Location signage** - Two location signs were located along the outer edge of the platform. These signs include name of the station, Lancaster and the Amtrak symbol, representing the trains that stop at this station.
- **Information signage** - Mounted on various structures and poles is general passenger information providing general ridership information. The sign appears to be a very secure location for displaying information and direction.

Platform Signage Eastbound Platform		
	Location	Information
Type	Freestanding	Pole and structure mounted
Condition	Good	Good
Clarity	Yes	Yes
Secured	Yes	Yes
Photograph

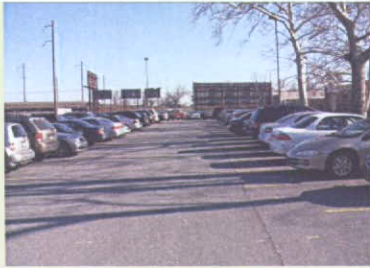
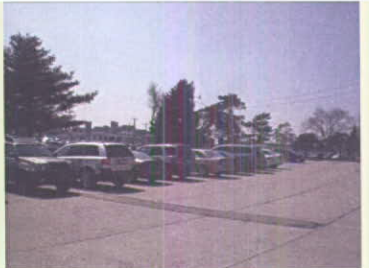
Passenger loading and unloading was observed for taxis, passenger cars and intercity buses directly in front of the building in the circular driveway. About eight to 10 vehicles were observed in the queue at the time of the field view.

Parking/Loading	
	Parking Lot East of Station	Circular Driveway
Total Spaces	110	55
Handicap Spaces	One	Four
Surface	Asphalt	Asphalt
Curbing	No	Yes
Condition	Good	Good
Dimensions - Parking stall	Nine feet by 18 feet	Nine feet by 18 feet
Interior Travel Lanes	24 feet	N/A
Lot Access	30 feet	26 feet
Fair Box	Yes	Meter
Daily Fee	\$5.00	\$0.25/minute
Parking Overflow	No	No
Passenger Loading	No	Yes
Photograph

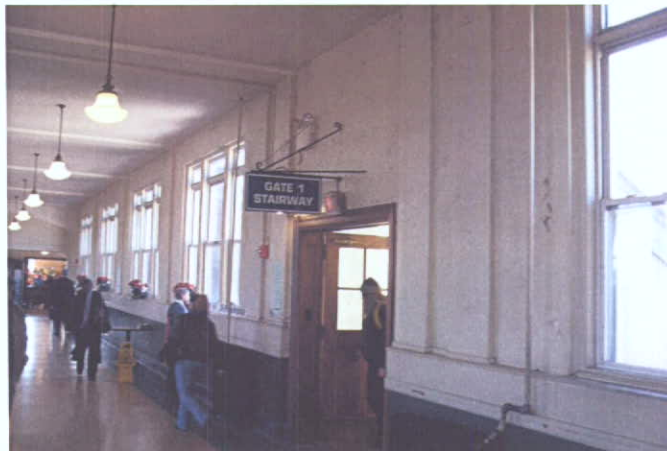
*Passengers destined to eastbound platform stairs*

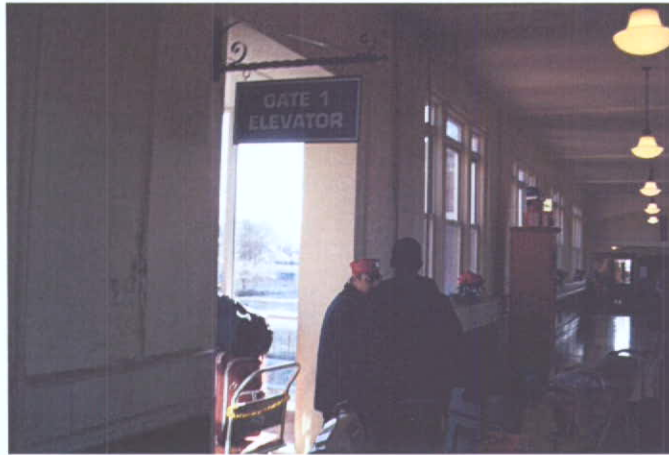
Passengers destined to eastbound platform stairs

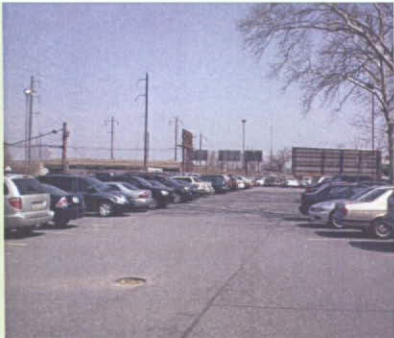
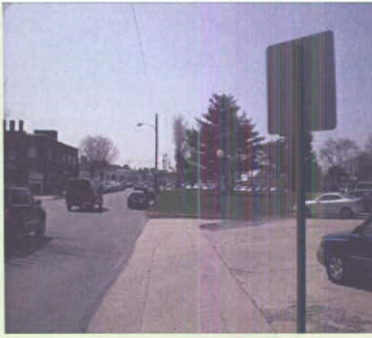
The parking area within the circular driveway has five freestanding poles evenly distributed along the driveway. Along McGovern Avenue there three pole-mounted cobra-head lights are oriented toward the street. All lights were functioning and appear in good condition.

Site Lighting		
	Parking Lot East of Station	Circular Driveway
Type of Light Fixtures	Incandescent	Incandescent
Number	Four	Five
Location	Lot perimeter	Along curb
Condition	Good	Good
Photograph

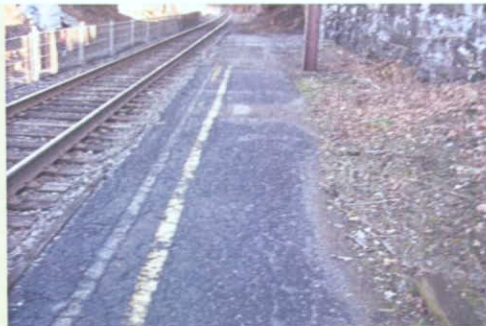
The eastbound platform surface is asphalt and in fair condition with deficiencies such as cracks and uneven pavement. The platform length is 265 feet. The platform width is about seven feet. Wooden steps are also provided along the platform length for boarding and exiting the train, these have also been painted yellow with an abrasive material on the step. There are two steps measuring 3.5 feet in depth by 20 feet long by eight inches high. The platform is generally free of obstructions.

Surface Condition Eastbound Platform	
	<i>Primary Platform</i>
Surface	Asphalt
Dimensions	Seven feet by 265 feet
Condition	Fair
Photograph

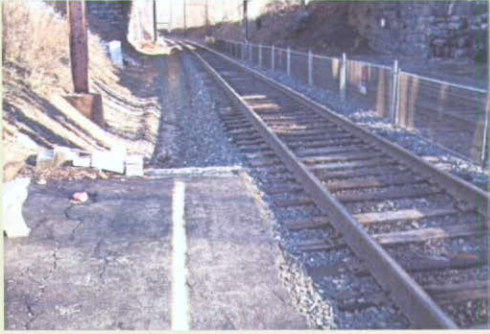
The westbound platform has a warning strip along the entire platform length. The warning system along this platform consists of a yellow painted surface that is fairly visible. The warning system is in fair condition and is six inches wide and extends a length of 265 feet on the westbound platform.

Warning Strips Westbound Platform	
Platform	
Type	Yellow paint
Surface	Asphalt
Dimensions	Six inches by 265 feet
Condition	Fair
Photograph

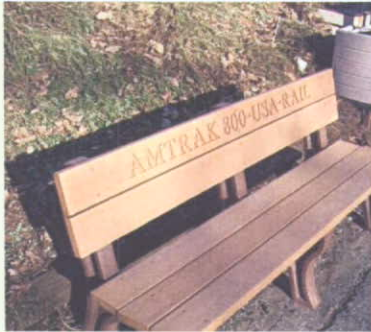
A total of three benches are provided on the platform. One additional bench is located within the shelter and is seven feet long. The benches and the sheltered structures are all in good condition.

Seating and Shelter Westbound Platform		
	Seating	Shelter
Type	Wood and metal	Metal
Dimensions	N/A	Seven feet
Condition	Good	Good
Quantity	Three	One
Covered	No	Yes
Photograph

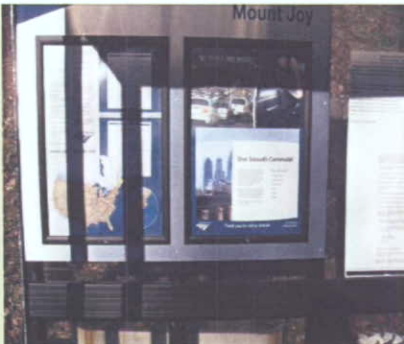
Two public address speakers are located on the platform. They appear in working order, however, there were no announcements made during the time of the field view.

Schedule and Public Address Speaker Westbound Platform		
	Schedule	Public Address Speaker
Type	Bulletin board	Two speakers
Condition	Good	Good
Clarity	Good	Not observed
Secured	Yes	Yes
Photograph

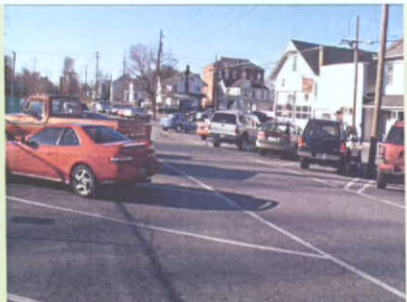
North and west of the station there is one parking lot immediately adjacent to the westbound platform. This parking has an asphalt surface is in good condition. The lot is shared with the Mount Joy Church of Christ and other commercial activities in the area. There is a total of 60 spaces. There is not a designated loading area, but an area located behind some of the parking spaces where people pull off of the road is used to unload passengers. This parking lot does not have any spaces designated for handicap parking.

In addition, there is a gravel parking lot adjacent to the station owned by Mount Joy Borough. There are a total of about 25 spaces estimated because the spaces are not designated. In the future, the Borough wishes to develop the property to take advantage of the proximity of the station.

Parking/Loading Westbound Platform		
	Parking Lot Adjacent to Westbound Platform	Mount Joy Borough Lot
Total Spaces	60	25
Handicap Spaces	0	0
Surface Type	Asphalt/gravel	Gravel
Curbing	No	No
Condition	Good	Good
Dimensions	15 feet by 24 feet	Undetermined
Interior Travel Lanes	15 feet	N/A
Lot Access	20 feet	30 feet
Fair Box	No	No
Daily Fee	No	No
Parking Overflow	No	No
Passenger Loading	No	No
Photograph

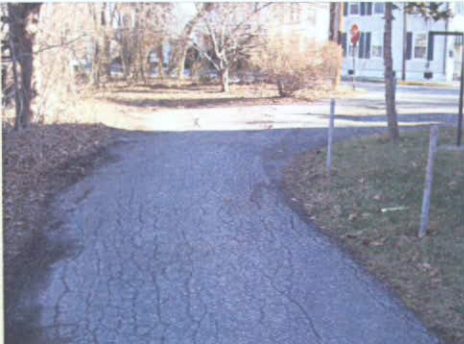
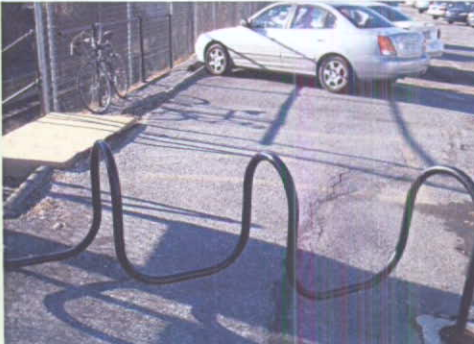
Other pedestrian amenities at the station include one bicycle rack located in the westbound side parking lot adjacent to the stairway. The capacity of this rack is about eight bicycles. There are no dining or retail services on site.

Sidewalks/Pedestrian Amenities		
	<i>Circulation</i>	<i>Other</i>
<i>Type</i>	Sidewalk Pedestrian alleyway	Bicycle rack
<i>Condition</i>	Sidewalk- good to fair Alleyway - good	Good
<i>Dimensions</i>	Sidewalk – four feet to six feet Alleyway – eight feet to 10 feet	N/A
<i>Photograph</i>

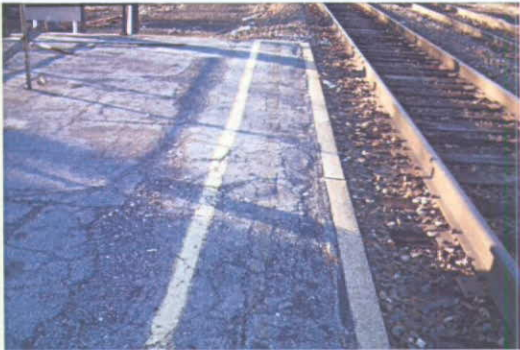
Surface Condition Eastbound Platform	
Photograph

The eastbound platform surface is asphalt. It is in fair condition with deficiencies such as cracks and some deterioration at the edges. The length of the platform is 180 feet. The width is 12 feet. These measurements include the area along the edge of the platform with the painted warning strip. A wooden step is also provided along the platform length for boarding and exiting the train, this step is faded with yellow paint and an abrasive surface.

The platform is generally free of obstructions. Several years ago the platform canopy was removed due to deterioration. In its place, the Borough erected a U-shaped plastic covering where the platform stairs and platform meet, thus creating a make-shift covered area. In discussions with Amtrak, passengers use this covering to escape adverse weather conditions.

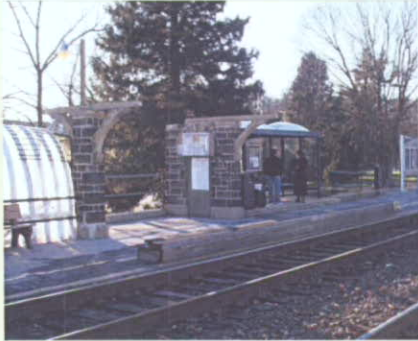
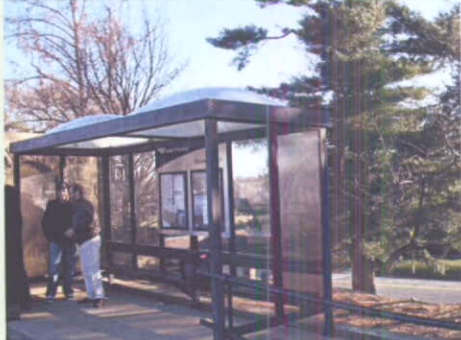
The eastbound platform at Elizabethtown Station has an enclosed shelter constructed of metal and plexi-glass. The shelter is approximately six feet wide by 10 feet long and is in good condition. One bench is provided within the shelter composed of metal and coated plastic. Two additional benches are provided outside the shelter along the platform area that are not covered.

Seating and Shelter Eastbound Platform		
	Seating	Shelter
Type	Wooden benches	Metal and plexi-glass
Dimensions	N/A	Six feet by 10 feet
Condition	Good	Good
Quantity	Two	One
Covered	No	Yes
Photograph

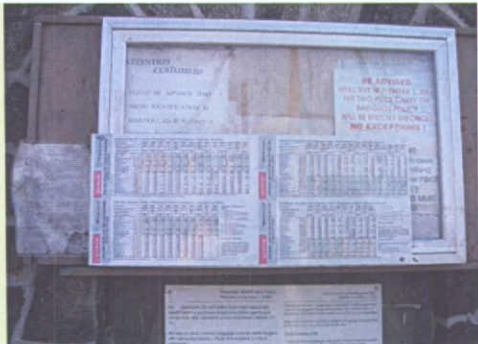
No public address system is located on this platform.

Schedule and Public Address Speaker Eastbound Platform		
	Schedule	Public Address Speaker
Type	Taped to bulletin board	None
Condition	Good	N/A
Clarity	Yes	N/A
Secured	No	N/A
Photograph

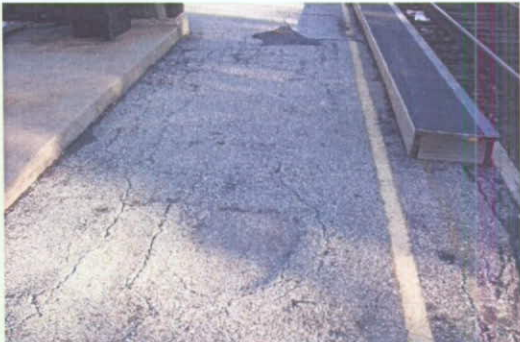
The westbound platform surface is asphalt. It is in fair condition with deficiencies such as cracks and some deterioration at the edges. The length of the platform is 180 feet. The width is 12 feet. These measurements include the area along the edge of the platform with the painted warning strip. A wooden step is also provided along the platform length for boarding and exiting the train, this step is faded with yellow paint and an abrasive surface.

The platform is generally free of obstructions. Several years ago the platform canopy was removed due to deterioration. In its place, the Borough erected a U-shaped plastic covering where the platform stairs and platform meet, thus creating a make-shift covered area. In discussions with Amtrak, passengers use this covering to escape adverse weather conditions.

Surface Condition Westbound Platform	
	<i>Platform</i>
<i>Surface</i>	Asphalt
<i>Dimensions</i>	12 feet by 180 feet
<i>Condition</i>	Fair
<i>Photograph</i>

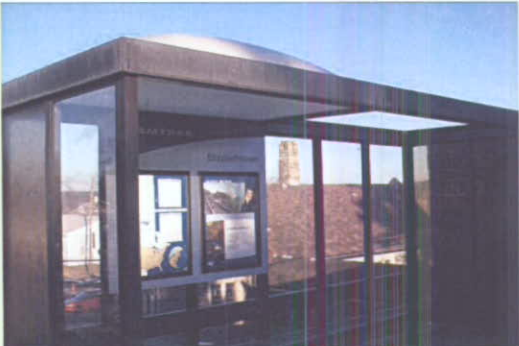
The eastbound platform at Elizabethtown Station has an enclosed shelter constructed of metal and plexi-glass. The shelter is approximately six feet wide by 10 feet long and is in good condition. One bench is provided within the shelter composed of metal and coated plastic. Two additional benches are provided outside the shelter along the platform area that are not covered.

Seating and Shelter Westbound Platform		
	Seating	Shelter
Type	Wooden benches	Metal and plexi-glass
Dimensions	N/A	Six feet by 10 feet
Condition	Good	Good
Quantity	Two	One
Covered	No	Yes
Photograph

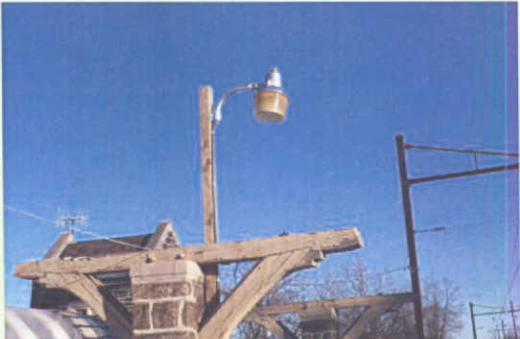
The lighting provided along the westbound platform consists of three light fixtures on wooden poles. The lighting is spaced along the platform. Lighting fixtures and poles are in good condition and all are operational.

Lighting Westbound Platform	
	Freestanding
Type	Incandescent
Quantity	Three
Condition	Good
Photograph

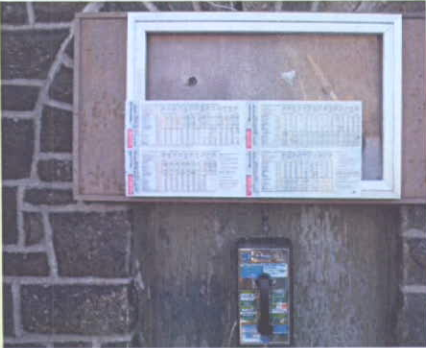
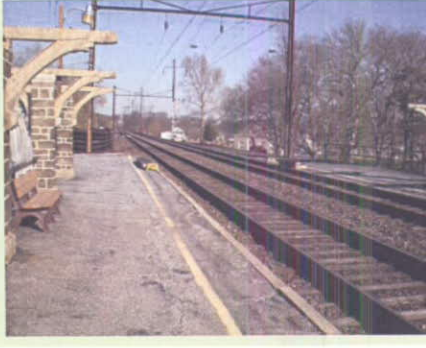
On the westbound platform, Amtrak scheduling information is taped on a bulletin board at the platform stairway like the eastbound platform. In addition, a secured schedule is located on a bulletin board in the platform shelter.

A public address speaker is provided on a pole. The operation of the system was not observed during the field view.

Schedule and Public Address Speaker Westbound Platform		
	Schedule	Public Address Speaker
Type	Mounted to structure Mounted to shelter	Speaker
Condition	Good	Good
Clarity	Yes	Not observed
Secured	No/Yes	Yes
Photograph

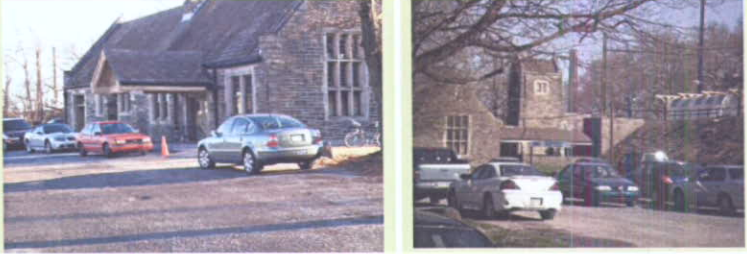
The parking lot surface is in fair/poor condition. With a surface such as this, the weather can play a factor as to whether the area is dry or wet and muddy. Access to this area is from Wilson Avenue and there is one point of entry/exit.

The second lot, west of the previous lot, contains 72 parking spaces. During the site visit, the lot had reached approximately 50% of maximum capacity. This parking lot also has no handicap parking spaces. The parking lot is constructed of asphalt, gravel and stone and does not have curbing or curb-stops. The nine feet by 18 feet parking stalls is created with painting the stones and gravel. Overall, the parking lot is in good condition on dry days, but there was evidence of puddles forming based upon weather conditions.

Parking/Loading	
	Adjacent to Station Building	West of Station Building
Total Spaces	28	72
Handicap Spaces	0	0
Surface	Gravel, stone	Gravel, asphalt, stone
Curbing	No	No
Condition	Fair	Fair
Dimensions - Parking stall	Nine feet by 18 feet	Nine feet by 18 feet
Interior Travel Lanes	N/A	24 feet
Lot Access	30 feet	18 feet/ 20 feet

Parking/Loading		
Fair Box	No	No
Daily Fee	No	No
Parking Overflow	No	No
Passenger Loading	No	No
Photograph

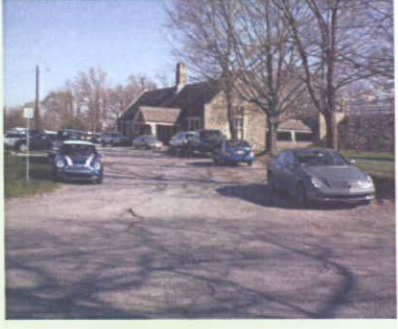
The small parking area adjacent to the station building has two wooden poles located near the parking area. Overall, lighting for this parking area would be deficient.

There is no lighting within the parking lot west of the station. On Wilson Avenue, three pole-mounted cobra-head lights are oriented over the street with some spillover to the parking lot. All lights were functioning.

Site Lighting		
	Parking Lot Adjacent to Station Building	Parking Lot west of Station Building
Type of Light Fixtures	Incandescent	None
Number	Two	N/A
Condition	Good	N/A
Photograph
