# Development of a Strategic Plan to Upgrade Stations on the Keystone Corridor

Final Report

JULY 7, 2009

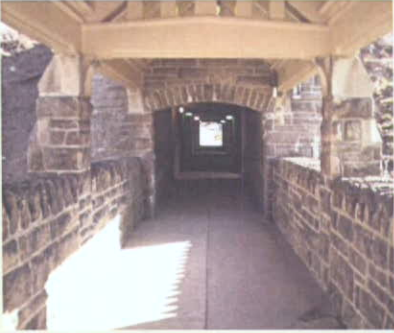
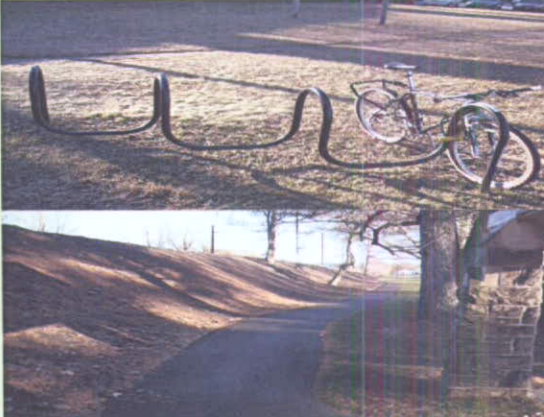
southern end of the tunnel to the platform. These stairs have railings on either side, which is three feet in height. The stairs are concrete and are in fair condition.

There is also a six foot asphalt pedestrian connection on the south side of the tracks along Masonic Drive. The path is in good condition and allows a direct link to the station.

Other pedestrian amenities at the station include two bicycle racks located at the abandoned station building. The capacity of this rack is 10 to 12 bicycles. There are no dining or retail services on site.

Sidewalks/Pedestrian Amenities		
	<i>Circulation</i>	<i>Other</i>
<i>Type</i>	Tunnel	Pedestrian path Bicycle racks
<i>Condition</i>	Fair	Good/Good
<i>Dimensions</i>	Eight feet wide	Six feet/ N/A
<i>Photograph</i>

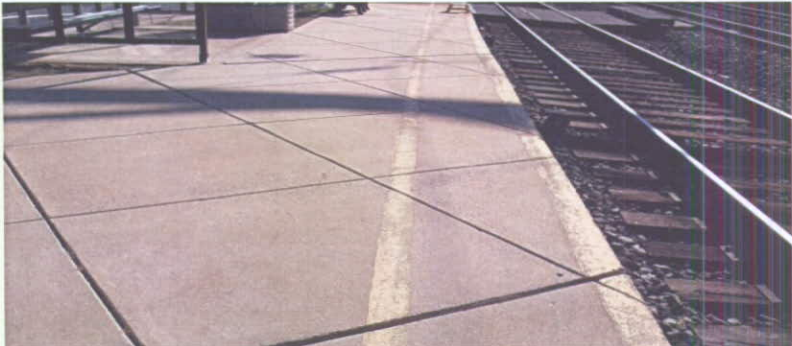
*Platform Surface*

The platform has two warning strips along the entire platform length. The warning system along this platform consists of a yellow painted surface about two feet apart. The painted warning system is in fair condition and it extends two feet in width for the entire length of the primary platform, which is 110 feet.

Warning Strips Platform	
Type	Yellow paint
Surface	Concrete
Dimensions	110 feet long
Condition	Fair
Photograph

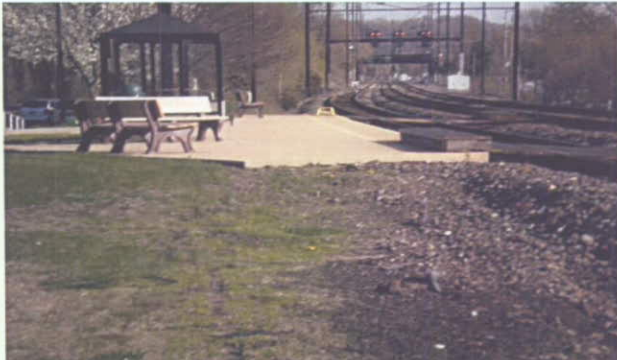
*Seating and Shelter*

The platform surface is concrete. It is in good condition. The length of the platform is 110 feet. The width is 10 feet. The platform is generally free of obstructions.

Surface Condition Platform	
	<i>Primary Platform</i>
Surface	Concrete
Dimensions	10 feet by 110 feet
Condition	Good
Photograph

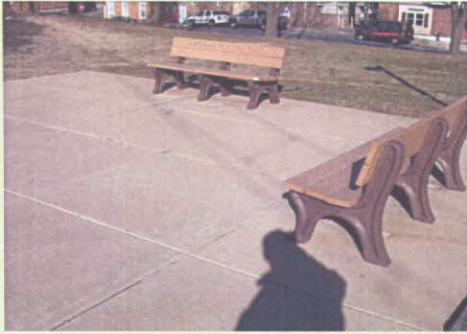
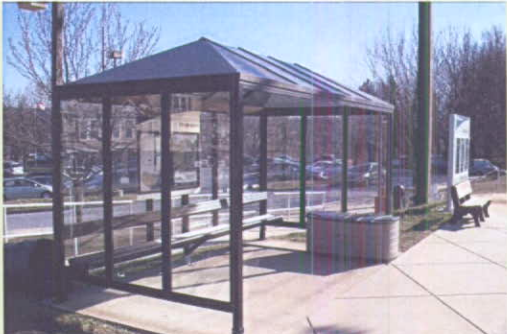
*Lighting*

The platform at Middletown Station has an enclosed shelter constructed of metal and plexi-glass. The shelter is approximately nine feet wide by 15 feet long and is in good condition. One bench is provided within the shelter that is composed of metal and coated plastic. Three additional benches are provided outside the shelter along the platform area and small plaza area that are not covered.

Seating and Shelter Platform		
	Seating	Shelter
Type	Wooden benches	Metal
Condition	Good	Good
Quantity	Three	One
Covered	No	Yes
Photograph

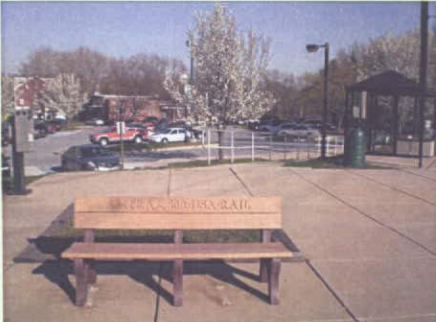
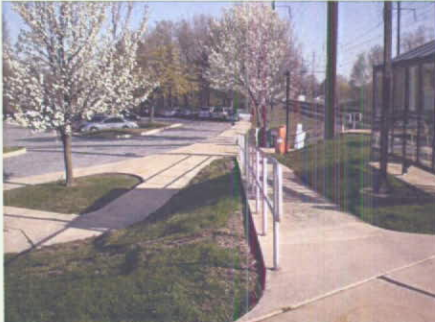
*Schedule and Public Address Speaker*

The lighting provided along the platform consists of one light on a metal pole. The lighting is located at the plaza area created by the two benches. The lighting fixture and pole are in good condition. In addition, two metal lights mounted on metal poles are located on the ramp from the parking area to the platform.

Lighting Platform		
	Freestanding	Ramp
Type	Incandescent	Incandescent
Quantity	One	Two
Condition	Good	Good
Photograph

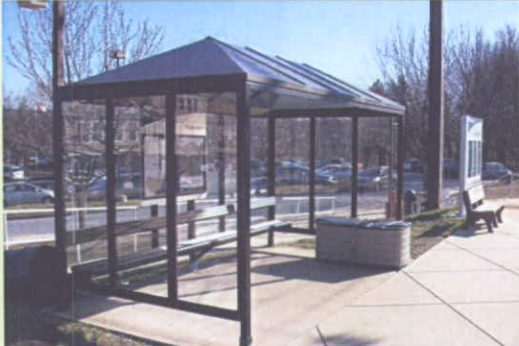
*Signage*

A schedule is displayed within the shelter on a newly installed bulletin board at the platform for Amtrak service. No public address speaker is along the platform.

Schedule and Public Address Speaker Platform		
	Schedule	Public Address
Type	Paper	None
Condition	Good	N/A
Clarity	Yes	N/A
Secured	Yes	N/A
Photograph

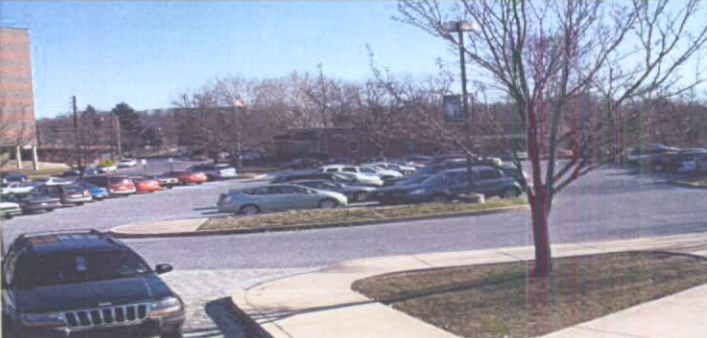
*Ticket Office*

The travel lanes in this parking area are about 24 feet in width. Parking spaces are nine feet by 21 feet and they are clearly delineated. The surface of the parking lot is in good condition with no significant cracks or deterioration noted. Access to this lot is from Mill Street and there are two points of entry/exit.

There are no opportunities for parking overflow within this parking lot. When the lot is full, drivers look elsewhere. Based upon the number of parked vehicles along Mill Street, it would appear that the overflow vehicles use the existing street curb parking.

Parking/Loading Platform	
	<i>Parking Lot Adjacent to Platform</i>
<i>Total Spaces</i>	71
<i>Handicap Spaces</i>	Four
<i>Surface</i>	Asphalt
<i>Curbing</i>	Yes
<i>Condition</i>	Good
<i>Dimensions- Parking stall</i>	Nine feet by 21 feet
<i>Interior Travel Lanes</i>	24 feet
<i>Lot Access</i>	24 feet/24 feet
<i>Fair Box</i>	No
<i>Daily Fee</i>	No
<i>Parking Overflow</i>	No
<i>Passenger Loading</i>	No
<i>Photograph</i>

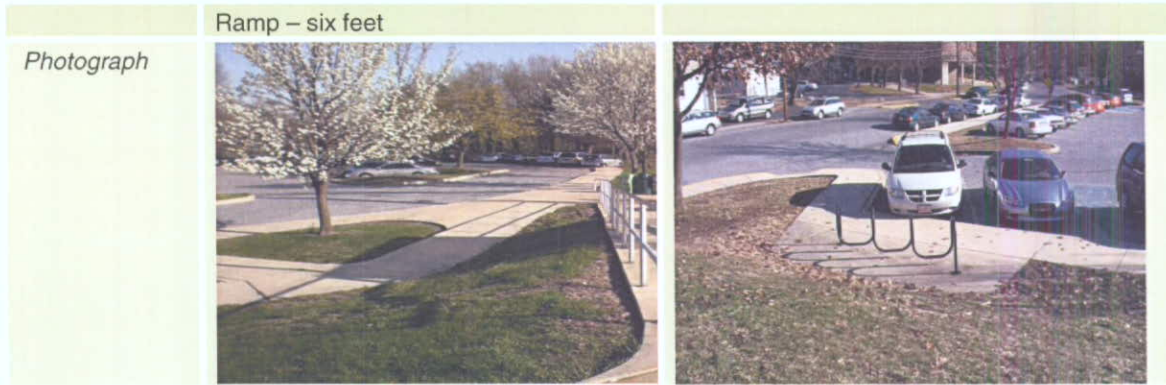
Connecting the parking lots to the platform areas is a set of stairs on the southern portion. On the northern portion there is a pedestrian ramp. These stairs and ramp each have railings on either side, which are three feet in height. The stairs and ramp are concrete and are in good condition.

Other pedestrian amenities at the station include a bicycle rack located adjacent to the handicap surface near the pedestrian ramp leading to the platform. The capacity of this rack is at least four bicycles. There are no dining or retail services on site.

Sidewalks/Pedestrian Amenities		
	<i>Circulation</i>	<i>Other</i>
<i>Type</i>	Sidewalks Ramp	Bicycle rack
<i>Condition</i>	Sidewalks - good Ramp - good	Good
<i>Dimensions</i>	Sidewalks – six feet	N/A

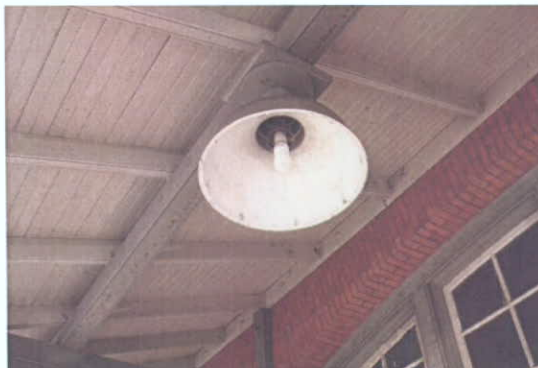
In addition to parking lot lighting, fixtures are situated along the station driveway from Walnut Street and the bus station located in the basement of the station. In addition, there is roof-mounted lighting that extends the entire length of the station building canopy. All of these lights were operable.

*Station building canopy lighting*

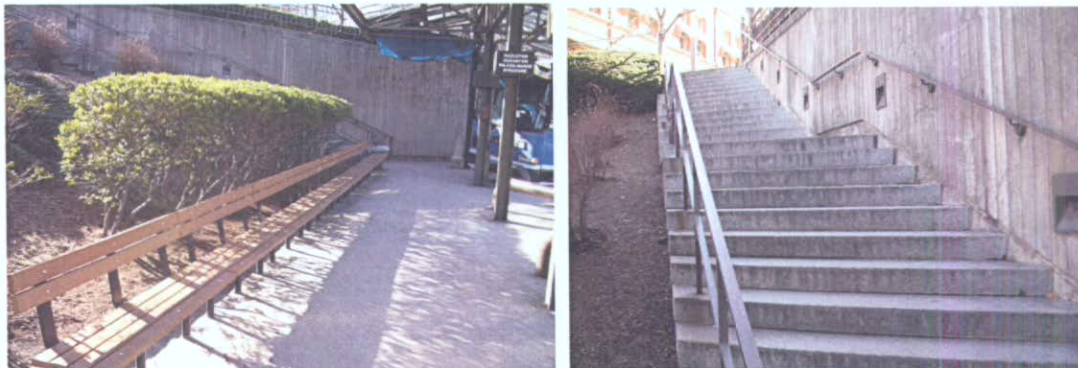
Connecting the parking lots and bus station areas is a set of stairs. On the northbound side of the station there is a flight of stairs leading up from the intercity bus station to the station building. These stairs have railings on either side, which is three feet in height. The stairs are concrete and are in good condition. In addition, there are sidewalks on both sides of the station driveway.

*Sidewalk along bus station leading to train station stairway*
