RESEARCH PROJECT NO. 99-051
EVALUATION OF POLYETHYLENE SNAP-TITE PIPE LINER

FINAL REPORT
JULY 2006

EVALUATION OF “63-inch” HIGH DENSITY POLYETHYLNE SNAP-TITE™ PIPE LINER

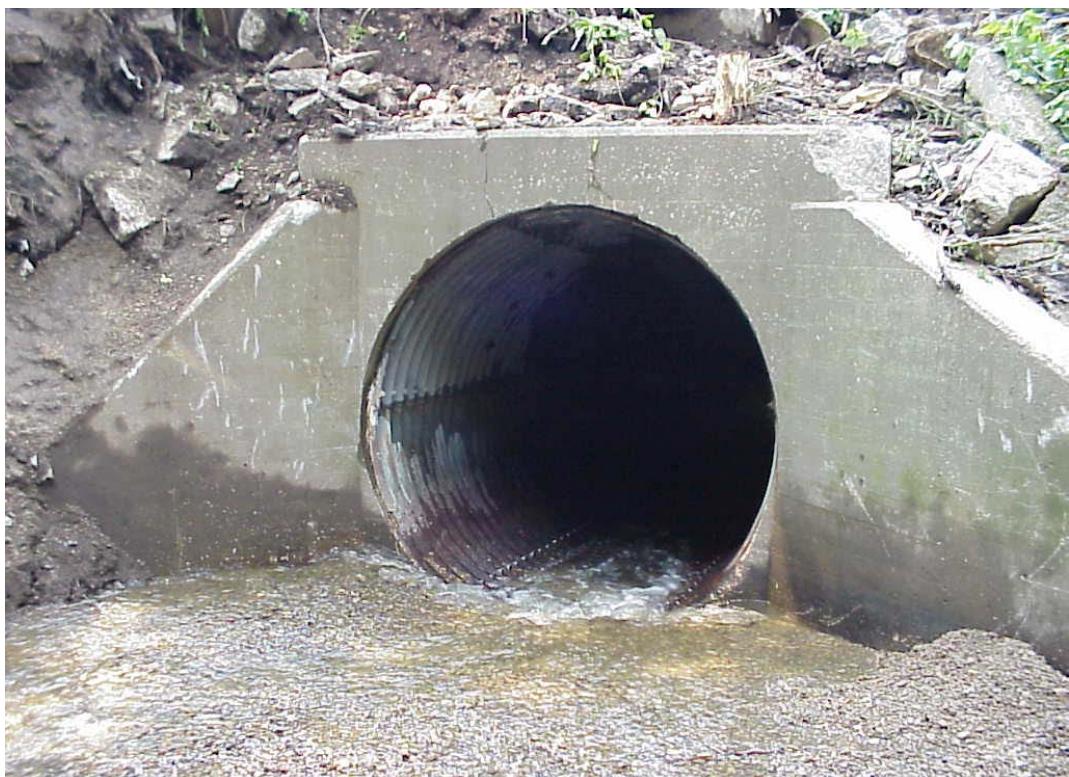
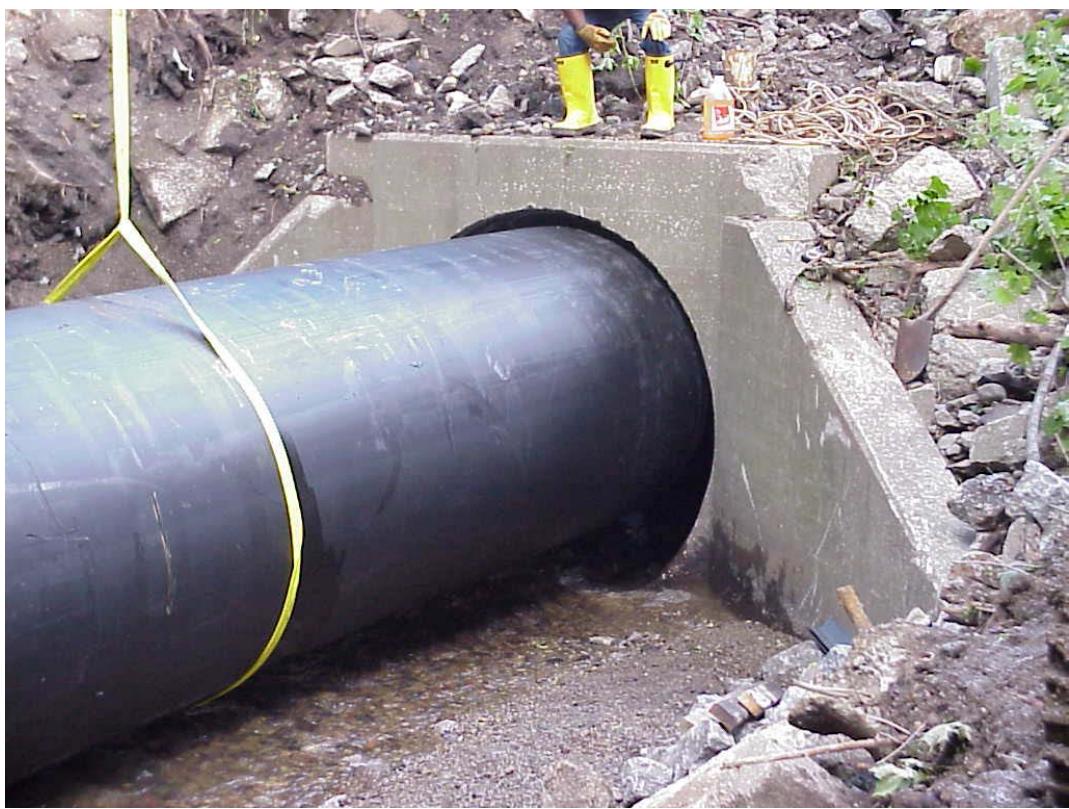
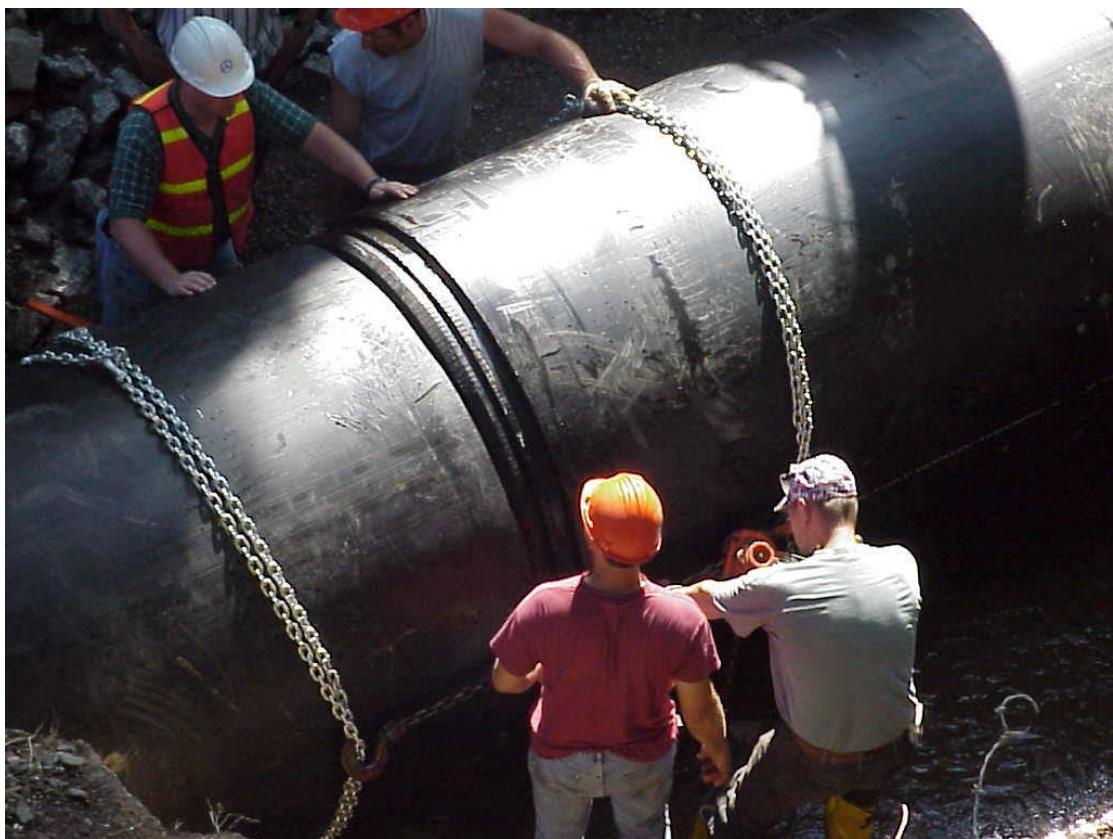
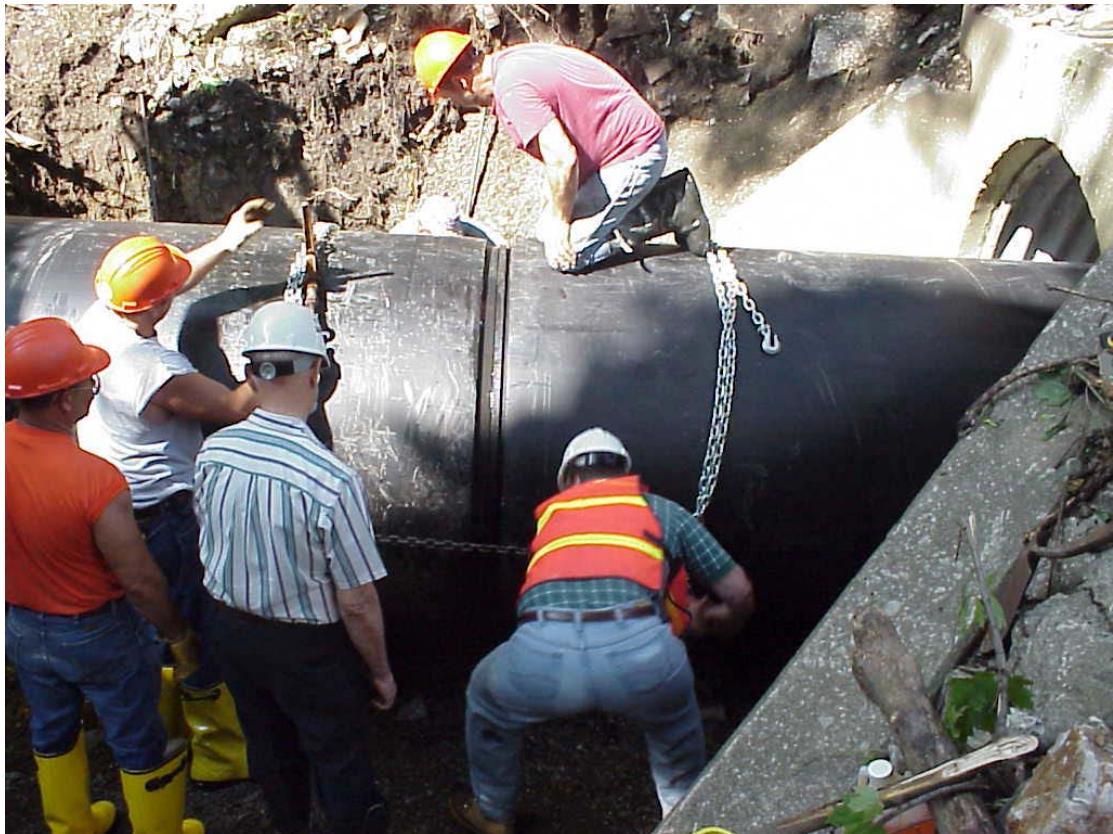
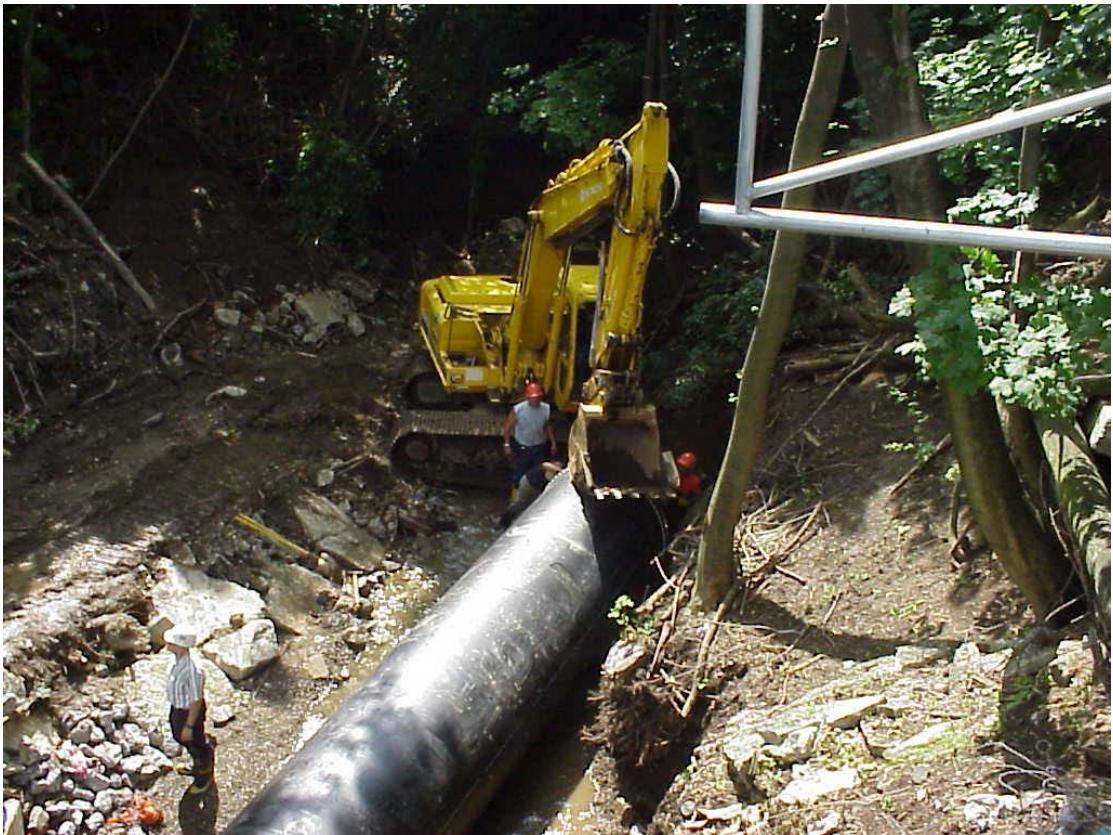
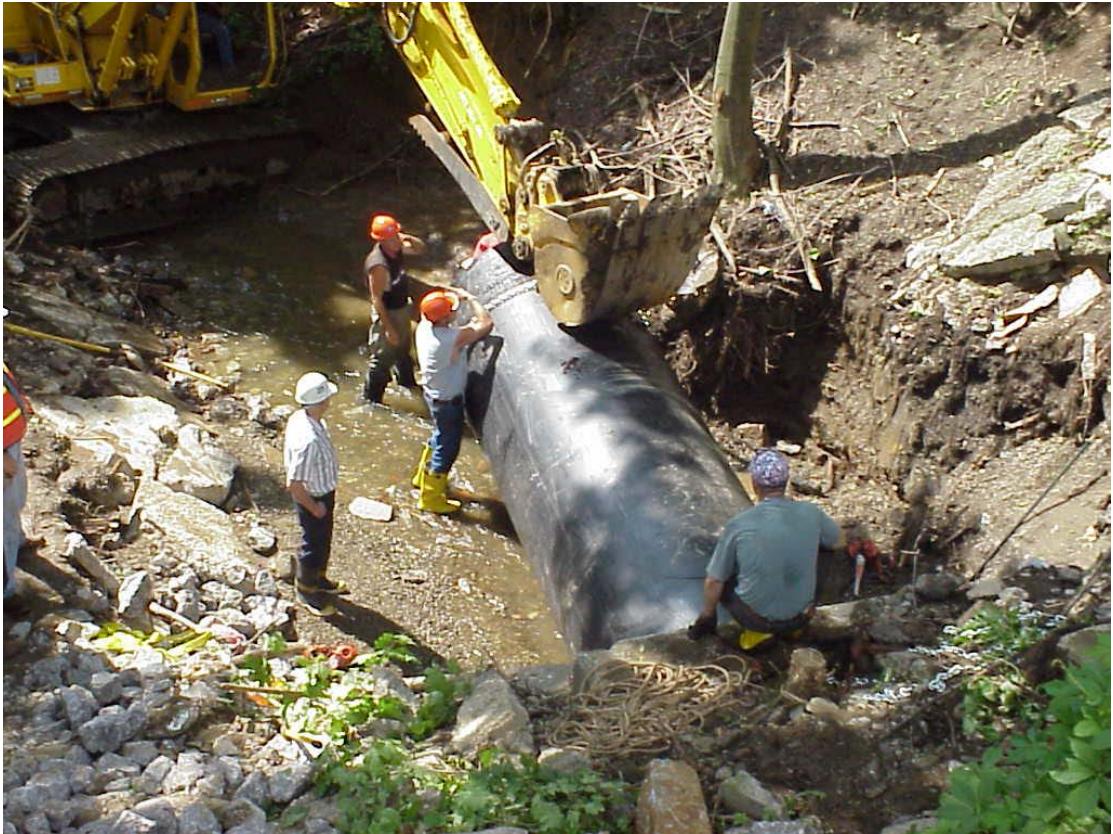
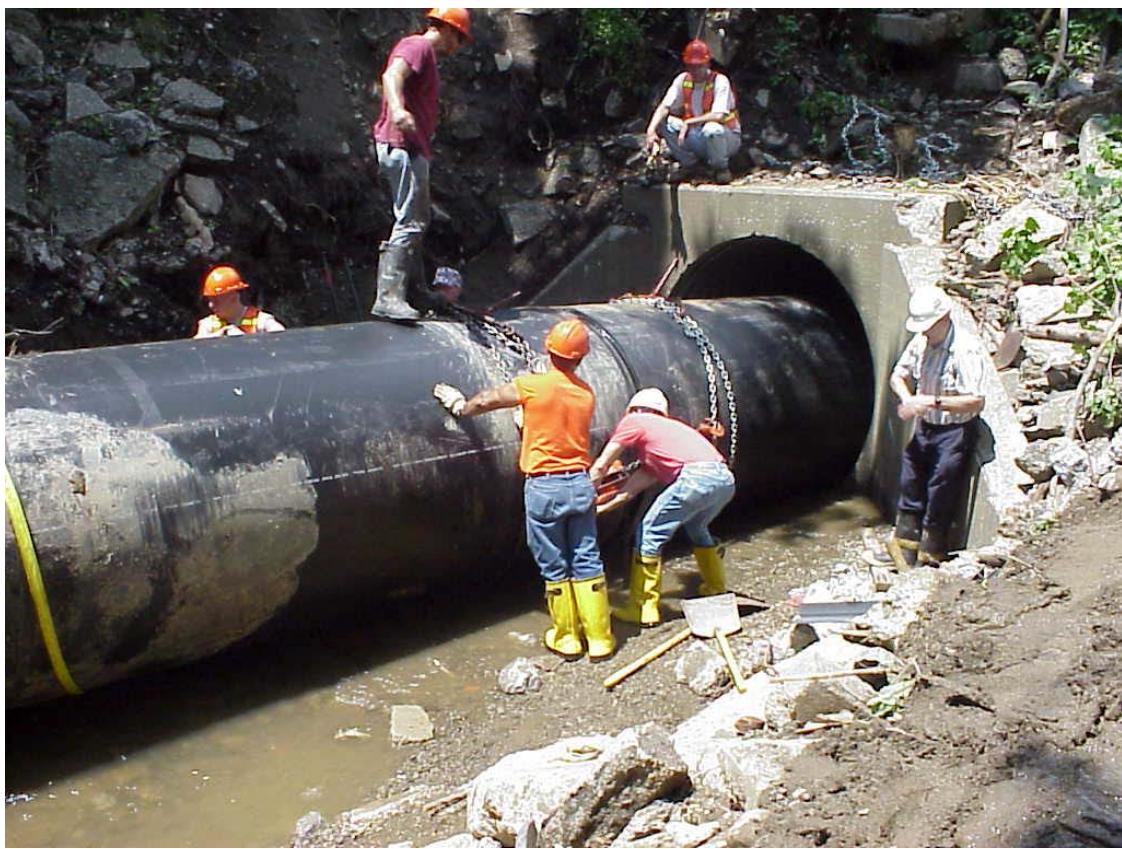
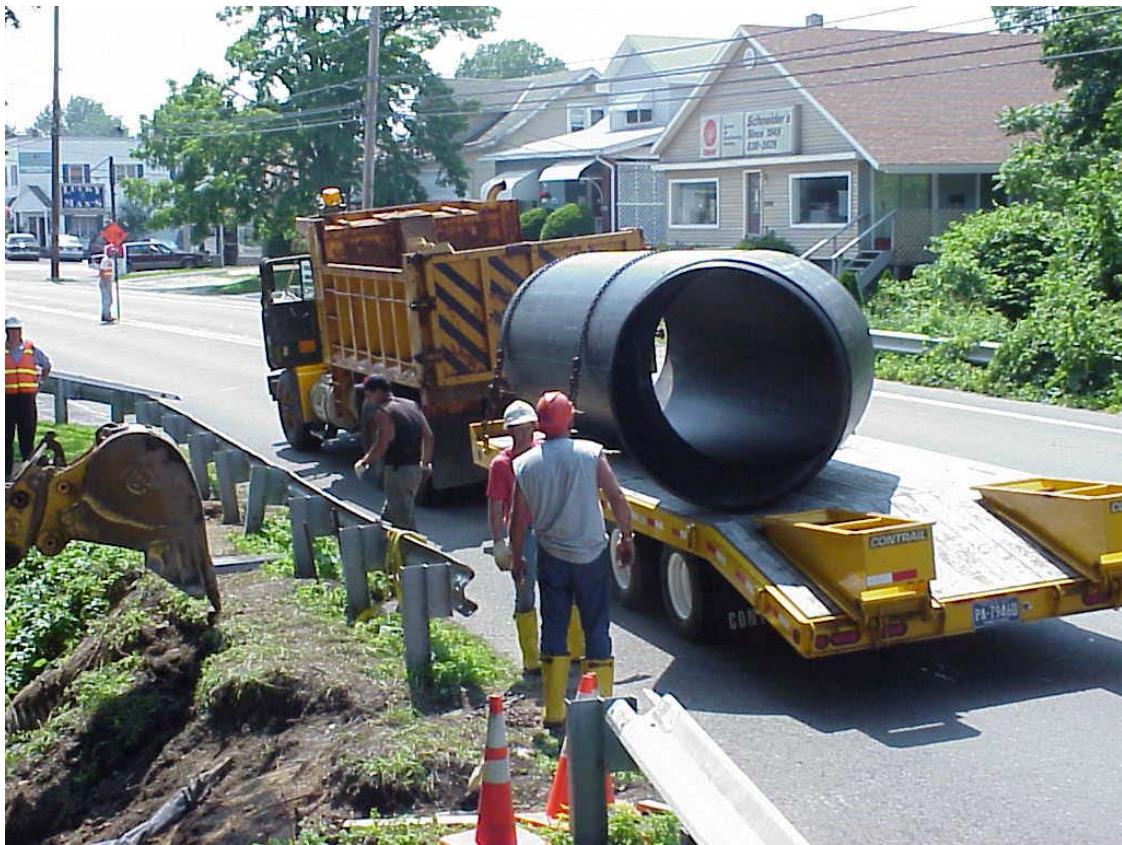
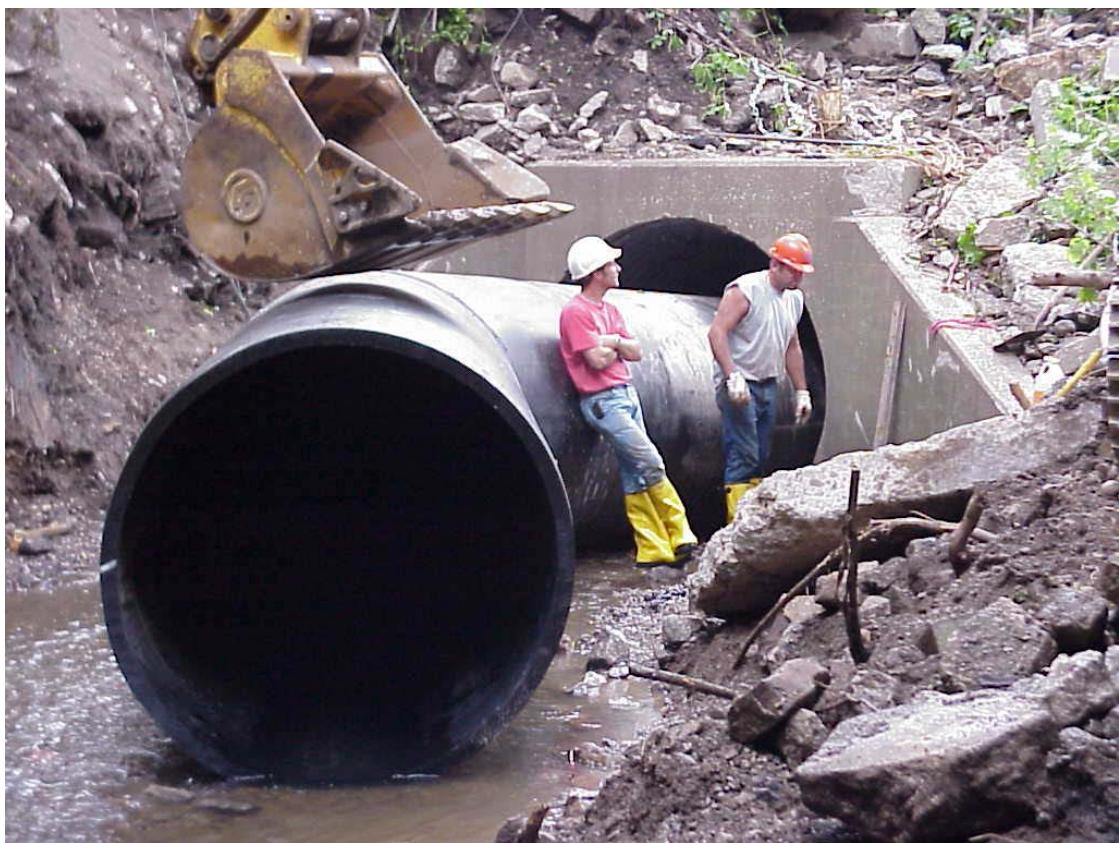
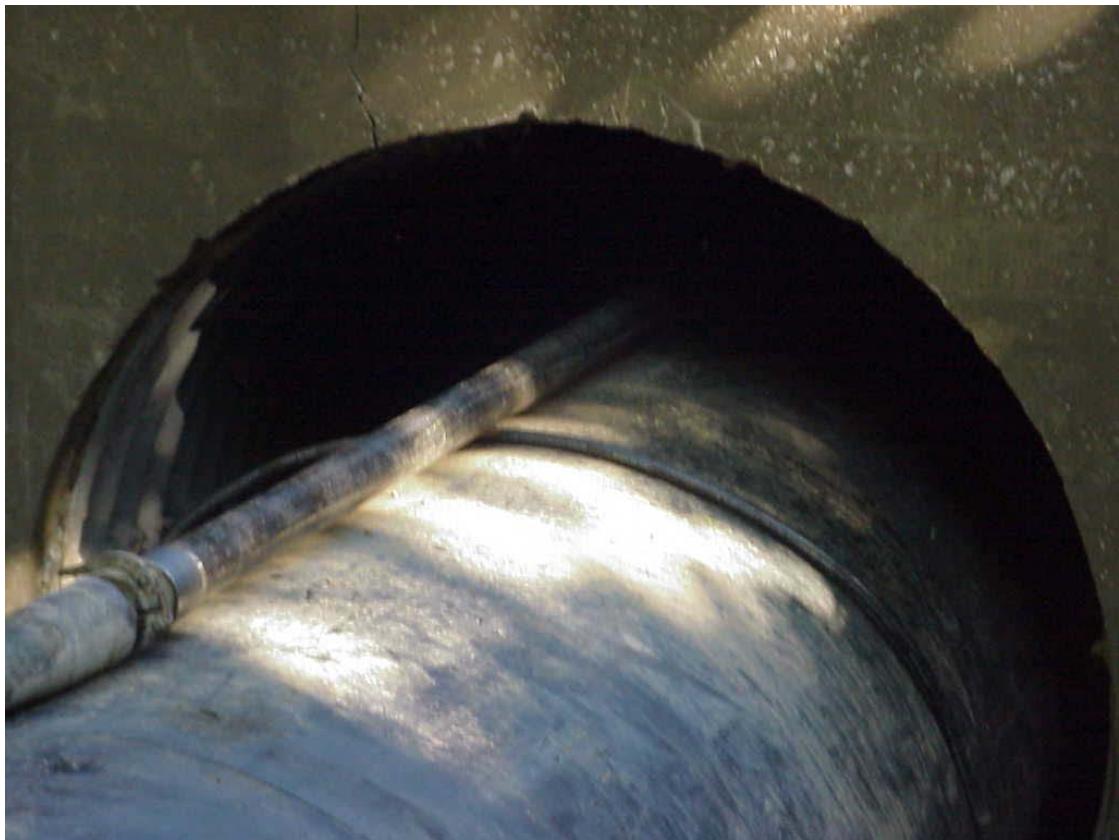
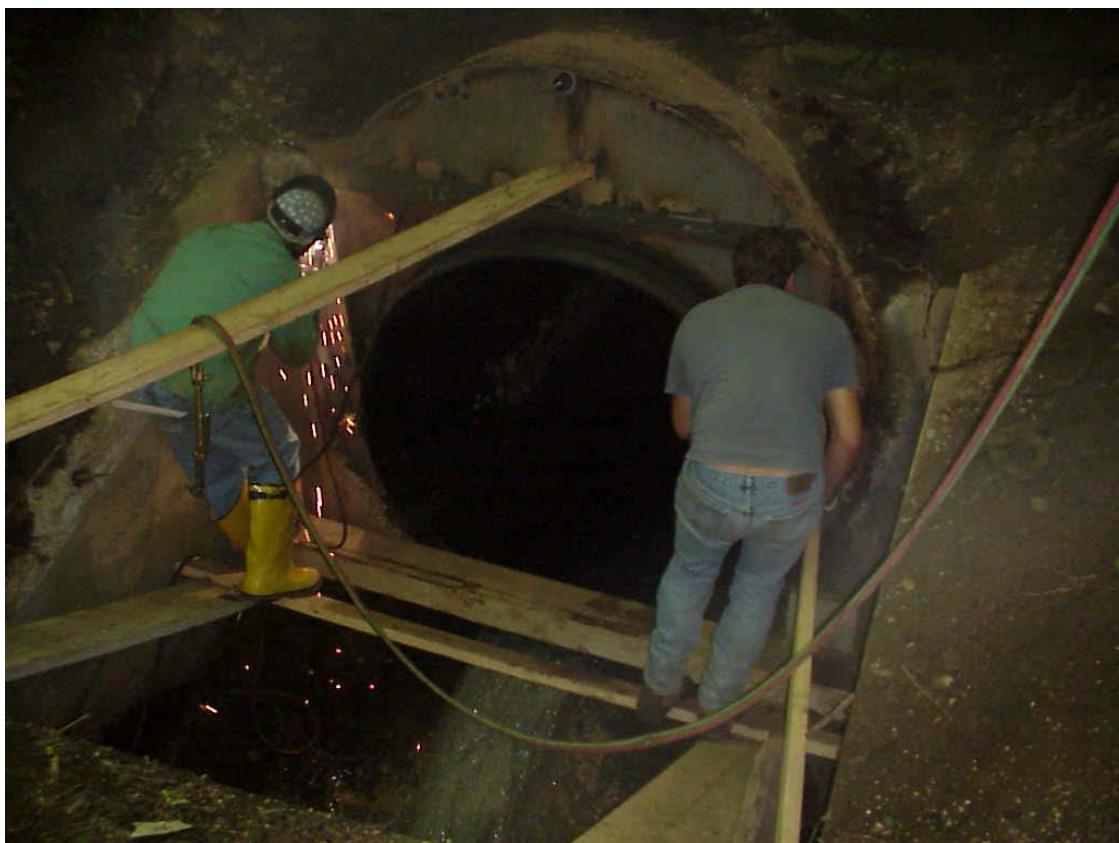
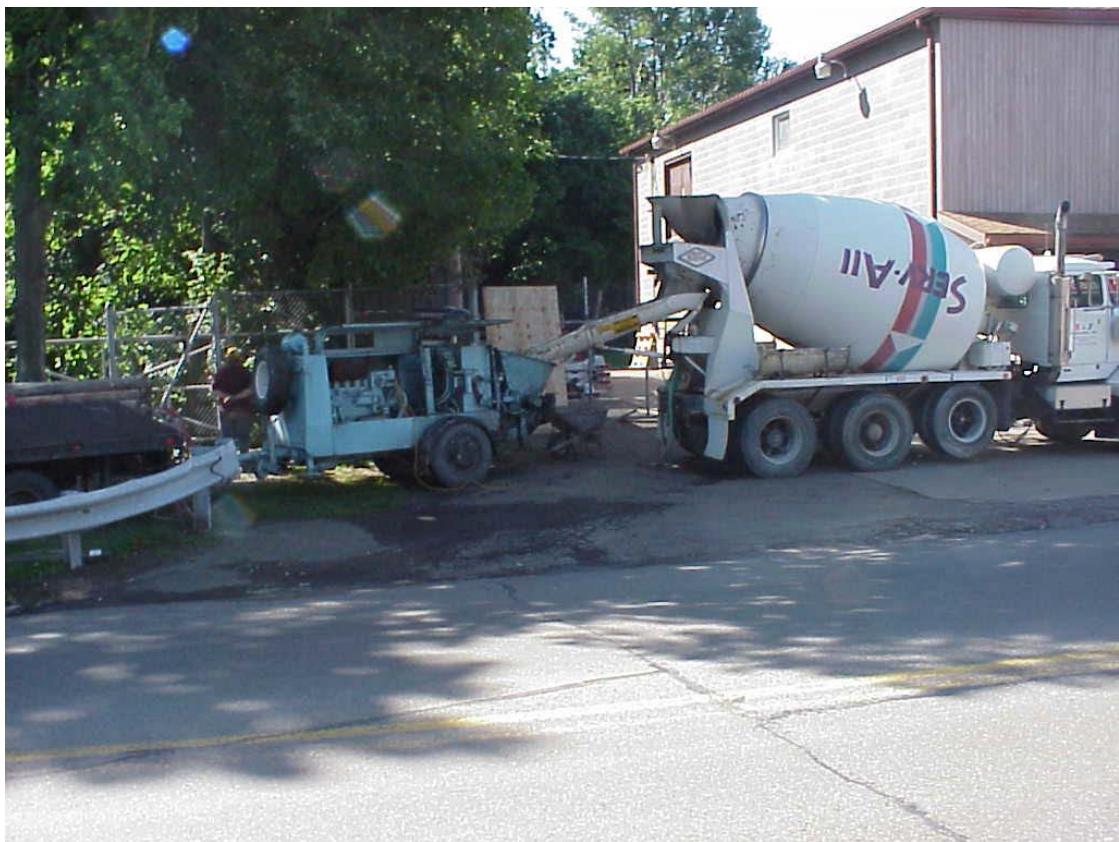
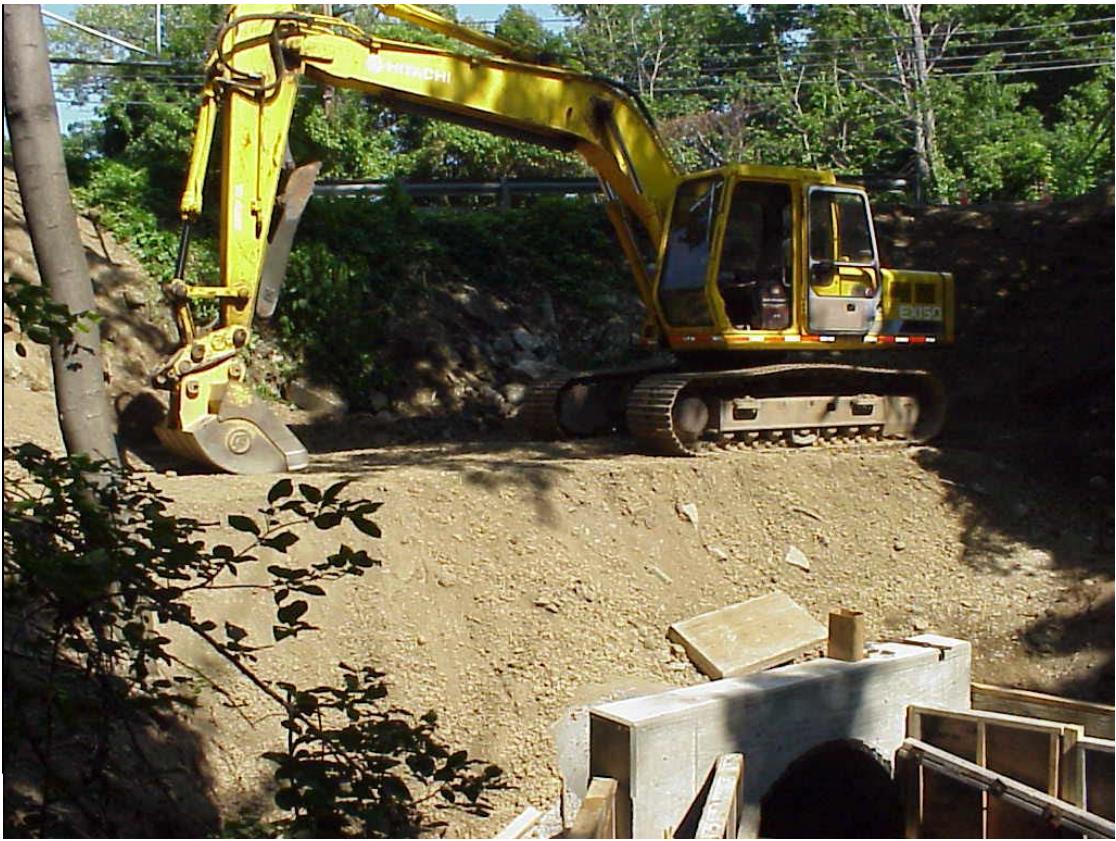
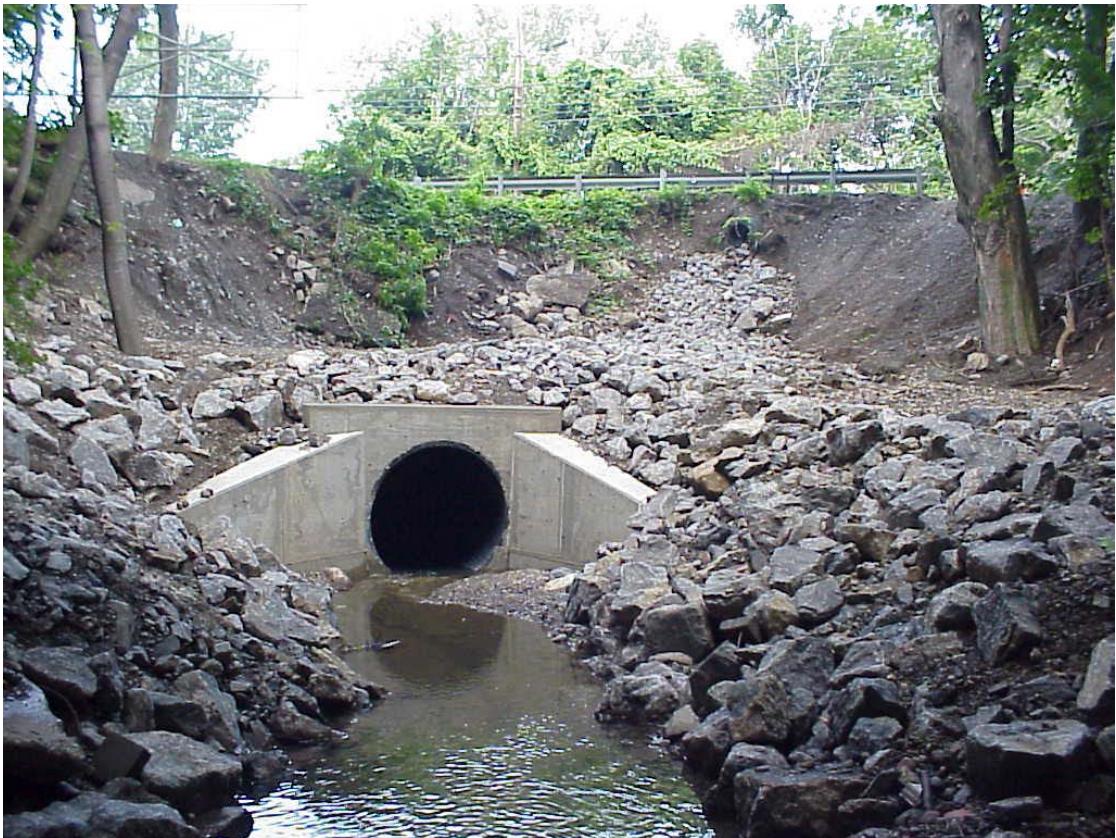
As a result of steep terrain a tracked excavator was used during the pipe liner installation. A minimal amount of excavation and tree removal occurred adjacent to the stream on the inlet side of the culvert in order to create a staging area for installation. The Snap-Tite pipe liner was installed according to the manufacturer's installation procedures which can be referenced in the Manufacturer's Installation Procedure section. This project occurred during a low flow period of the stream so the minimum amount of disturbance took place. Subsequent to the installation of the pipe liner the water flow was diverted back into it and the construction of a new D-W endwall was completed. Before the backfilling of the pipe extension a silt barrier fence was placed at the base of the slope in order to encompass the backfill area. While the embankment was being placed, R-4

rock-lined ditches were constructed down to the stream. In order to correct any of the minor disruptions to the environment, the disturbed areas were seeded and mulched after the completion of the embankment. After the permanent erosion and sediment controls were established the temporary controls were removed. Photos, with captions, of the actual pipe liner installation can be referenced in Construction Photos section of this report.
