DEPARTMENT OF TRANSPORTATION

# Microbial Concrete Sealer

FINAL REPORT

University of Pittsburgh

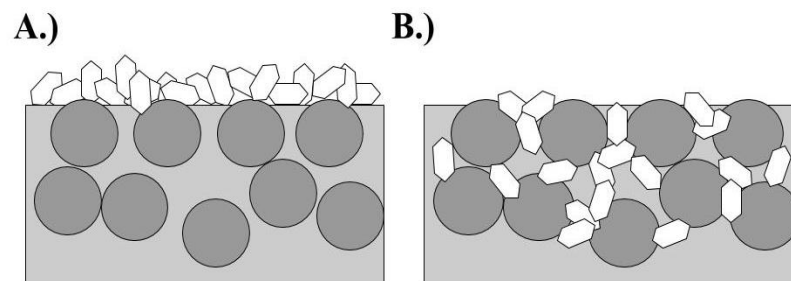
**Figure 1: General categories of MICP application to concrete.** Biodeposition (A.) results in a layer of calcium carbonate on the surface of the porous cement matrix, whereas biocementation (B.) adheres the cement matrix components together with calcium carbonate.

Biodeposition describes MICP that forms a surface-level barrier of calcite that protects the structure underneath, whereas MICP classified as biocementation uses the precipitated calcite within the structure's matrix to increase adhesion of the internal components (Figure 1) (De Muynck et al. 2010)(Achal et al. 2011).

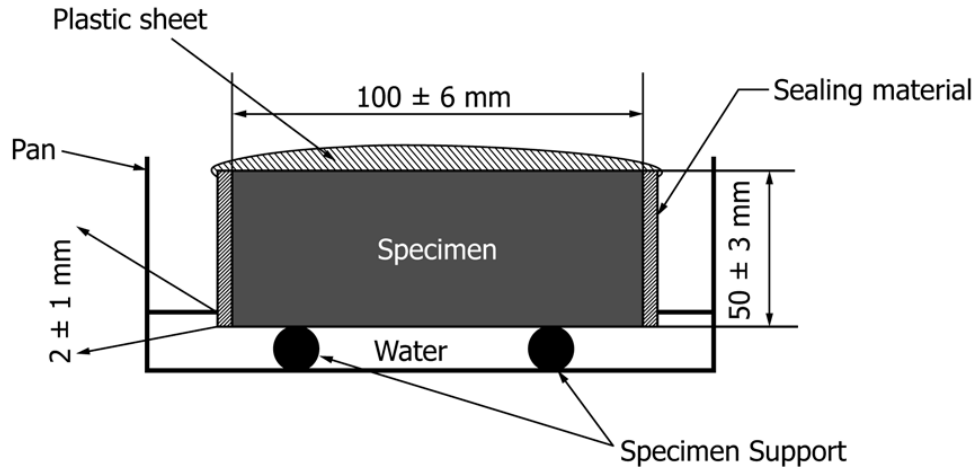
The ASTM standard test for permeability and absorption tests both the surface and interior concrete. Samples are 50mm-long, 100mm-diameter discs, either cut from cast cylinders or drilled cores. They are placed either in an environmental chamber capable of maintaining a temperature of 50°C and a relative humidity of 80%, or in a 50°C oven and a desiccator with relative humidity controlled by a solution of potassium bromide (not to come into direct contact with the specimens). After 3 days the specimens are removed, with the sides sealed (with epoxy paint, tape, or adhesive sheets), and the non-water exposed surface covered with a plastic sheet. Specimens are then placed in a pan on supports and submerged under up to 3mm of water. The specimen is weighed over the course of 6h for the first day, then daily over the course of a week (ASTM C1585).

**Figure 2. ASTM C1585 Test Setup (ASTM C1585)**

This is likely the easiest method, although a concerning risk is that prolonged time in the oven or environmental room may prove detrimental to the microbes. The biomortar should be either applied in a thin layer over the water-exposed surface, or potentially used to seal two discs together. A similar method, ASTM C642, tests the maximum amount of water that can be absorbed by dry specimens. In that test, the specimens are oven-dried, immersed in 21°C water, and then boiled underwater for 5 hours. This may prove a simpler method, provided the boiling does not impact the microbes.

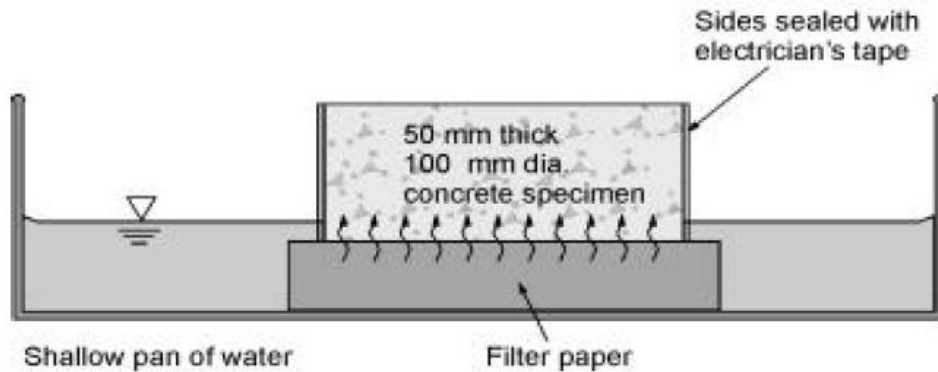
Not to be confused with absorption, sorptivity is “a material’s ability to absorb and transmit water through capillary suction.” The ASTM field test is relatively simple: a sample is dried for 7 days at 50°C and cooled for 3 days in a sealed container, then sealed on the sides with electrical tape. Similar to the absorption test above, the sample is placed in a container immersed in 5-10 mm of water, although placed on filter paper. The sample is periodically (over the course of minutes) removed and weighed to determine the amount of water absorbed. The cumulative water absorbed versus time can be plotted, and the sorptivity is calculated by finding the best fit line.

**Figure 3. Sorptivity Test Setup (Stanish et al. 1997)**

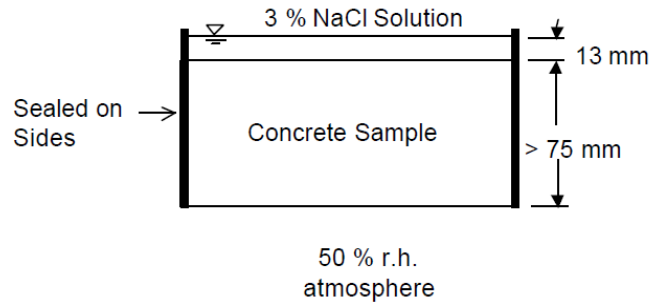
The abovementioned chloride ponding test is performed on specimens of at least 75mm in thickness and 300mm<sup>2</sup> surface area. The slabs are moist cured for 14 weeks and then stored for 28 days at 50% relative humidity. The slabs' sides are sealed with one face exposed to a drying environment and the other submerged under a 13mm pond of 3% NaCl solution for 90 days. At the end of this lengthy period, successive 0.5-inch slices are taken from the slabs and the average chloride concentration is determined. However, this resultant chloride penetration profile is very crude and is not purely the result of chloride diffusion.

**Figure 4. AASHTO T259 Test Setup (Stanish et al. 1997)**

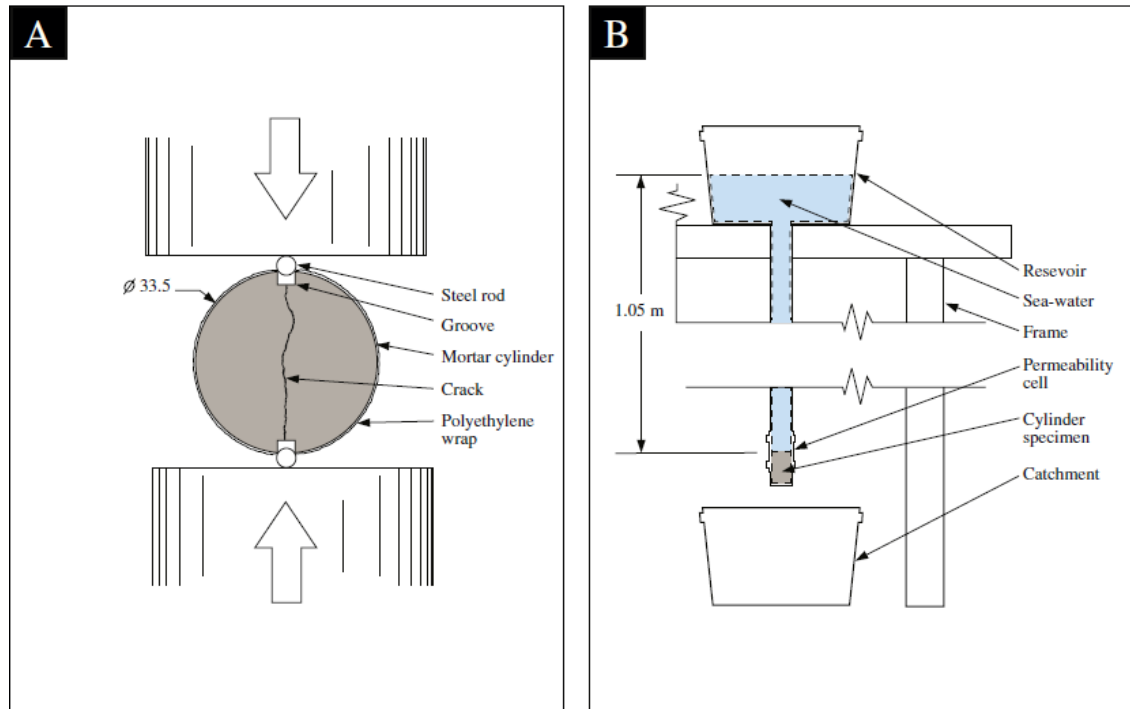
A study of particular interest examined the self-healing properties of mortar submerged in seawater. Mortar cylinders were wrapped in polyethylene and subjected to tensile cracking. They were placed under 1 to 1.05m of synthetic seawater, with the water seeping through the cracks to be collected and weighed in a catchment bucket. However, the paper's explanation of the testing procedure is somewhat unclear. It says the specimens were submerged and vacuumed for 2 hours, then submerged in 4 L of seawater for either 28 or 56 days, then dried for 28 days, with permeability measurements taken at each interval.

**Figure 5. Test Setup (Palin et al. 2016)**

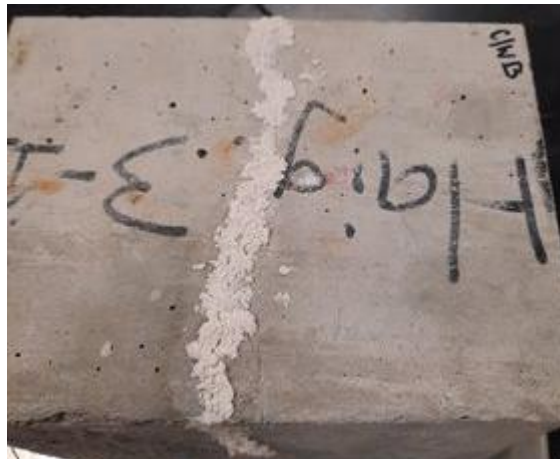
After numerous iterations of biomortar design, the final biomortar was prepared by creating a 3:8 mixture of 7-day old MICP culture and sterile sand to make a paste which was put in the lower half of the crack using a sterile spatula. The upper section of the crack was then filled with a slurry comprised of a 5:2:0.4 mixture of sterile sand, 7-day old culture of MICP microorganisms (Figure 10), and binder. The microbial dose in the biomortar was approximately  $3.39 \times 10^9$  colony-forming units /mL. This two-phase application provided the best visual seal in the RC cracked specimens, likely because the foundational paste acted as scaffolding to the slurry that had a greater proportion of microorganisms in the lower half of the crack. Over the 7 days the biomortar was allowed to set, the consolidation was apparent on the biomortar's surface, which was likely a thin calcin layer created by the microorganisms (Figure 6).

**Figure 6. Photo showing a representative example of the biomortar after setting**

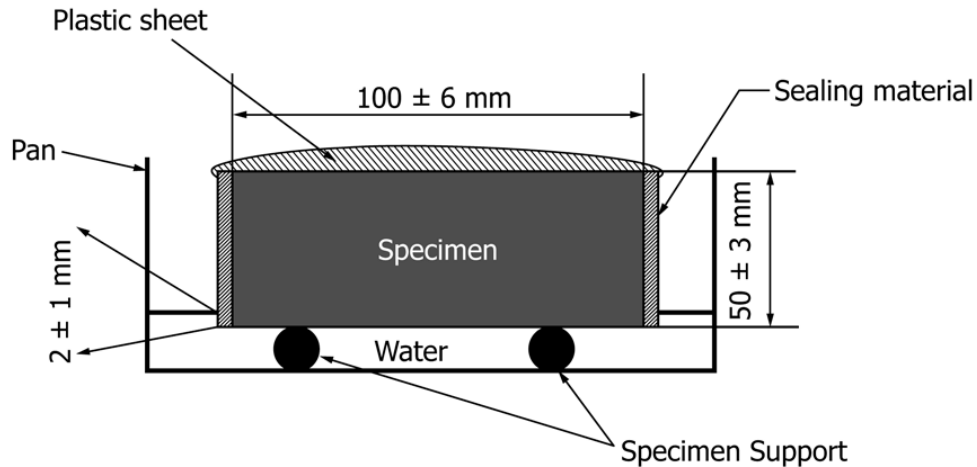
In the modified procedure from ASTM C1585, cylindrical specimens are cured for 7 days and stored in a 100°C oven for 24 hrs., before storage in dry sealed containers for a further 5 days. After this storage period, each of the four cylinders is cut into four 2-in. tall cylinders, giving 16 specimens for testing. Biomortar is then applied to the circular faces of eight of these specimens, while the other eight are left untreated as a control group. After 16 hours, the biomortar on the treated and untreated specimens is hard enough for the specimens to be returned to a curing room for moist curing for 7 more days. Upon maturation of the biomortar, the sides of the specimens are painted with waterproof commercial sealant, and the untreated faces are covered with plastic. The specimen is then placed biomortar-side down on supports partially submerged in water, as depicted in Figure 7. This prevents any water ingress except through the exposed surface treated with biomortar. Over the next seven days, the specimens are weighed at regular intervals (over the course of 6 hours on the first day and once daily on each following day) to determine the weight increase from absorbed water. Both the control specimens and the specimens treated with the biomortar are tested.

**Figure 7. ASTM C1585 Test Setup (ASTM C1585)**

Next, the absorption of water into the water-exposed surface is determined. The absorption is the change in mass divided by the product of the cross-sectional area of the test specimen and the density of water. For the purposes of this test, the density of water was assumed to be .001 g/mm<sup>3</sup>; the temperature dependence of the density of water was neglected. The absorbance is calculated using the equation below.

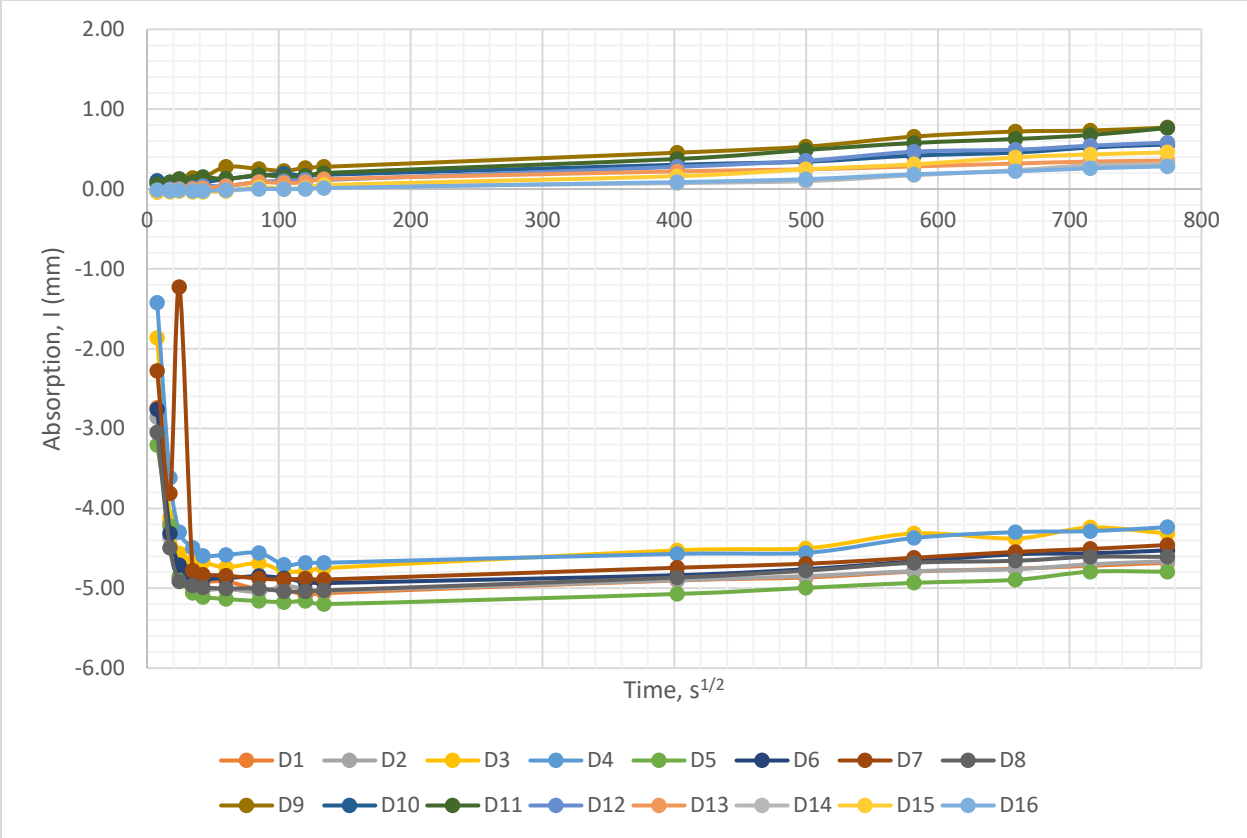
**Figure 8. Water Absorption of Cylindrical Specimens**

While the cylindrical control specimens exhibit reasonably linear behavior, the absorption values of the biomortar-coated specimens are offset by the mortar washout across the first day of testing. The biomortar washout decreases the starting mass far more than absorption of water increases it, resulting in apparently negative values for absorption. Results stabilize to more linear behavior over the following week, allowing the calculation of initial and secondary rates of water absorption  $S_i$  and  $S_s$ , by obtaining the slopes of the absorption graph via least squares linear regression analysis. Initial rate is calculated using absorption values of the first day and secondary rate is calculated with the remaining values. These results are displayed below in Table 5.

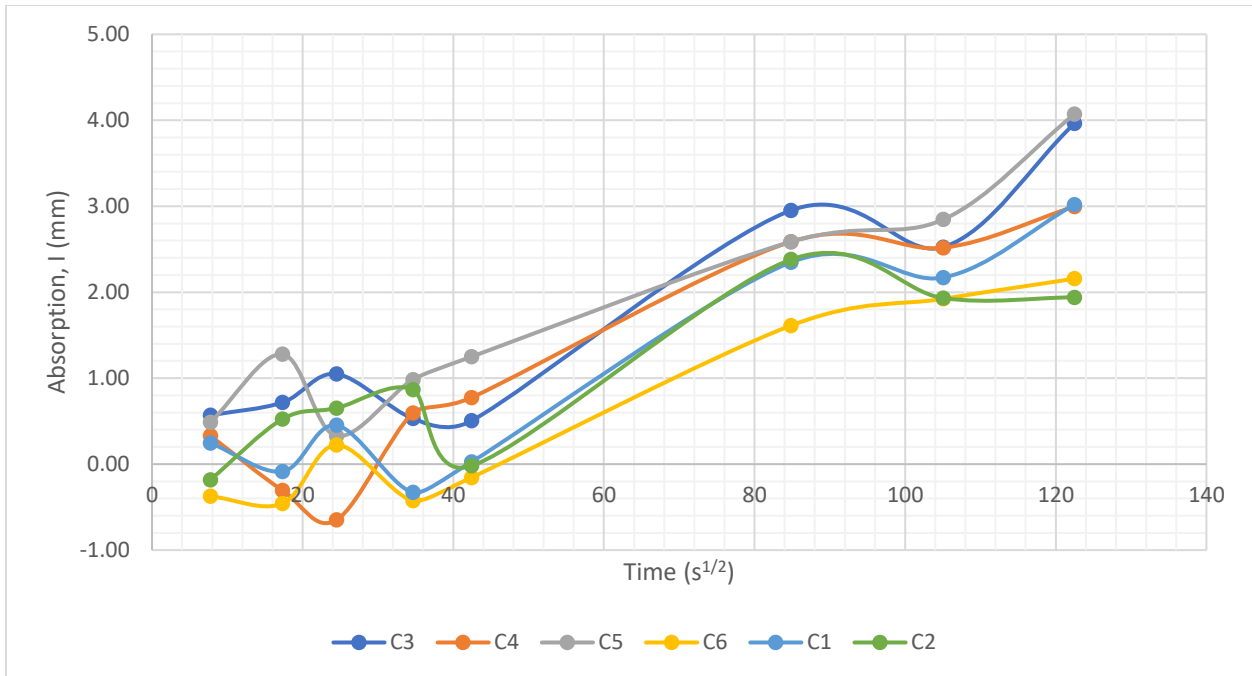
The rates of water absorption are offset by the biomortar washout on the first day, but stabilize and remain consistent for the secondary rates for all specimens.

**Figure 9. First Day Water Absorption of Cubic Specimens**

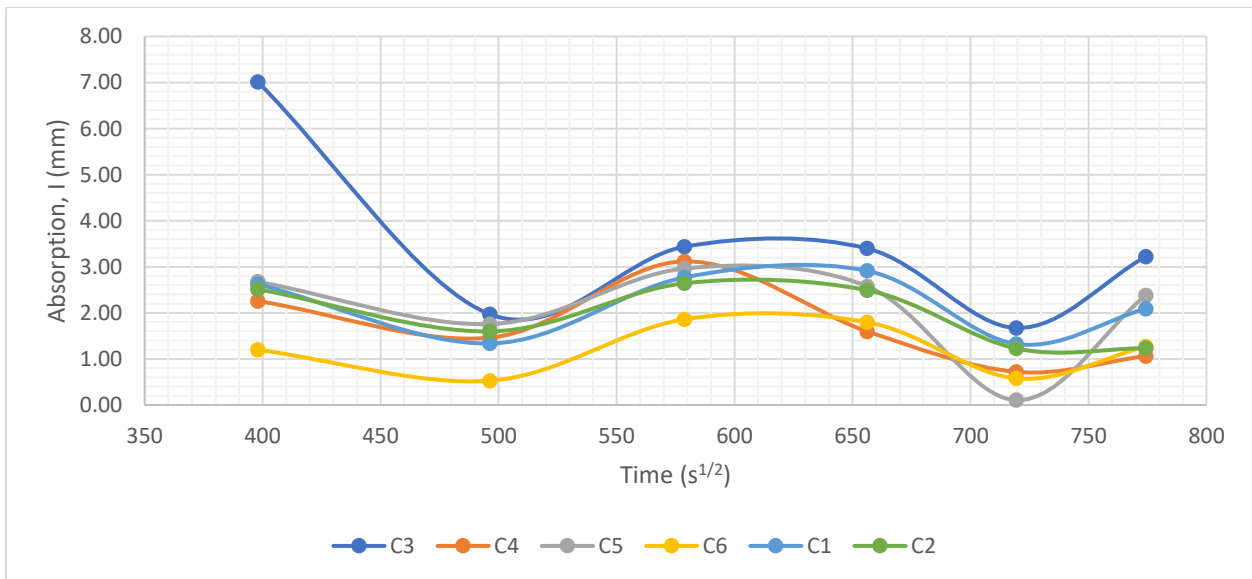
**Figure 10. First Week Water Absorption of Cubic Specimens**

Although the biomortar remained cohesive for up to three days in the grooves of the cubic specimens, and consistency between specimens in terms of long-term results was greater overall, the absorption values of the cubes varied erratically in the first 30 minutes of testing due to mortar washout. Specimen C4 in particular suffered heavy washout, resulting in the offset in absorption values. Results stabilized during the remaining week of measurements, but the results were
