Safety Improvements - Barriers

MARKET STREET BRIDGE REHABILITATION

East Bridge

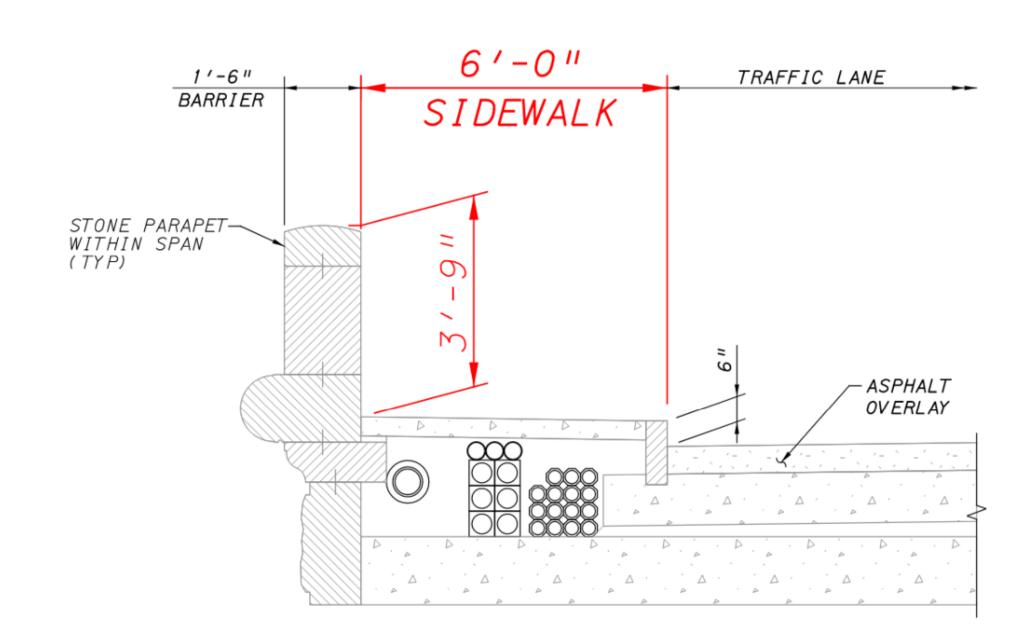
EXISTING SIDEWALK/BARRIER

(UPSTREAM SIDE SHOWN) (DOWNSTREAM SIDE SIMILAR)

Existing Historic Cut Sandstone Parapet

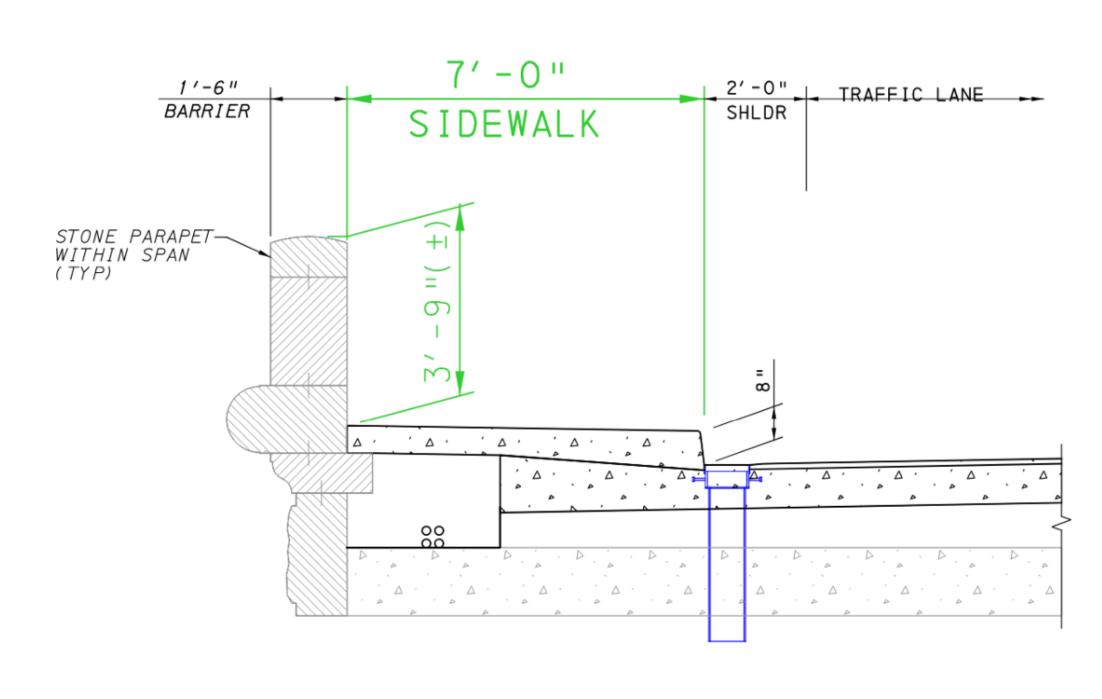
PROPOSED SIDEWALK/BARRIER

(UPSTREAM SIDE)

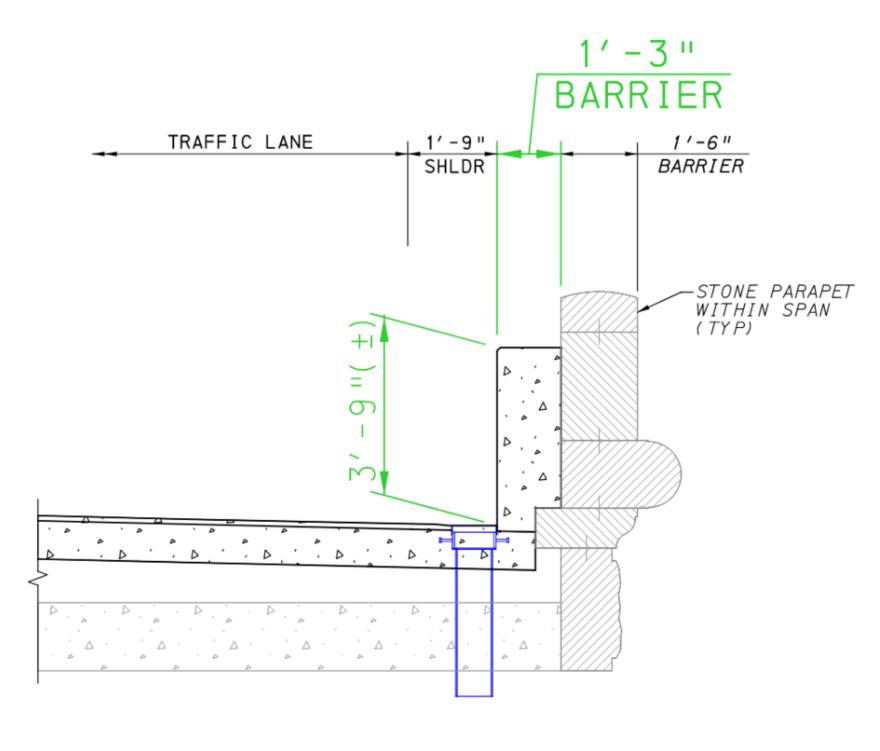
PROPOSED BARRIER

(DOWNSTREAM SIDE)

Preserve Historic Cut Sandstone Parapet
