Sign Post Driver

Upper Mount Bethel Township, Northampton County

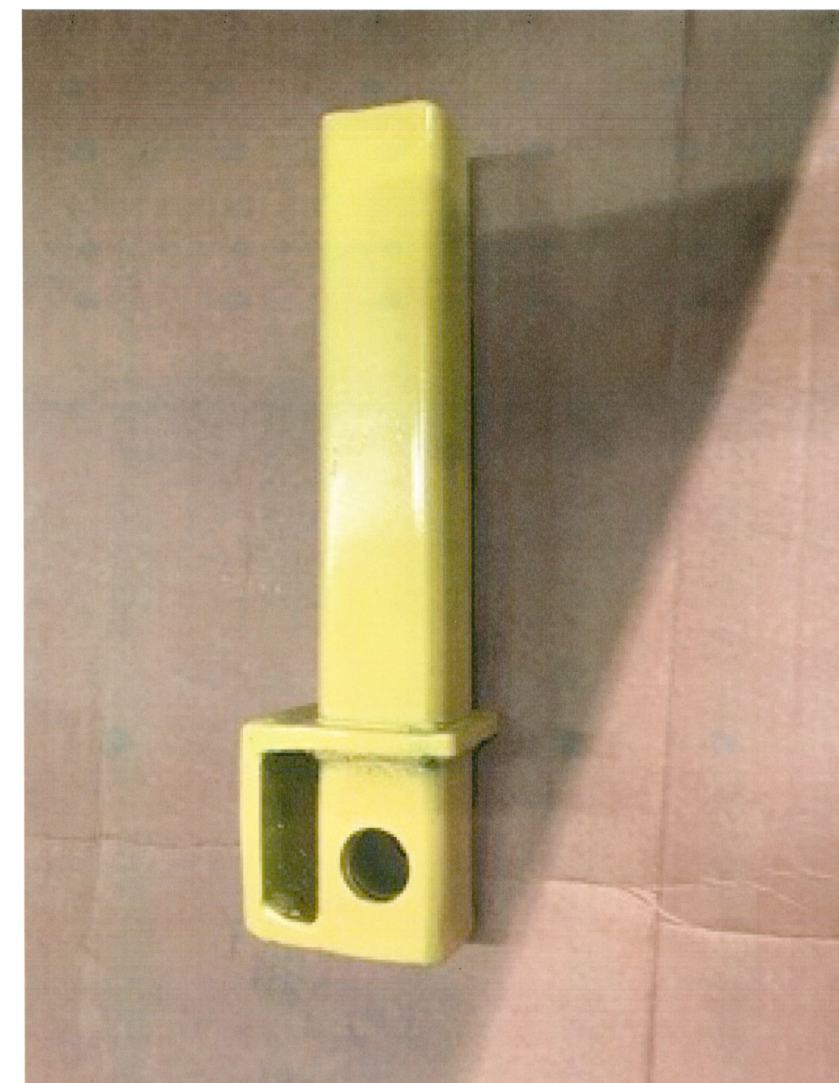
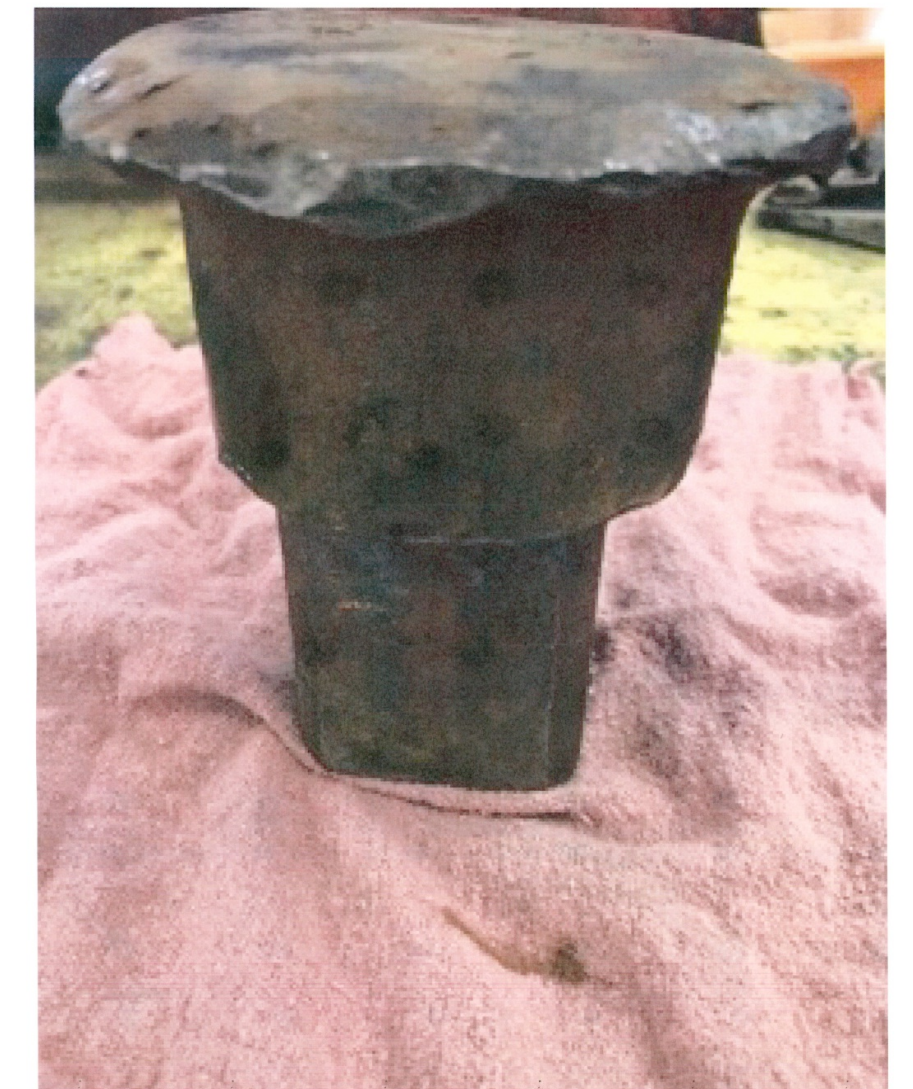
We no longer waste sign posts saving the township money.
