Brine Shop

Warren County/District 1

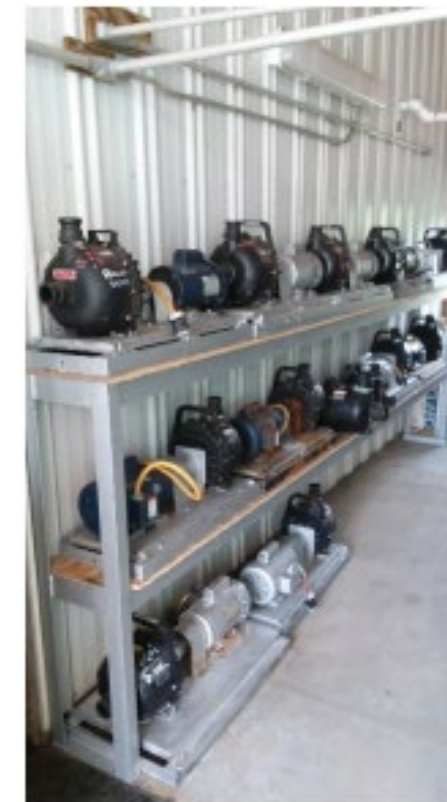
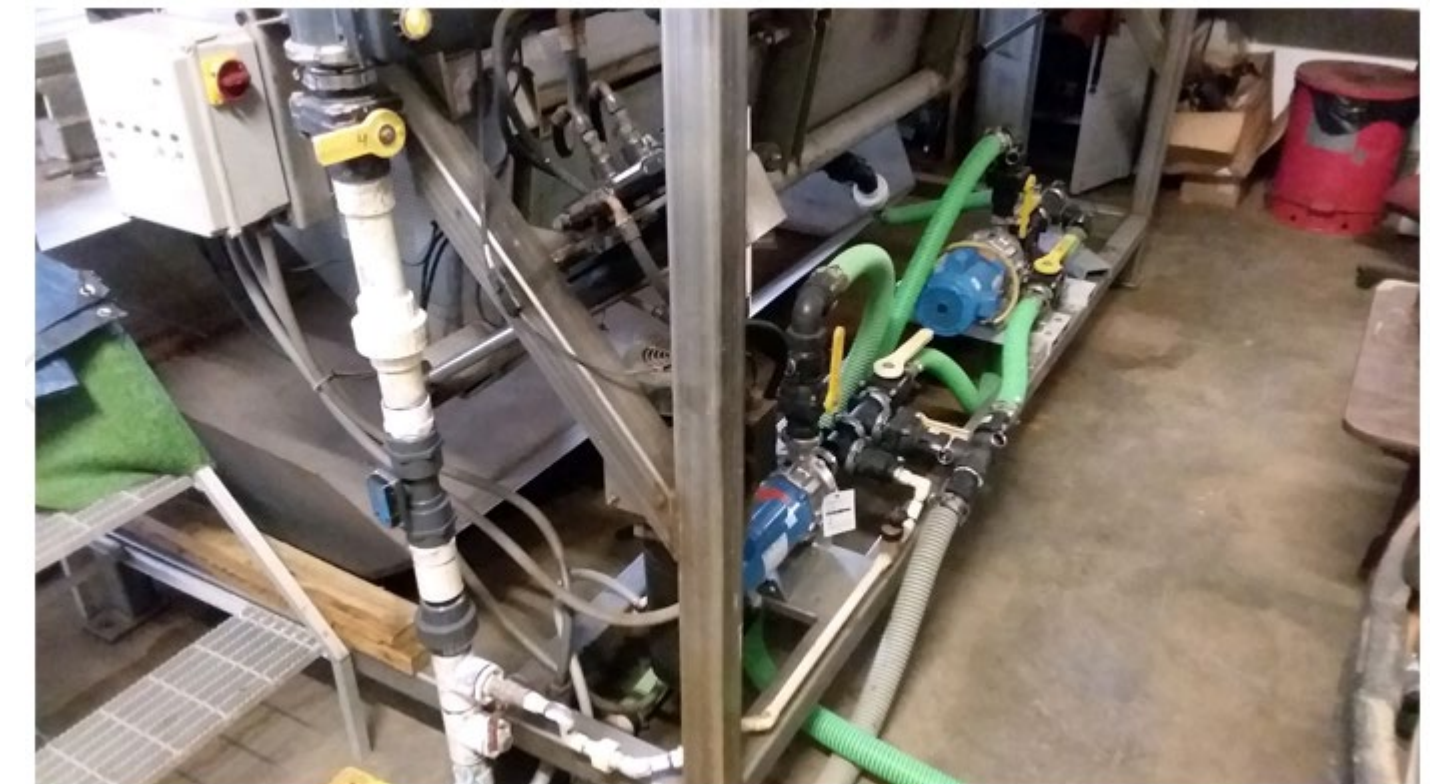
The first improvement was to create a better storage area for spare pumps and pumps stored over the winter. The MR2 staff, Josh Benjamin and Frank Byers, built shelving units to store the pumps. Additionally, a mock brine pumping area was created to test electrical and pumping capabilities for pump rehabilitation and trouble shooting in the workshop. Before, pumps were stored on the shop floor and testing was limited to field diagnostics; less diagnostic testing resulted in replacing pumps instead of repairing them.

The second improvement was altering how brine was produced. Alterations included relocating the supply gallon meter to more accurate locations, adjustments of valves, removal of unneeded filters, and directing the brine into a mixing tank. All these changes allow brine to be full free flow without the need to turn on and off water supply valves. Production went from 5,000 gallons per hour to 7,500 gallons per hour with consistent salt percentage/specific gravity.

Increased production, improved facility safety, and produced a more consistent product.
